SR 400 (I-4) Project Development and Environment (PD&E) Study
FM No.: 432100-1-22-01

Contamination Screening Evaluation Report
Segment 1: from west of CR 532 (Polk/Osceola County Line) to west of
SR 528 Beachline Expressway

Polk County (16320), Osceola County (92130), Orange County(75280)

July 2016

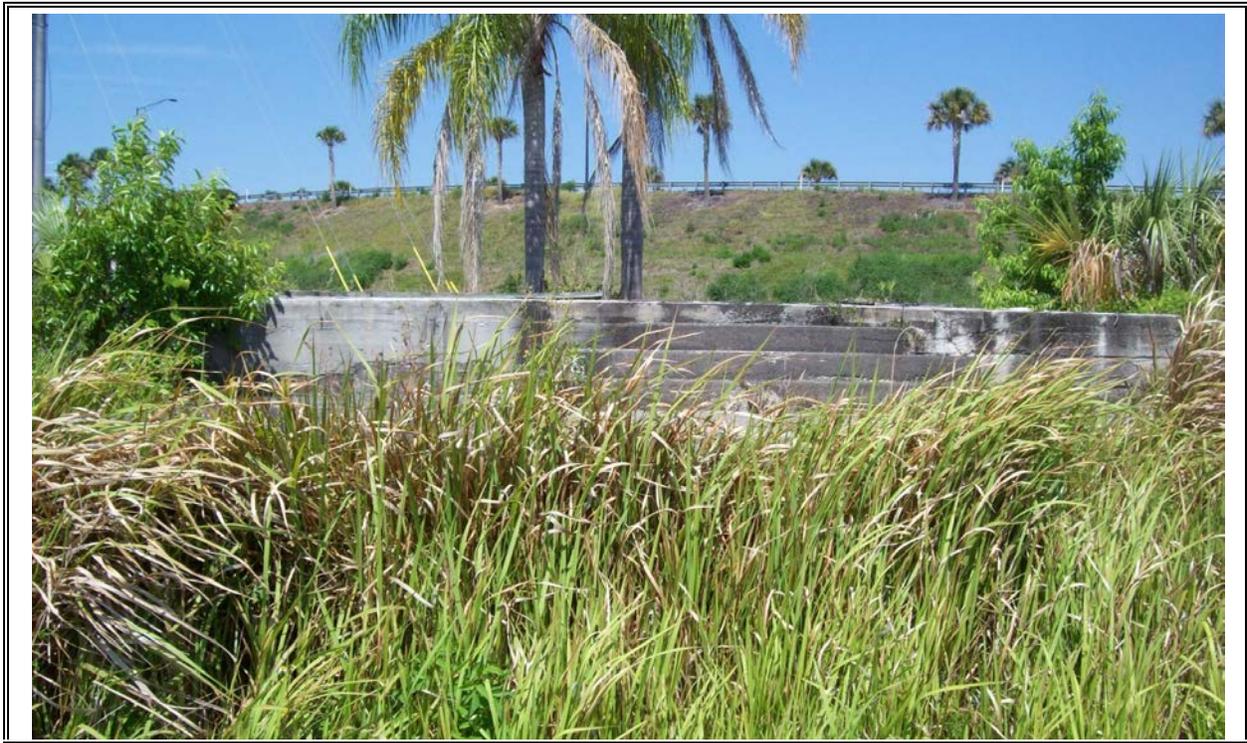
Site 10: Florida Gas Transmission Company – historic foundation

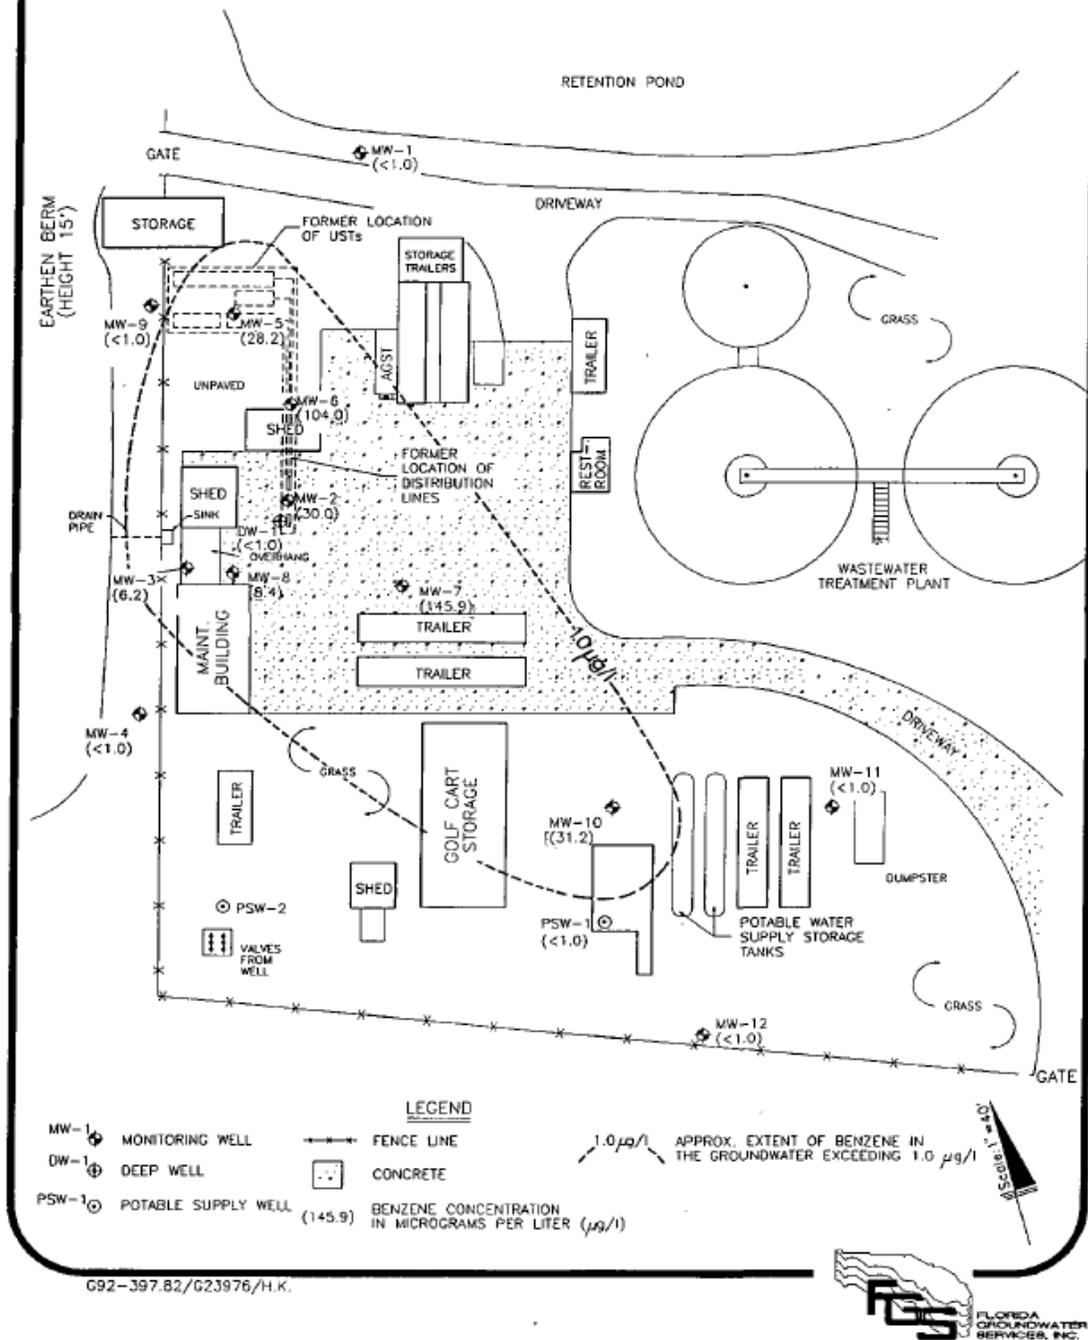
Site 30: Orlando Sun Resort & Spa, formerly Hyatt Orlando and Ramada Orlando Celebration Resort & Convention Center – Benzene Concentration Map by Florida Groundwater Services Inc.
