PAVEMENT SURVEY AND EVALUATION REPORT

FINANCIAL PROJECT NUMBER: 429079-1

STATE ROAD 400 (I-4)

SECTION NUMBER: 75280; MP 0.000 to MP 1.740
From Osceola County Line to East of SR 536

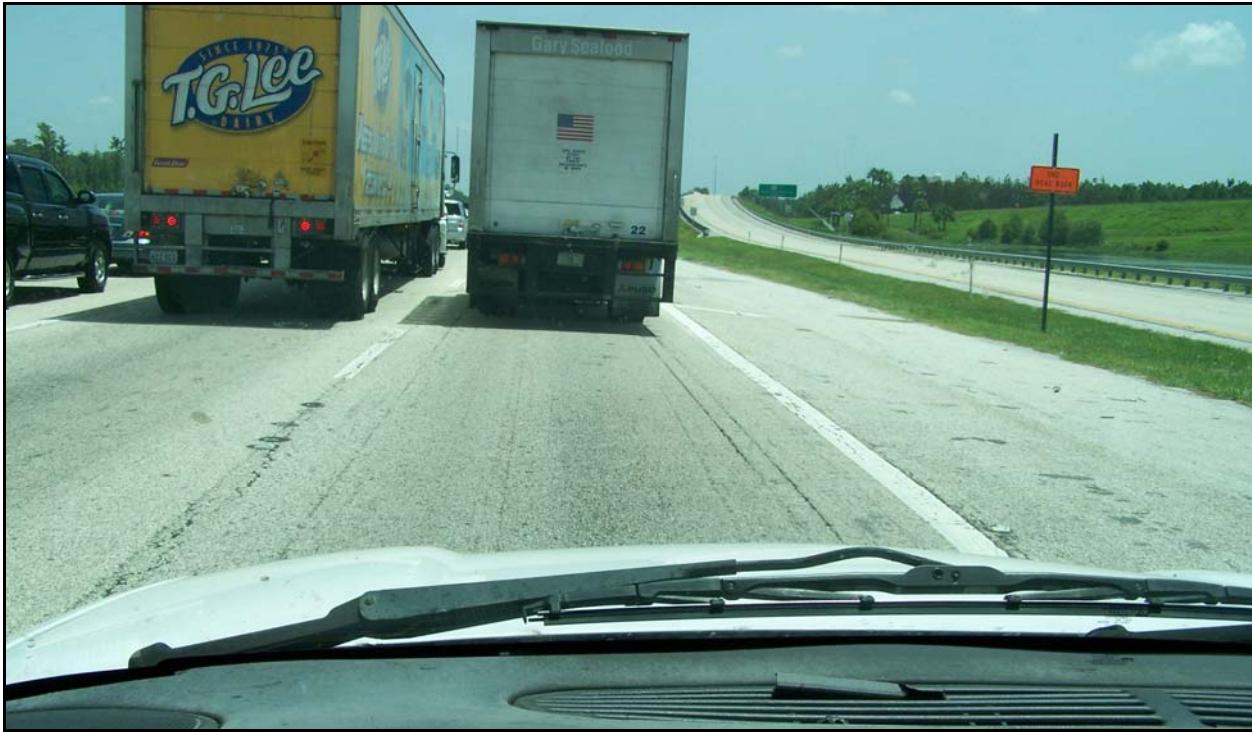
The eastbound mainline lanes are in fair to poor condition. The inside R1 passing and R2 middle lanes are in fair condition with shallow open-graded friction course cracking, and minor raveling. The R3 travel lane is in poor condition. There is moderate pop-outs of the coarse aggregates within the friction course, and some raveling in the wheelpaths. The cracking observed is mostly shallow (under one inch) Class I branch cracking in the wheelpaths. There are also two moderate to severe longitudinal Class II/III cracks at the pavement joints between the R2 to R3 lane, and from the R3 lane to the R4 lane. The R4 auxiliary lane is in fair condition, with pavement distresses similar to the R1 and R2 lanes.

Photo 1: I-4 eastbound near MP 0.029. This photo shows the deteriorated condition of the R3 lane.

We recommend that 3.25 inches of milling be performed to provide long-term pavement preservation of the existing pavement. This will remove all cracks and friction course raveling.

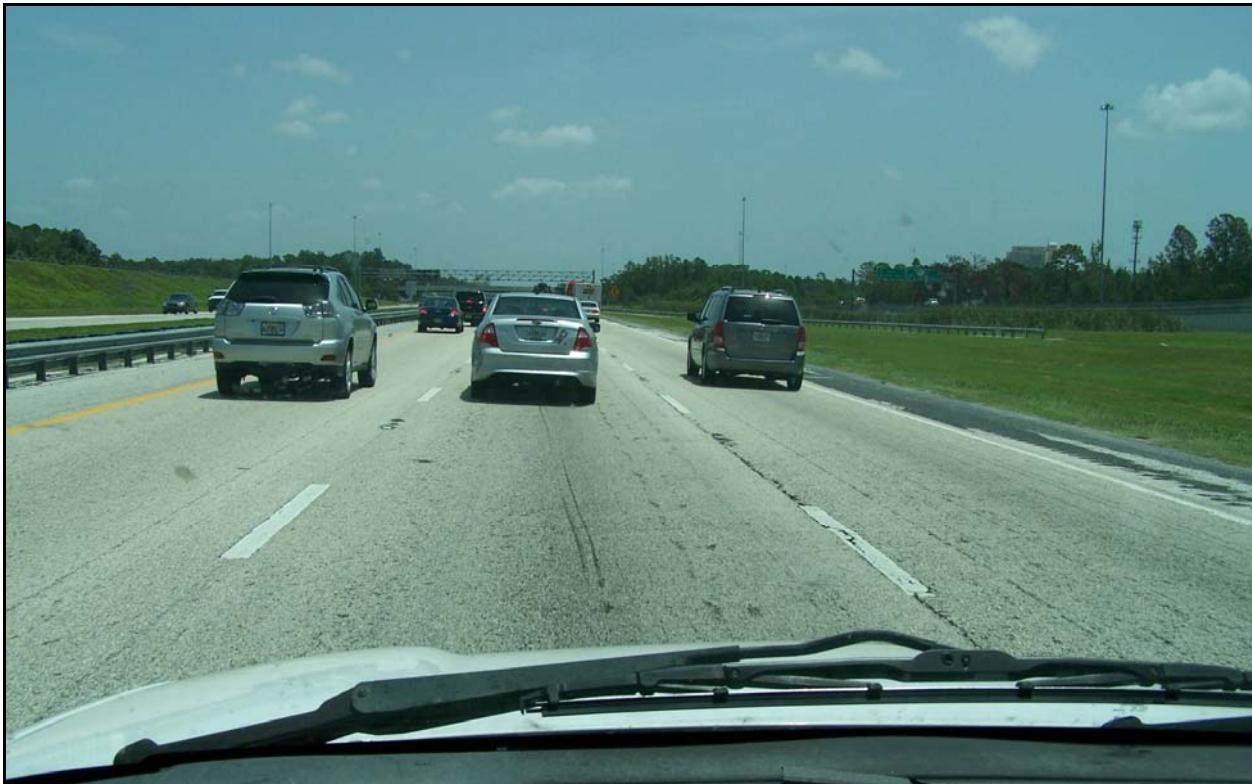
Photo 2: I-4 eastbound near MP 0.454. The R1 and R2 lanes are in better condition than the R3 travel and R4 auxiliary lanes. Note the chip seal overlay on the outside shoulder.

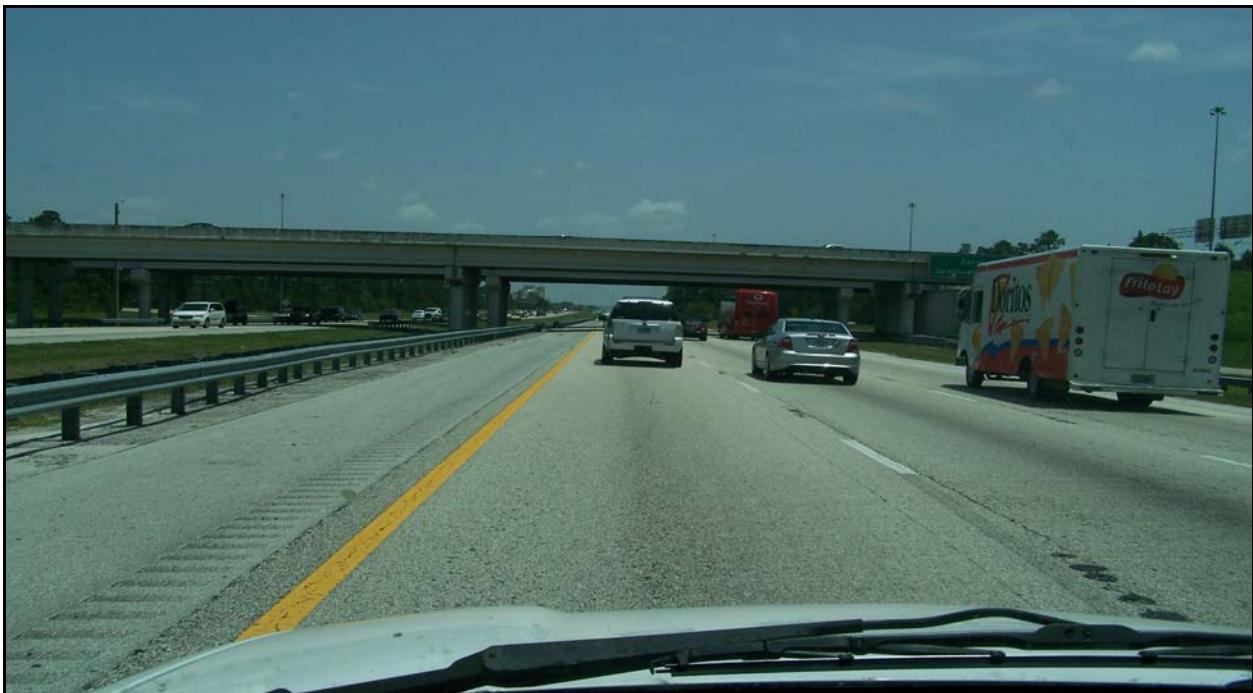
Photo 3: I-4 eastbound near MP 1.049. This photo shows the fair condition of the inside paved shoulder and the R1 lane.

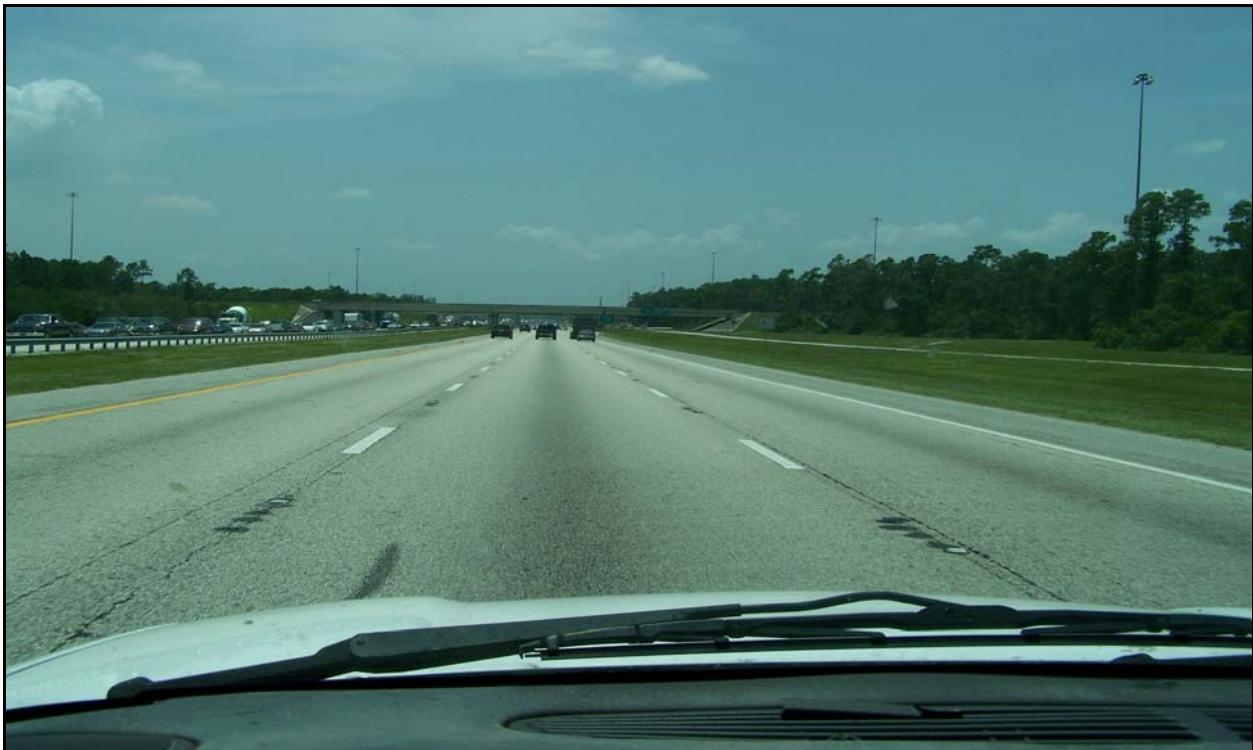
The westbound mainline lanes are in fair condition. All lanes (L1, L2, L3, and L4) have mostly shallow (less than one inch) Class I branch cracking of the open-graded friction course in the wheelpaths. There were no significant locations of rippling or raveling of the friction course. There is light longitudinal cracking in the pavement joints between all mainline lanes.

Photo 4: I-4 westbound near MP 1.423. The westbound lanes are not in as degraded condition as the eastbound lanes. The mainline lanes of I-4 within the project limits are tangent with no curves. Our milling recommendations for the westbound lanes are for the long-term pavement preservation of the existing pavement.

We recommend that 2.75 inches of milling be performed to provide long-term pavement preservation of the existing pavement. This will remove all cracks and friction course raveling.

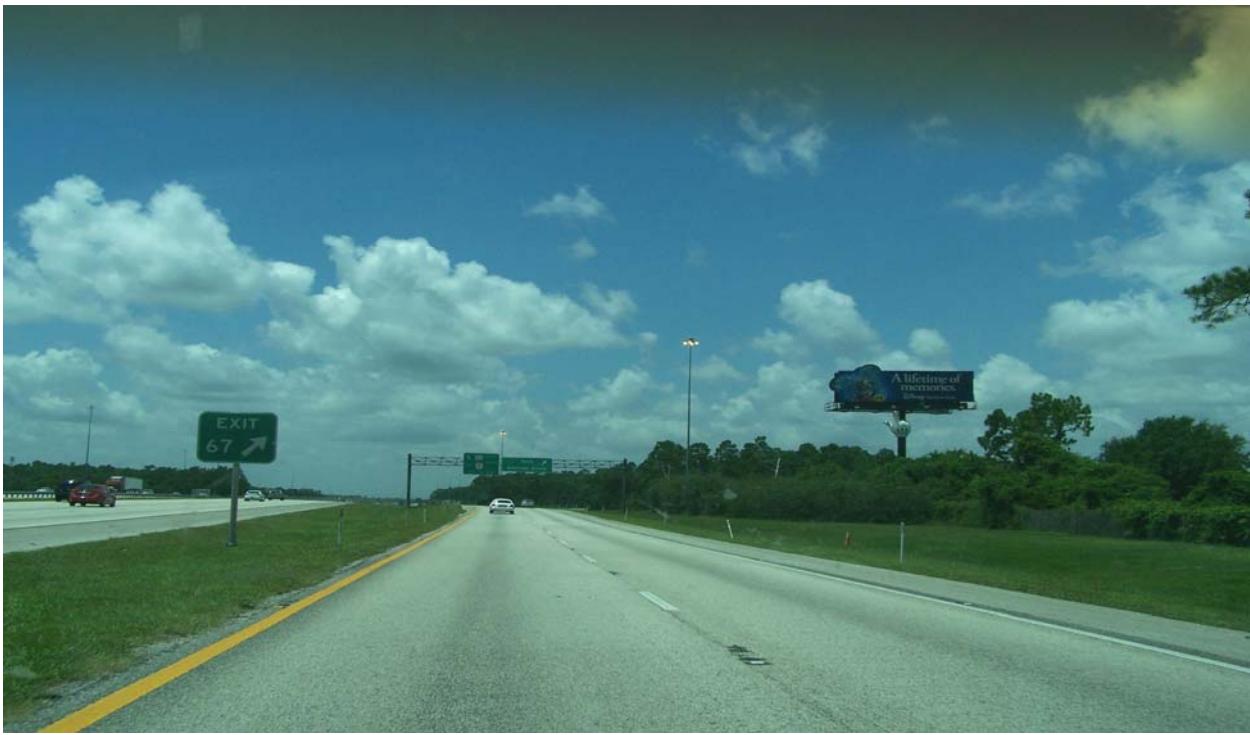
Photo 5: I-4 westbound on Ramp 75280-127. This photo shows the relatively fair condition of this connector ramp. Note that the outside shoulder is not paved with an open-graded friction course.

We recommend a minimal milling scheme of 2.25 inches for the ramps and their connectors and 1.5 inches of milling for the paved shoulders at each ramp. This will remove deteriorated and oxidized pavement.

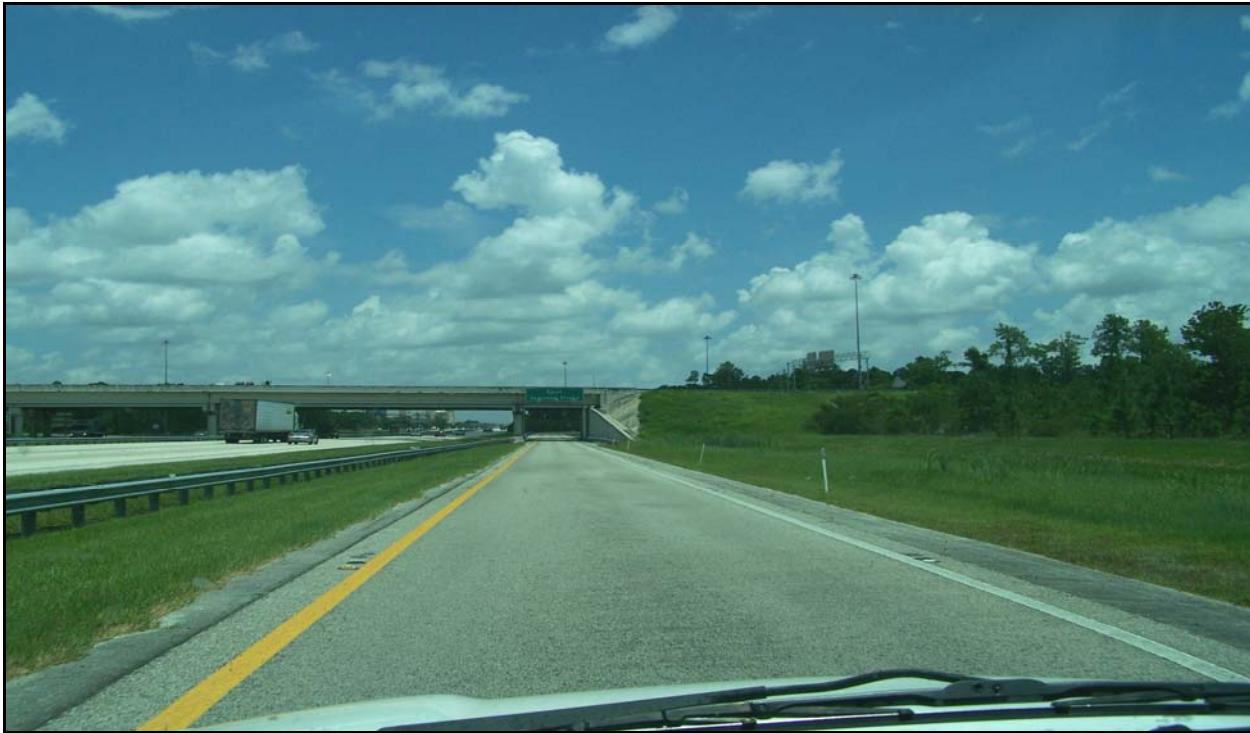
Photo 6: I-4 westbound on Ramp 75039-008. This is the ramp from I-4 eastbound to SR 536 westbound.

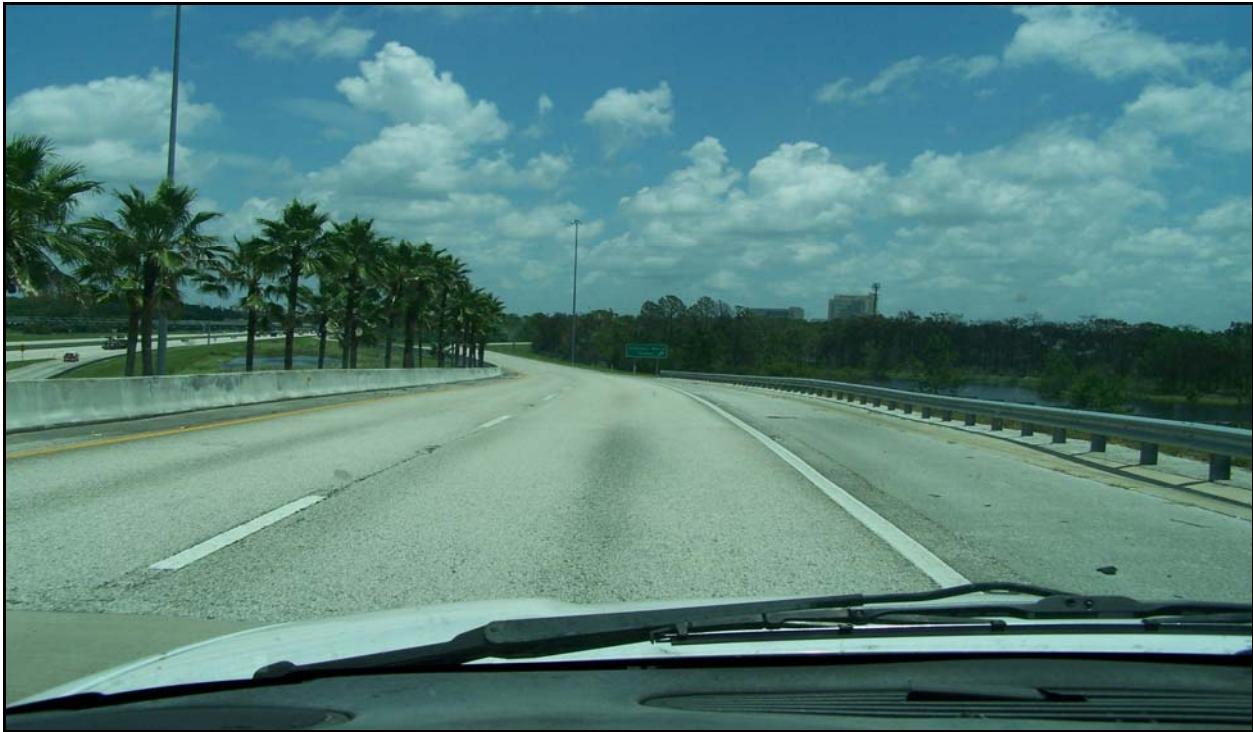
Photo 7: I-4 eastbound on Ramp 75039-008. This is the ramp from I-4 eastbound to SR 536 westbound. Note the lack of pavement distress other than oxidized friction course.
