# PAVEMENT SURVEY AND EVALUATION REPORT

FINANCIAL PROJECT NUMBER: 430644-1

## STATE ROAD 400 (I-4)

SECTION NUMBER: 75280; MP 1.740 to MP 6.018  
**From East of SR 536 to West of SR 528**

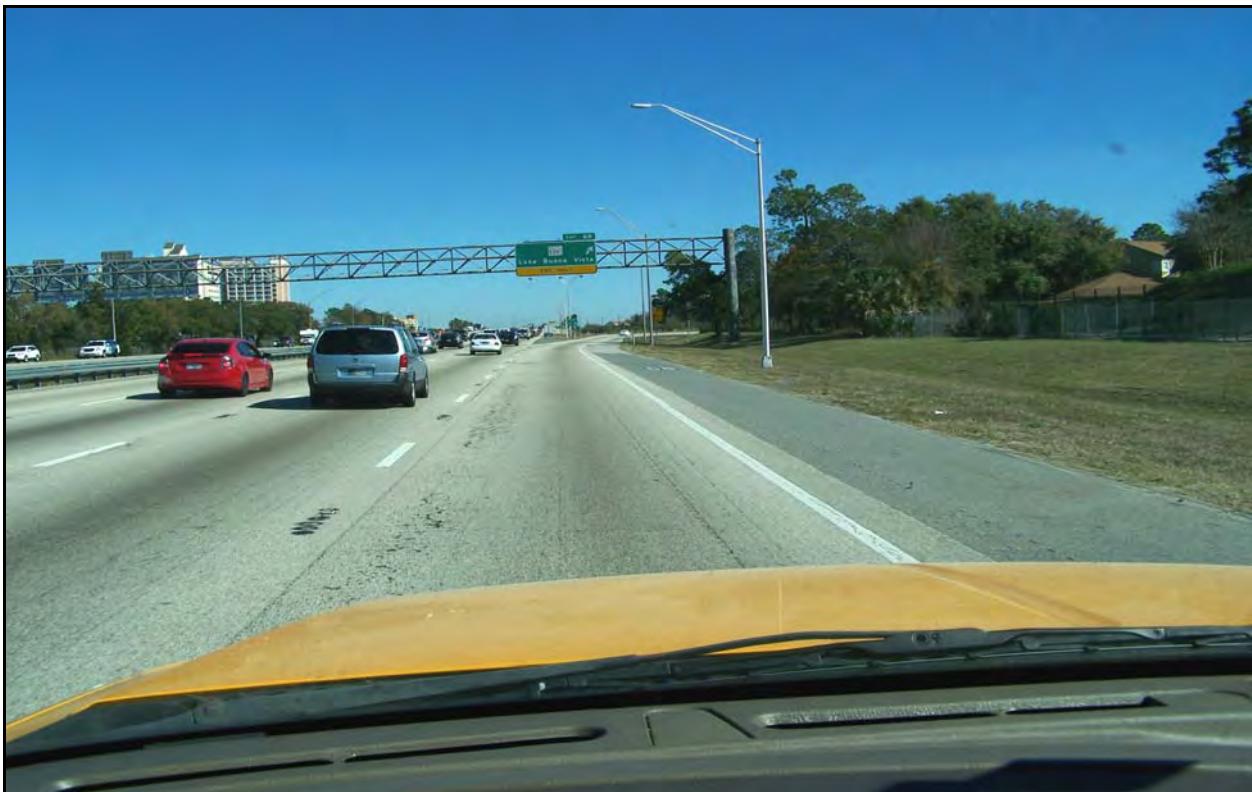
Photo 1: I-4 eastbound near MP 2.089. From the beginning of the project at MP 1.740 to where the R4 lane ends at MP 2.130 there is a continuous series of alligator cracks and raveling in the inside wheelpath. This is also where a significant amount of traffic going to local attractions departs I-4.

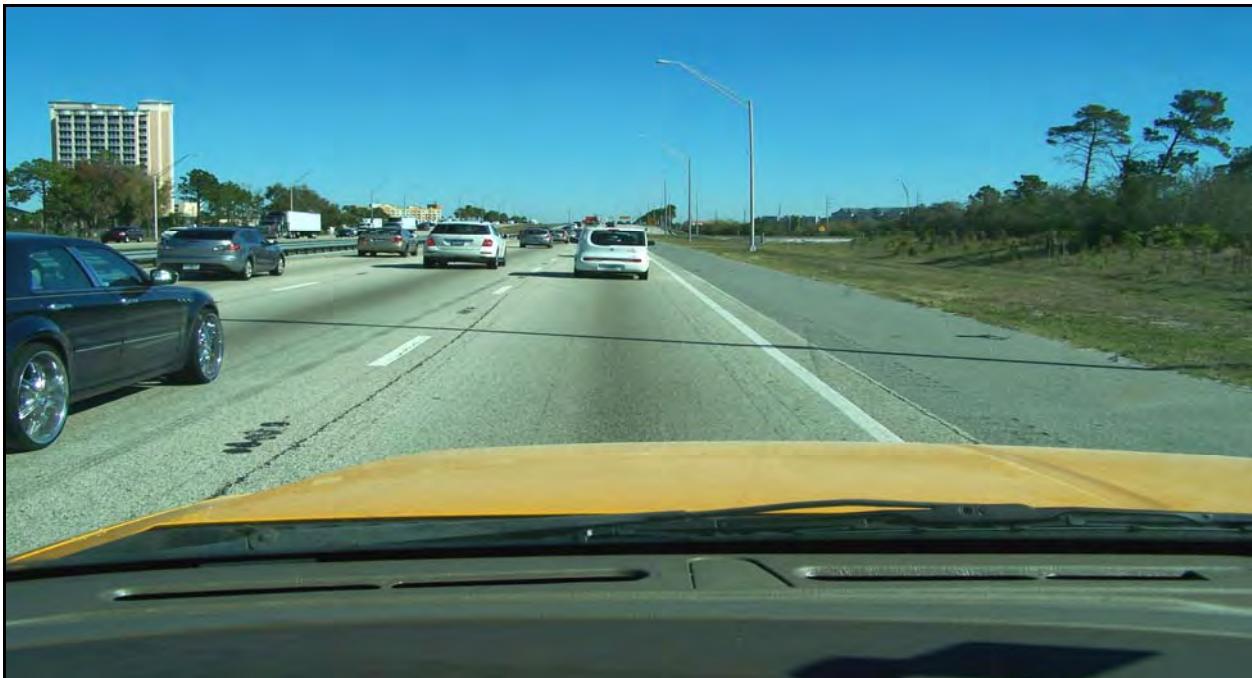
Photo 2: I-4 eastbound near MP 2.359. Note the fair condition of the outside paved shoulder and a continuous longitudinal crack at a construction joint between the R2 and R3 lanes.

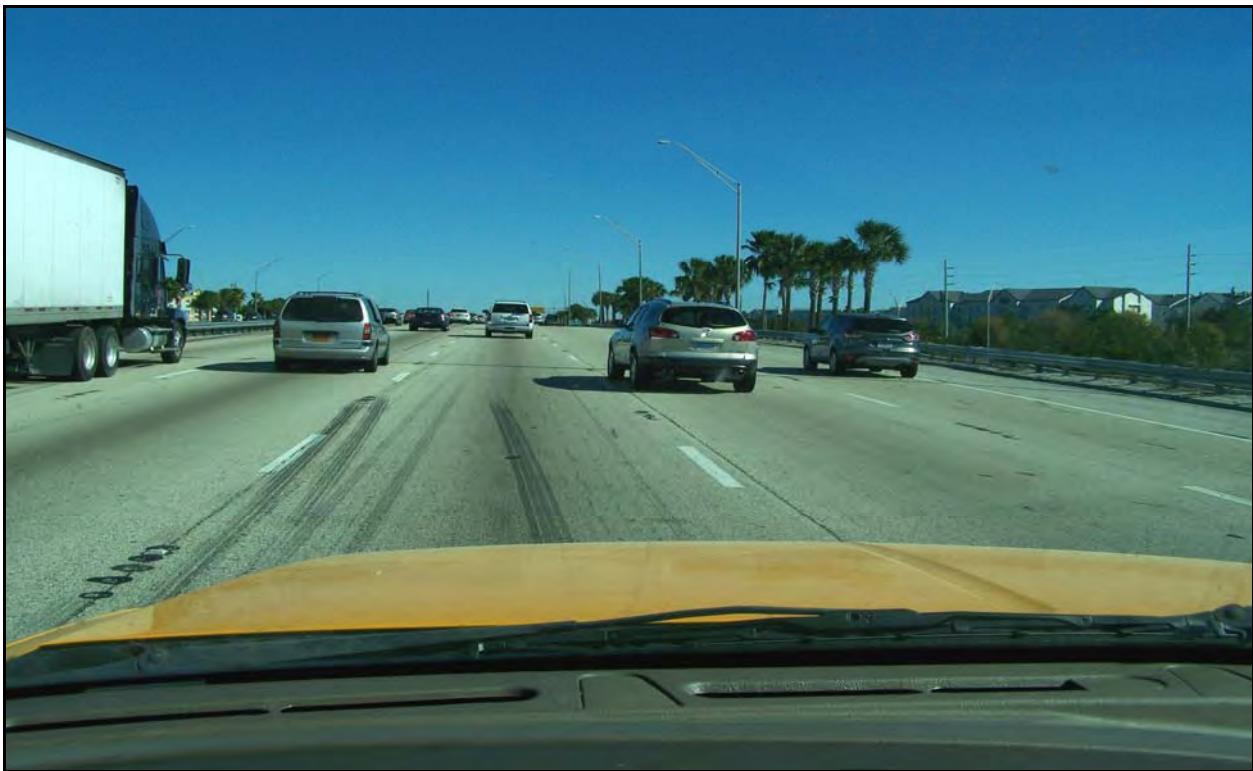
Photo 3: I-4 eastbound near MP 2.484. The inside R1 and R2 lanes of the eastbound roadway have far fewer pavement distresses than the R3 and R4 lanes.

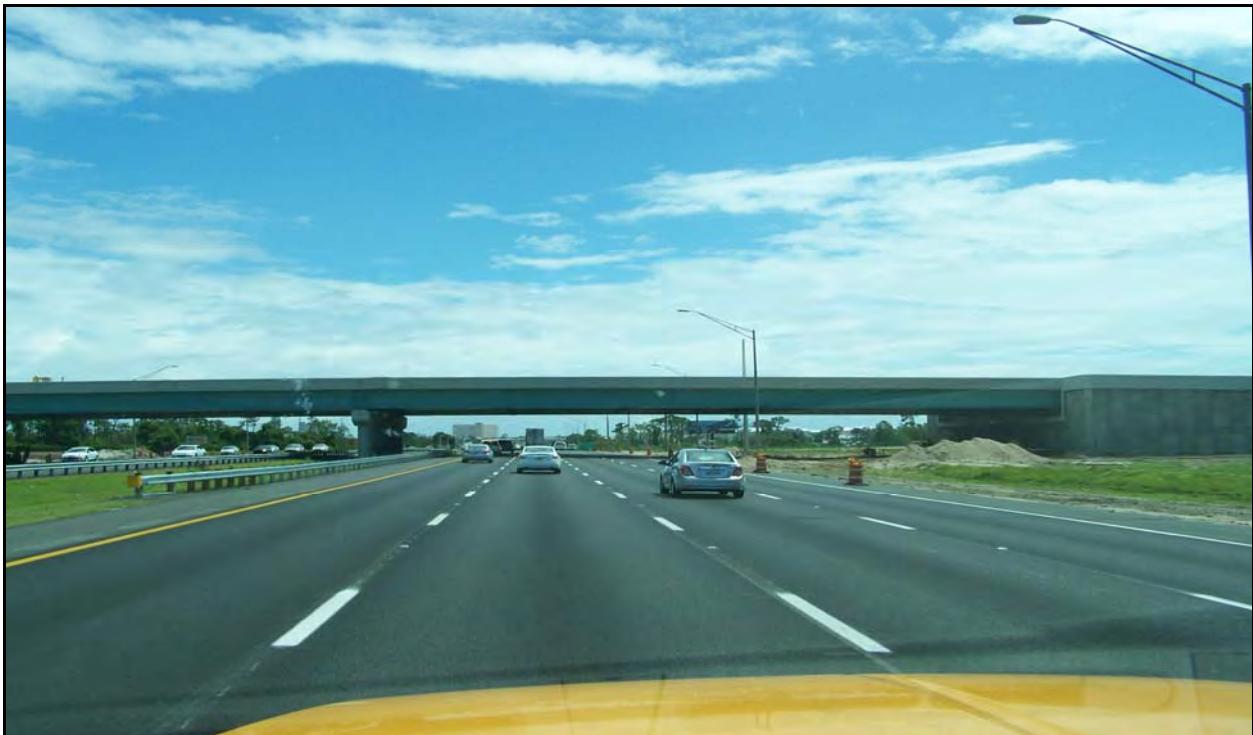
Photo 4: I-4 eastbound near MP 4.300. This photo shows the pavement condition from MP 4.074 to MP 4.607 that will not be an exception to rehabilitation. The mainline lanes were only milled 0.75 inches and resurfaced with FC-5 only.

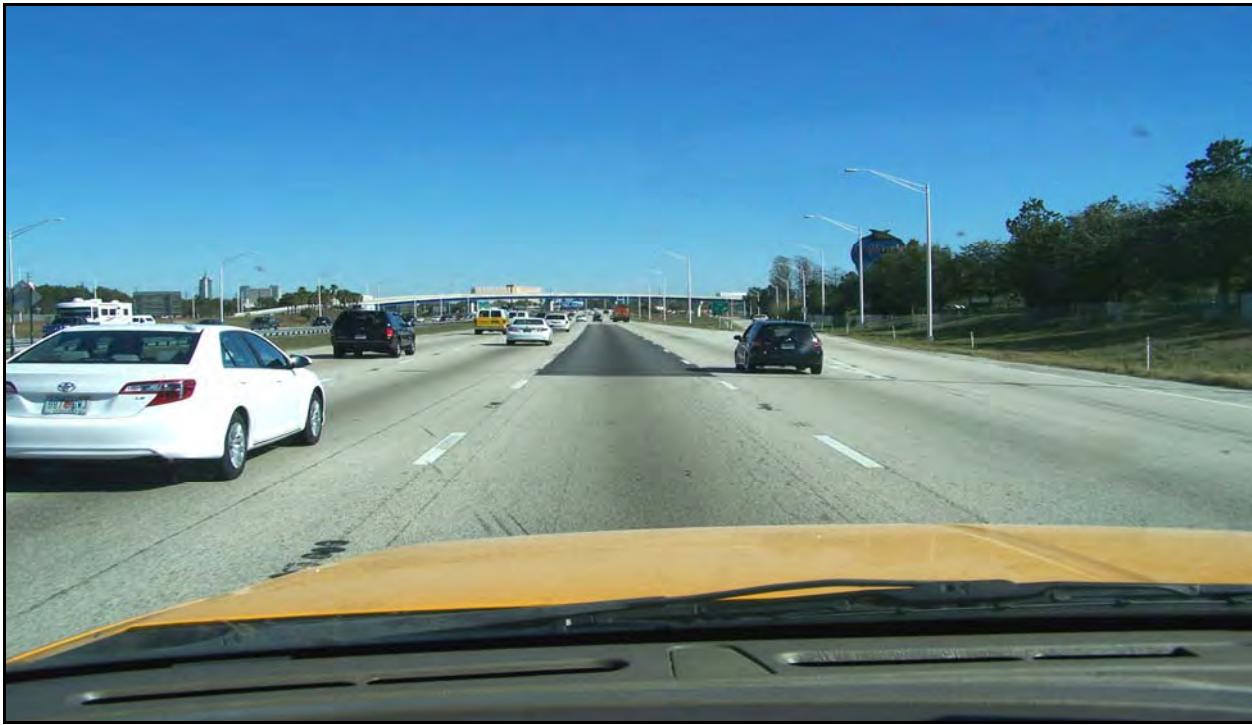
Photo 5: I-4 eastbound near MP 5.124. There are a number of patches that have been placed in both roadways to repair ride or raveling problems.

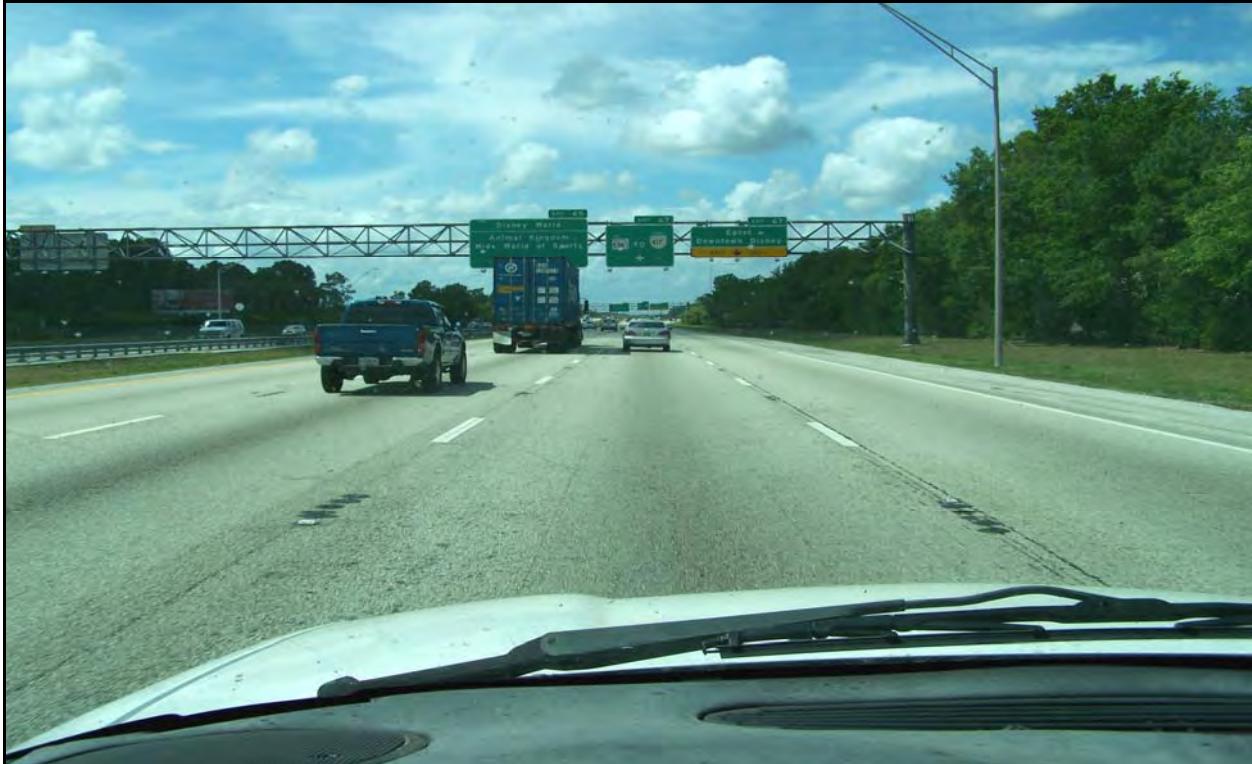
Photo 6: I-4 westbound near MP 2.193. The westbound roadway has light pavement distresses. Note the pop-up of aggregates in the open-graded friction course in the L3 lane.

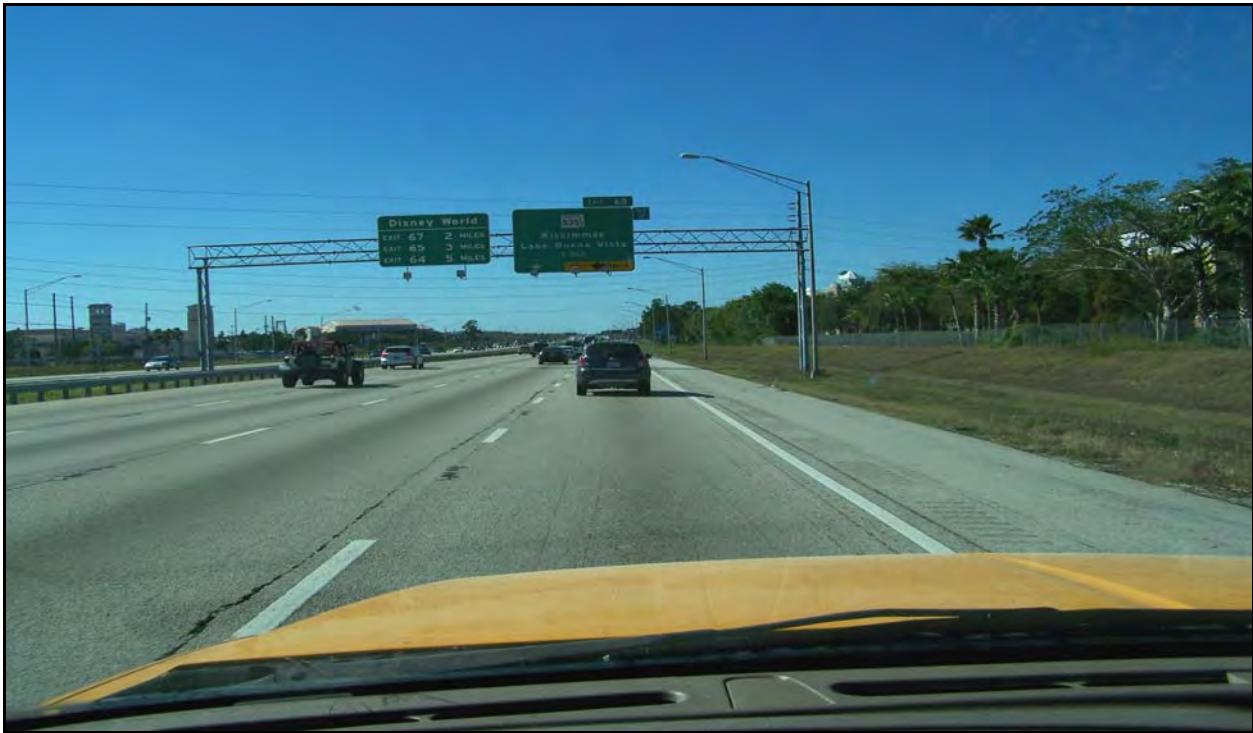
Photo 7: I-4 westbound near MP 3.930. There is a longitudinal crack between the L3 and L4 along a construction joint.

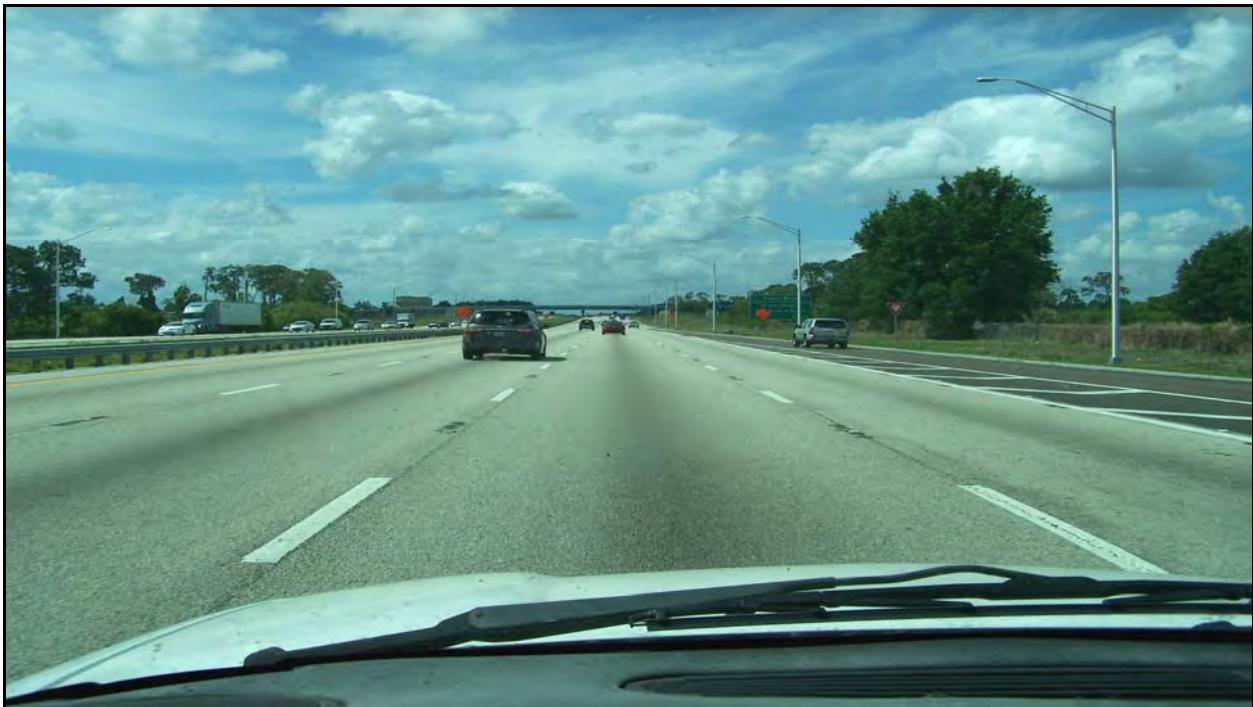
Photo 8: I-4 westbound near MP 4.903. Typical condition of the westbound roadway.

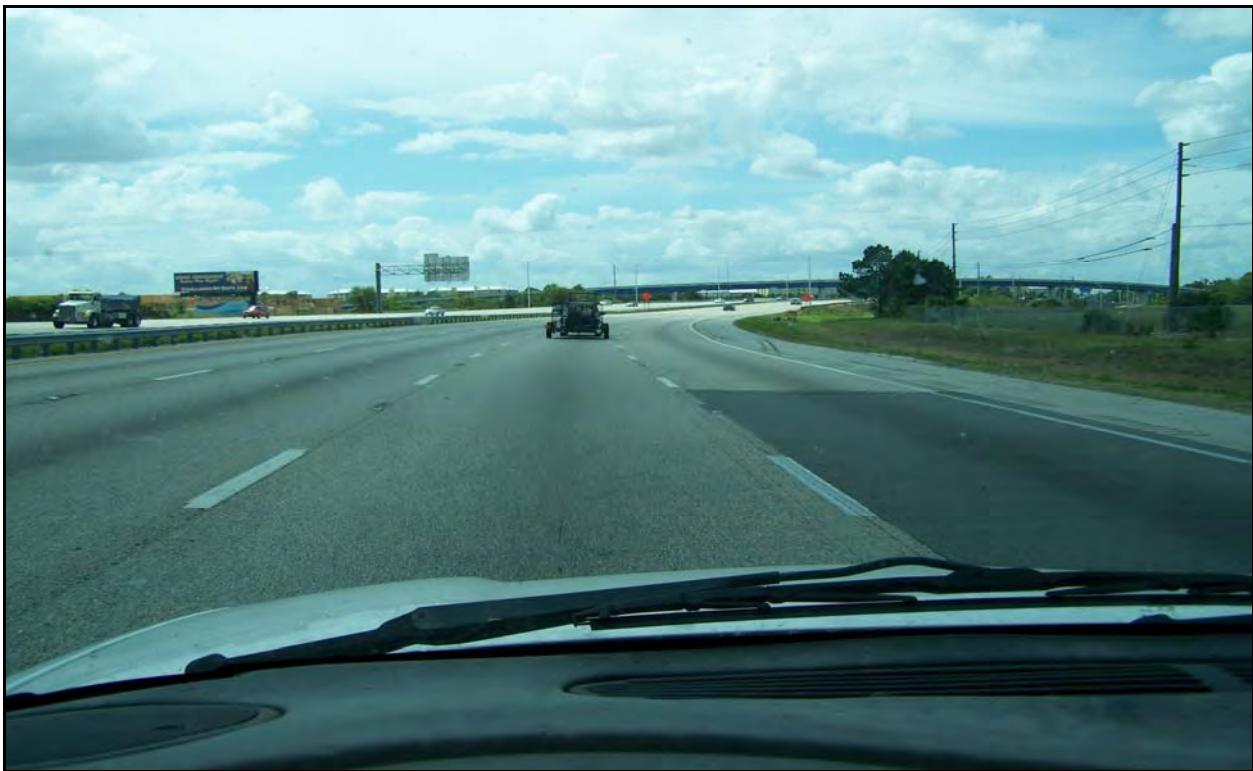
Photo 9: I-4 westbound near MP 5.788. Typical condition of the westbound roadway.

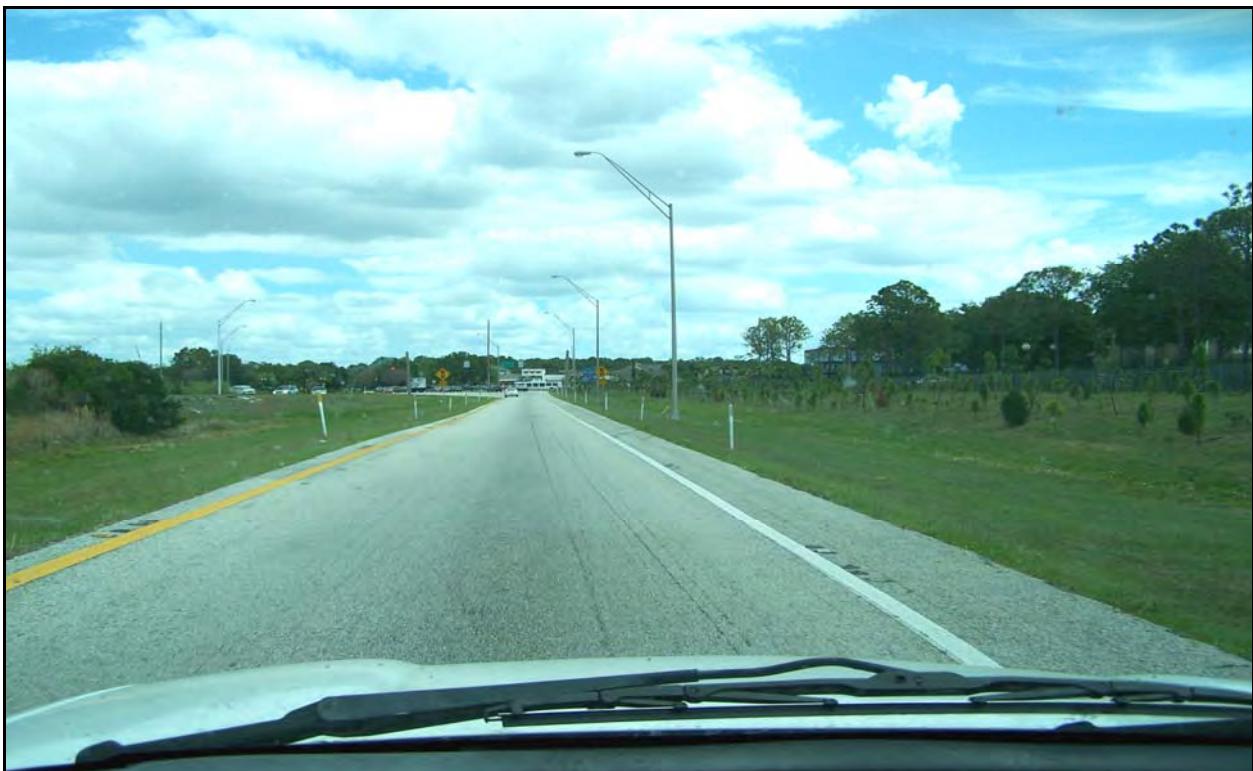
These ramps are in fair condition. There is minor Class I surface cracking of the open-graded friction course along with minor rippling in the center of the ramp lanes. There are locations of isolated pop-out raveling of the friction course that is beginning to occur. This is expected to worsen over time between now and the time of resurfacing. The paved shoulders on these ramps are in fair condition with minimal cracking or other pavement distress.

Photo 10: Ramp 080 from I-4 Eastbound to SR 535. The ramps for the SR 535 are in fair condition with few distresses.

We recommend a minimal milling scheme of 2.25 inches for the ramps and 1.5 inches of milling for the paved shoulders at each ramp. This will remove deteriorated and oxidized pavement.

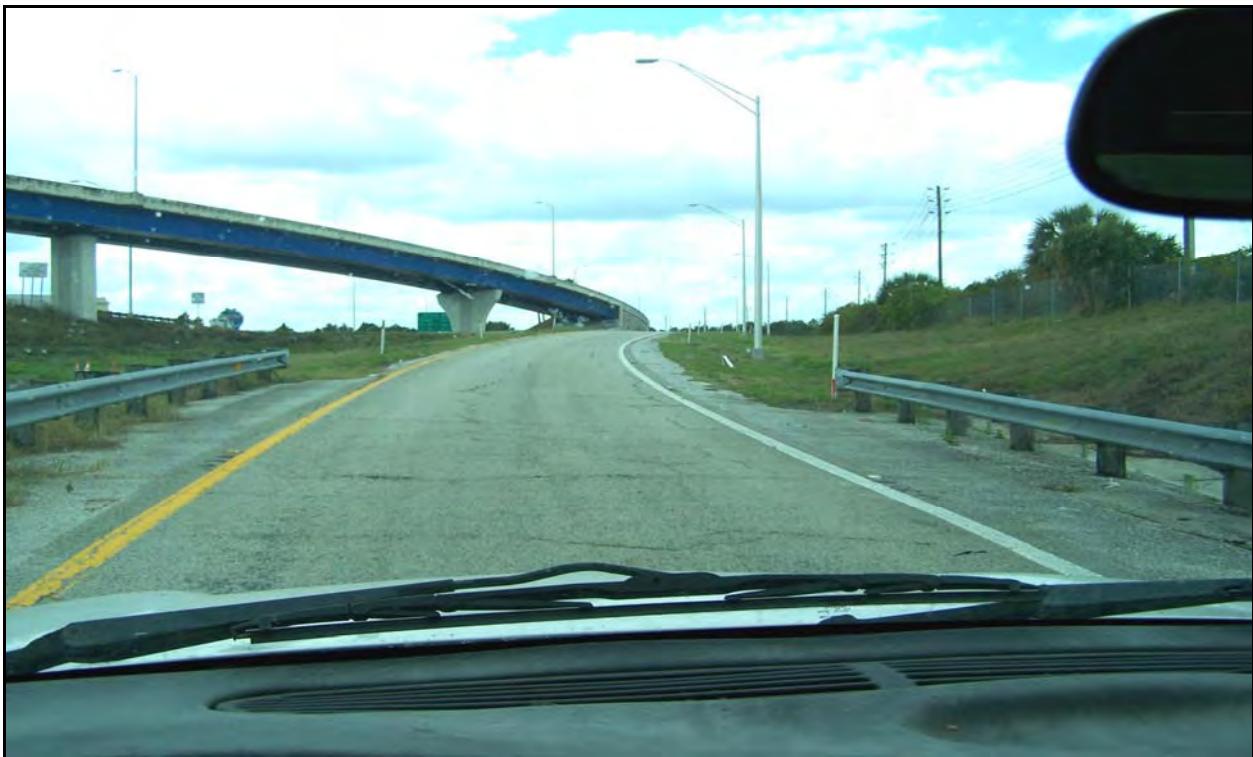
These ramps are in poor condition. There is moderate to severe Class II/III block, branch and longitudinal cracking which is attributed to the soil cement base of the structural and open-graded friction courses along with moderate rippling in the center of the ramp lanes. There is significant raveling of the open-graded friction course. The paved shoulders on these ramps are in fair condition with some cracking that has reflected over from the ramp pavement.

Photo 11: Ramp 021 from Central Florida Parkway to I-4 Westbound. The ramps at the interchange with the Central Florida Parkway are in poor condition. Note the severe cracking and raveling distresses.

We recommend a milling scheme of 2.75 inches for the ramps and 2.0 inches of milling for the paved shoulders at each ramp. This will remove most of the cracking and all deteriorated surface pavement.
