PAVEMENT SURVEY AND EVALUATION REPORT

FINANCIAL PROJECT NUMBER: 432453-1

STATE ROAD 400 (I-4)

SR 400 (I-4) From SR 528 (Beachline Expressway) to West of SR 435 (Kirkman Road)

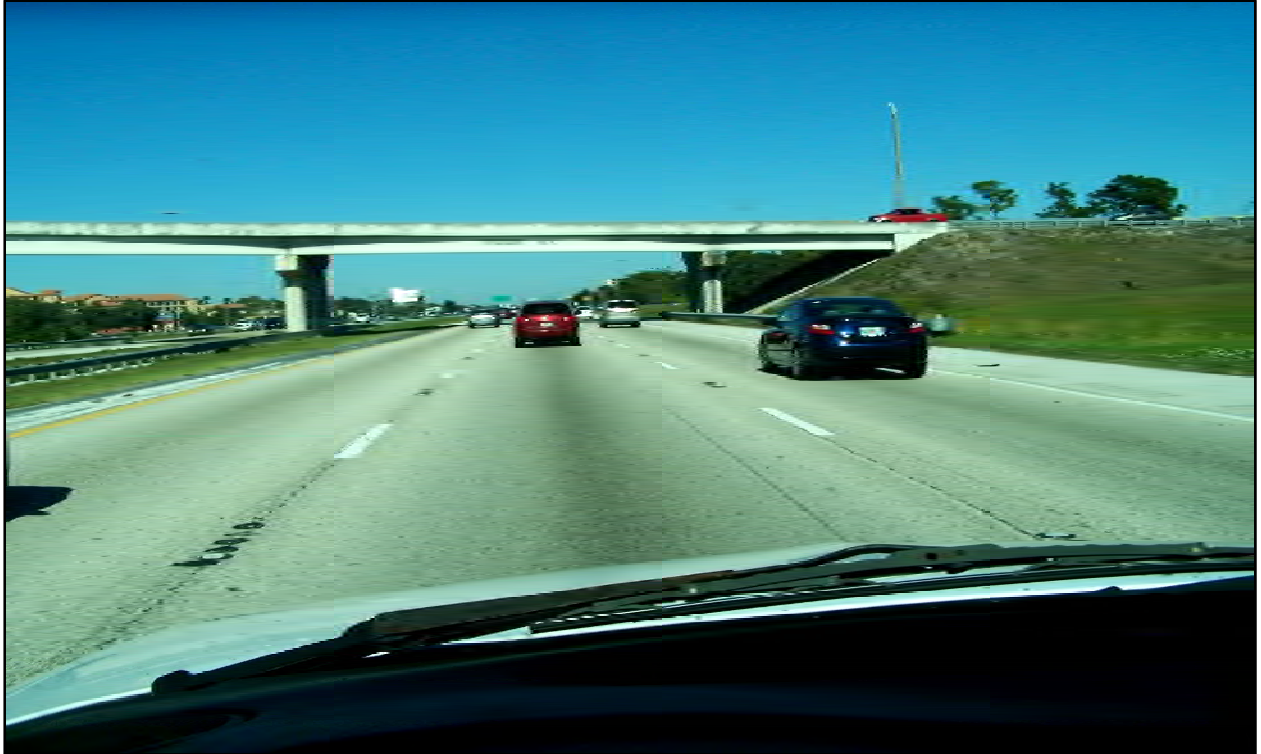
Photo 1: I-4 eastbound near MP 6.305. Typical condition of the mainline lanes between MP 6.018 to MP 6.482.

We recommend that 2.75 inches of milling be performed to provide long-term pavement preservation of the existing pavement. This will remove the majority of all cracks and friction course raveling.

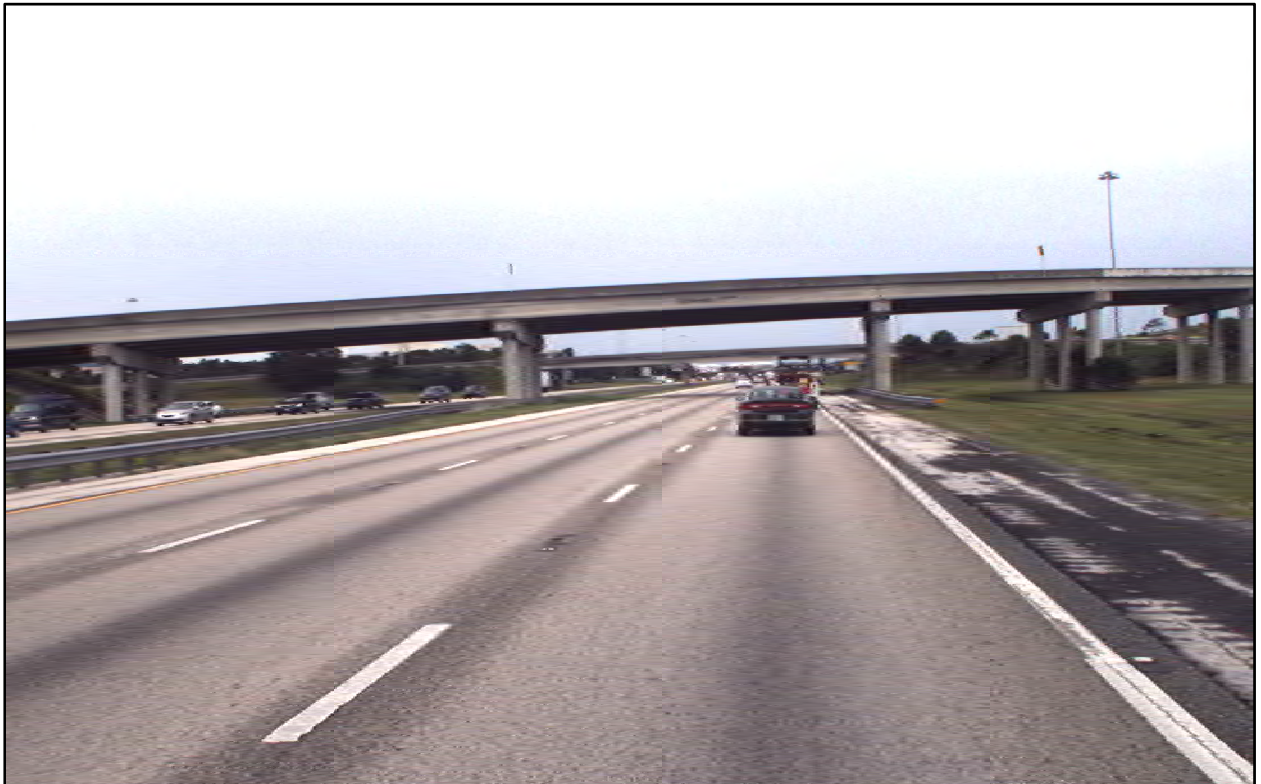
Photo 2: I-4 westbound near MP 6.430. The westbound outside shoulder from MP 6.200 to MP 6.430 was repaired with what appear to be chip seal that has raveled with time.

We recommend that 2.00 inches of milling be performed to replace degraded structural course and provide long-term pavement preservation of the existing shoulders.

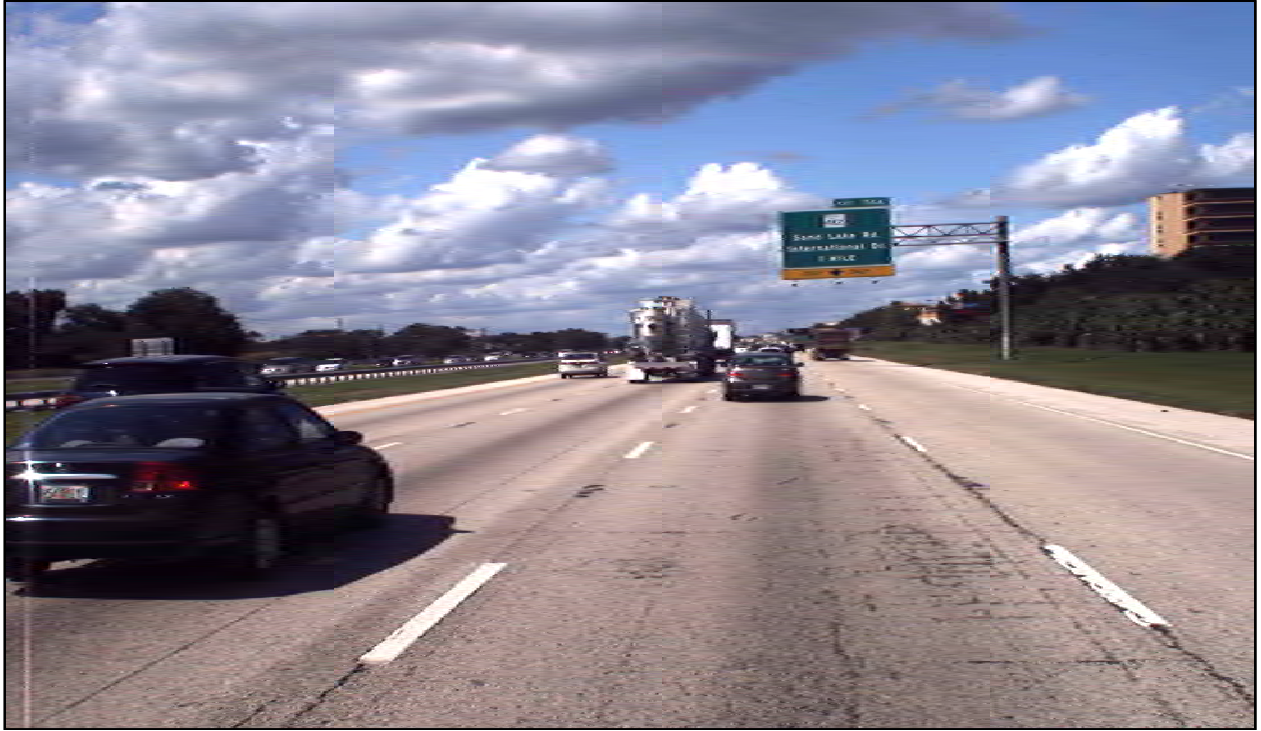
From MP 6.018 to MP 8.264, the inside R1 passing and R2 middle lanes are in fair condition with shallow open-graded friction course cracking, minor asphalt flushing and minor raveling. The R3 travel lane is in poor condition. There is moderate raveling of the friction course in the wheelpaths. MPSV data shows the R3 lane in this area is thinner than the R1 and R2 lanes with an average thickness of 6.6 inches with a range of 5.0 to 7.7 inches from MP 6.850 to MP 7.486. In this location there are a series of severe alligator cracks and moderate raveling in the outside wheelpath. There are also two moderate to severe longitudinal Class II/III cracks at the pavement joints between the R2 to R3 lane, and from the R3 lane to the R4 lane. The R4 auxiliary lane is in fair condition, with pavement distresses similar to the R1 and R2 lanes.

Photo 3: I-4 eastbound near MP 6.885. This is an example of the poor condition of the R3 lane with the cracking in the outside wheelpath.

We recommend that 3.75 inches of milling be performed to provide long-term pavement preservation of the existing pavement. This will remove all cracks and friction course raveling.

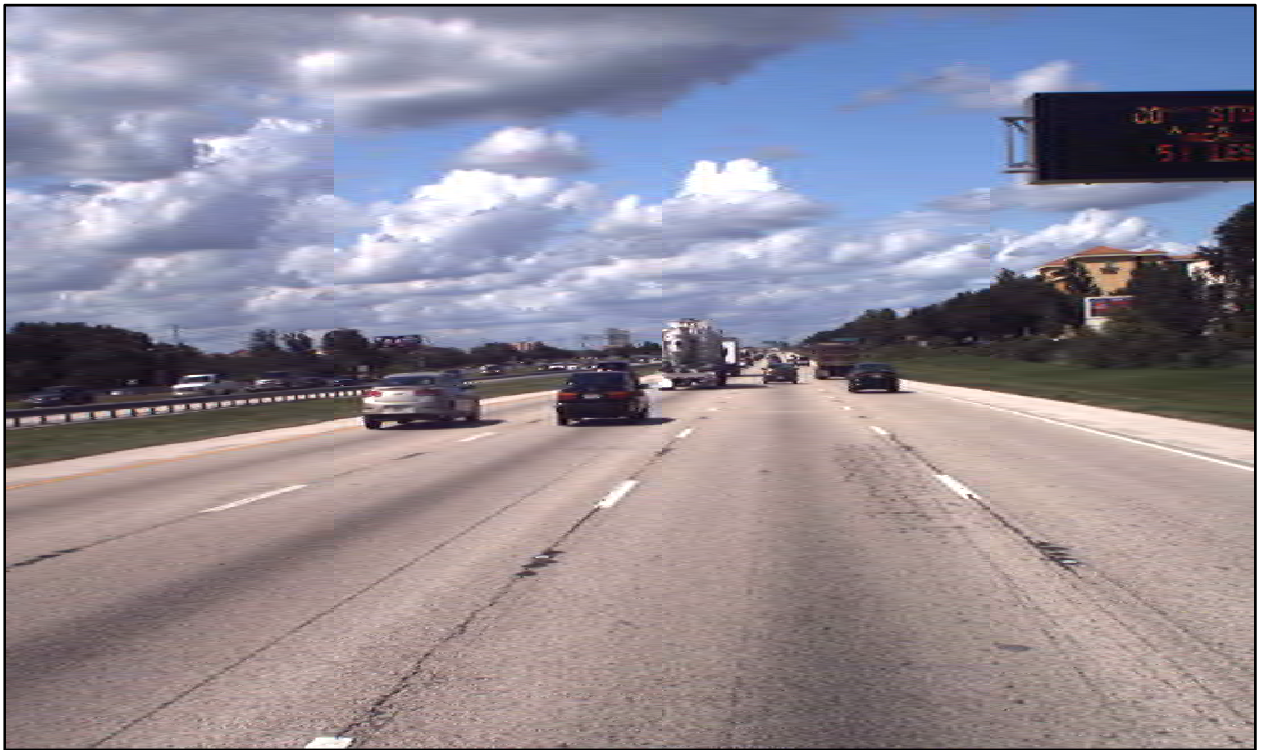
Photo 4: I-4 eastbound near MP 7.235. This is another example of the severe cracking in the outside wheelpath. This is also an area where the Ground Penetrating Radar indicates thinner pavement averaging 6.6 inches.

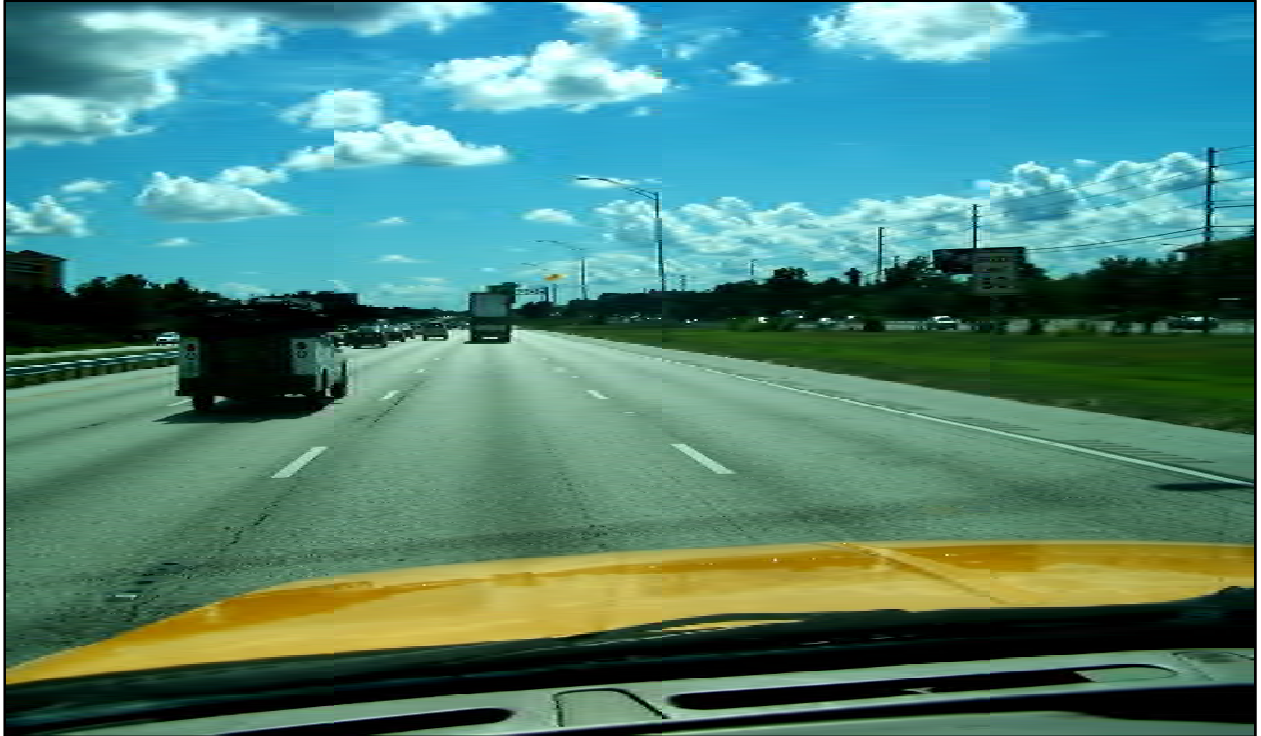
The westbound mainline lanes from MP 6.018 to MP 8.264 are in fair to poor condition. The inside L1 passing and L2 middle lanes are in fair condition with minor asphalt flushing and minor raveling. The L3 and L4 travel lanes are in poor condition. In the L3 and L4 lanes there is moderate raveling of the friction course and in the wheelpaths. There are also continuous moderate to severe longitudinal Class II/III cracks with moderate raveling at the pavement joints between the L3 and L4 lanes. Some of these longitudinal cracks are in the L3 lane, with others in the L4 lane.

Photo 5: I-4 westbound near MP 7.593. This photo shows that the westbound mainline lanes have less severe pavement distress than the eastbound lanes.

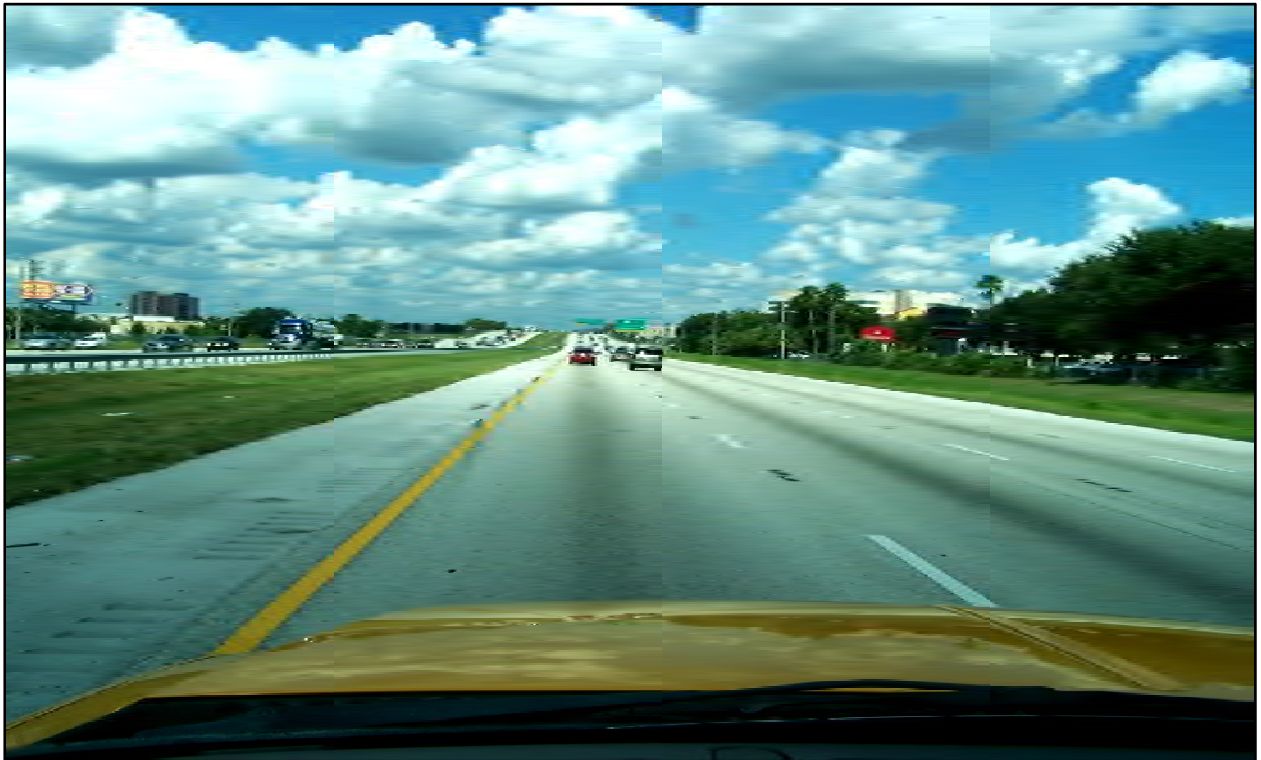
Photo 6: I-4 eastbound near MP 7.805. This photo shows the relatively fair condition of the inside R1, R2, and inside paved shoulders within the project limits.

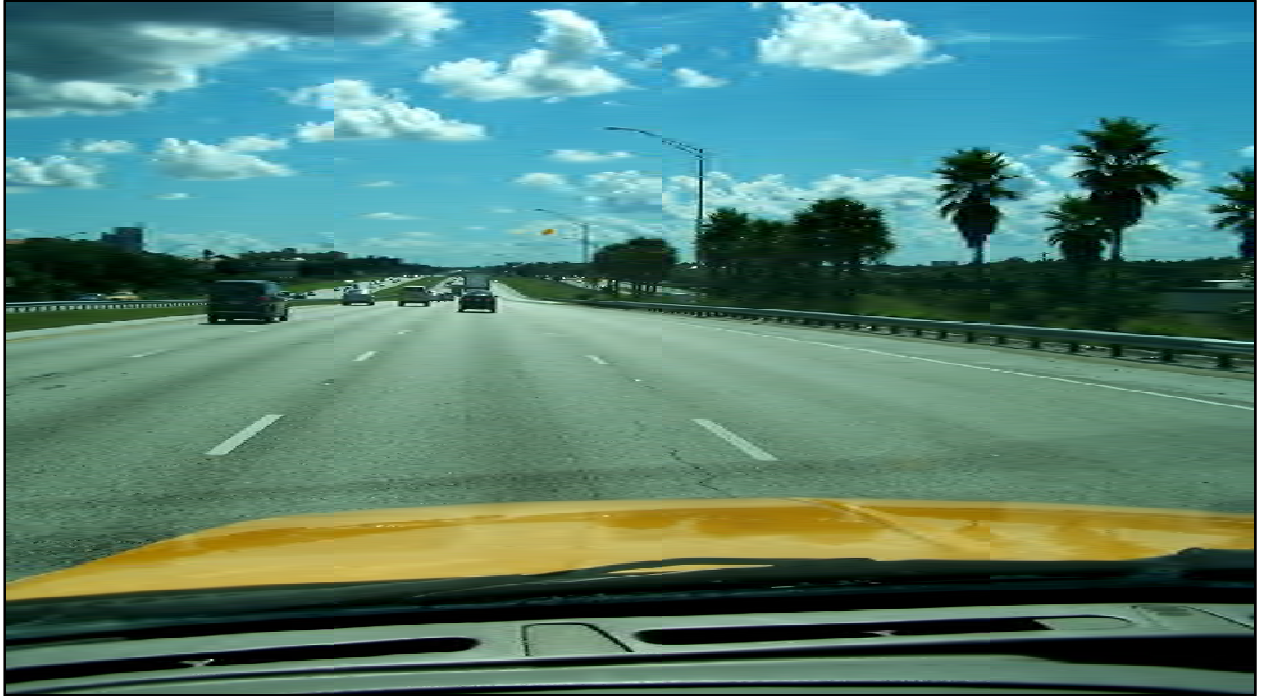
Photo 7: I-4 westbound near MP 8.198. The westbound mainline lanes have less cracking distress than the eastbound roadway.

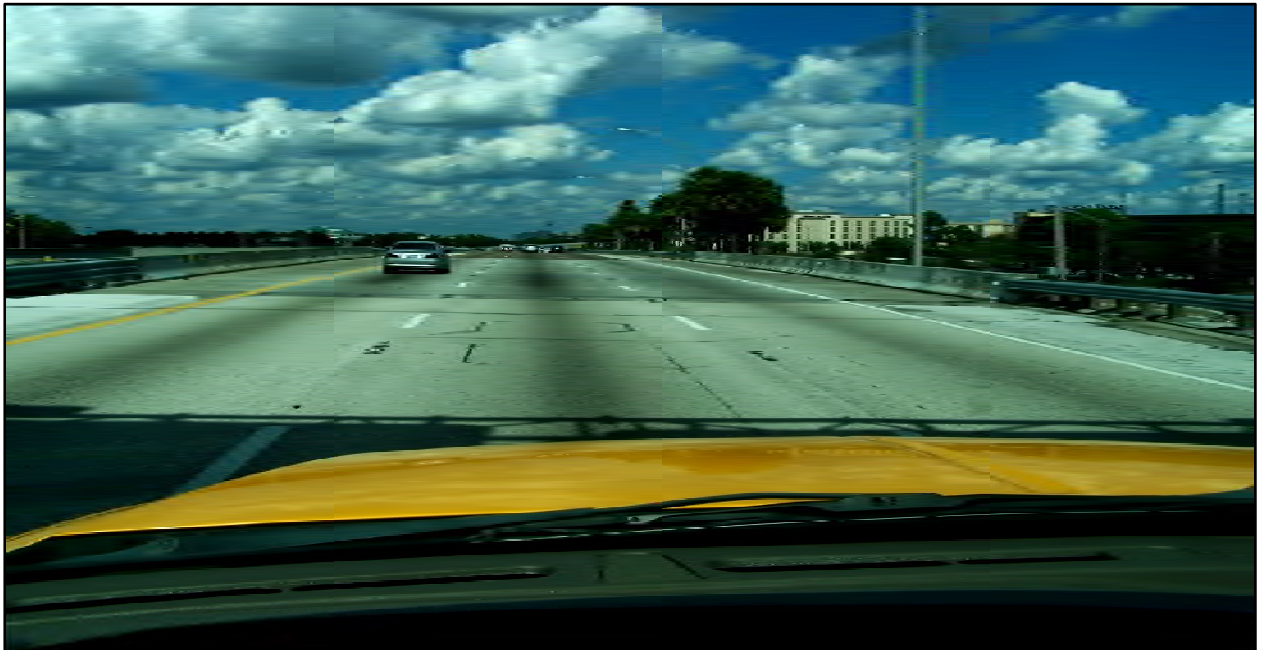
The approaches to bridges 759335 and 759336 are in fair condition with light to moderate branch cracking across all lanes. The lanes are only patched on the R3/L3 lanes. The conditions of these approaches do not require deep rehabilitation.

Photo 8: I-4 eastbound near MP 8.250. The approaches to the bridges within the project limits are in fair condition. Corrective actions will not be needed.

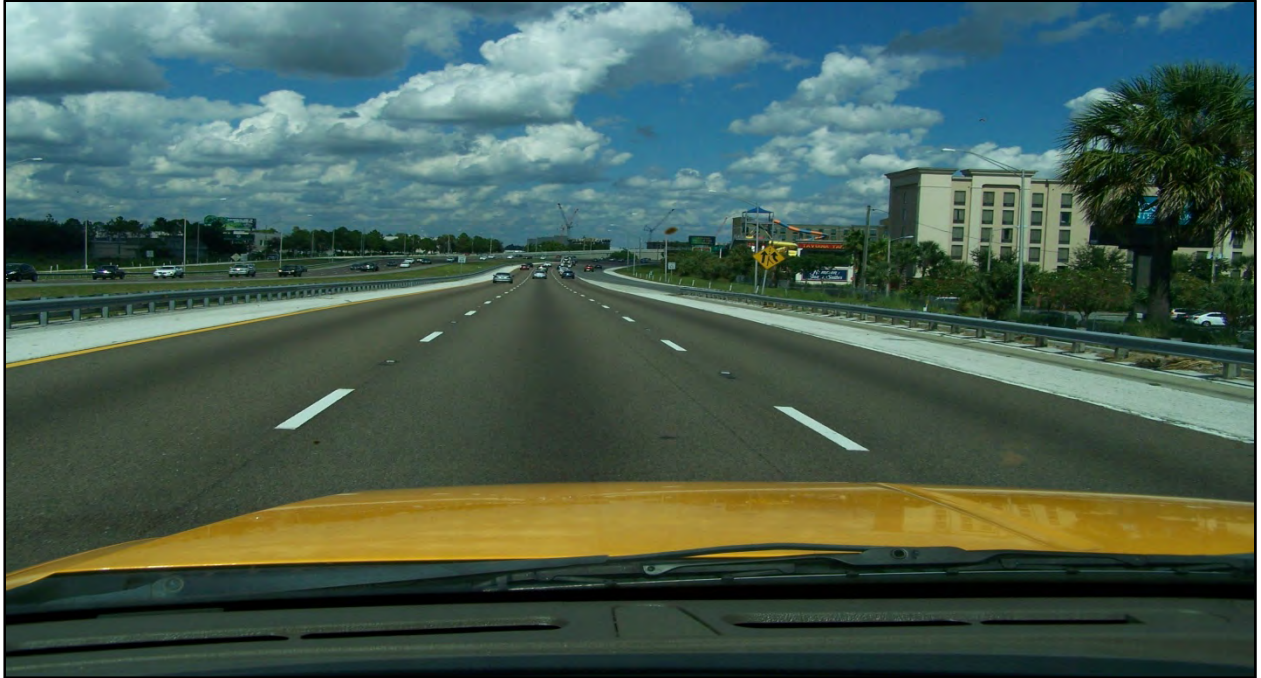
From MP 8.282 (Sand Lake Interchange) to MP 8.844 the eastbound R1, R2, and R3 lanes were resurfaced with a granite-based FC-5 friction course at some point in 2006-2007. The condition of the friction course is fair; however, there is reflective cracking from older asphalt layers coming to the surface of the roadway.

Photo 9: I-4 eastbound near MP 8.400. This location between MP 8.264 and MP 8.844 was resurfaced in 2007. Note the granite open-graded friction course.

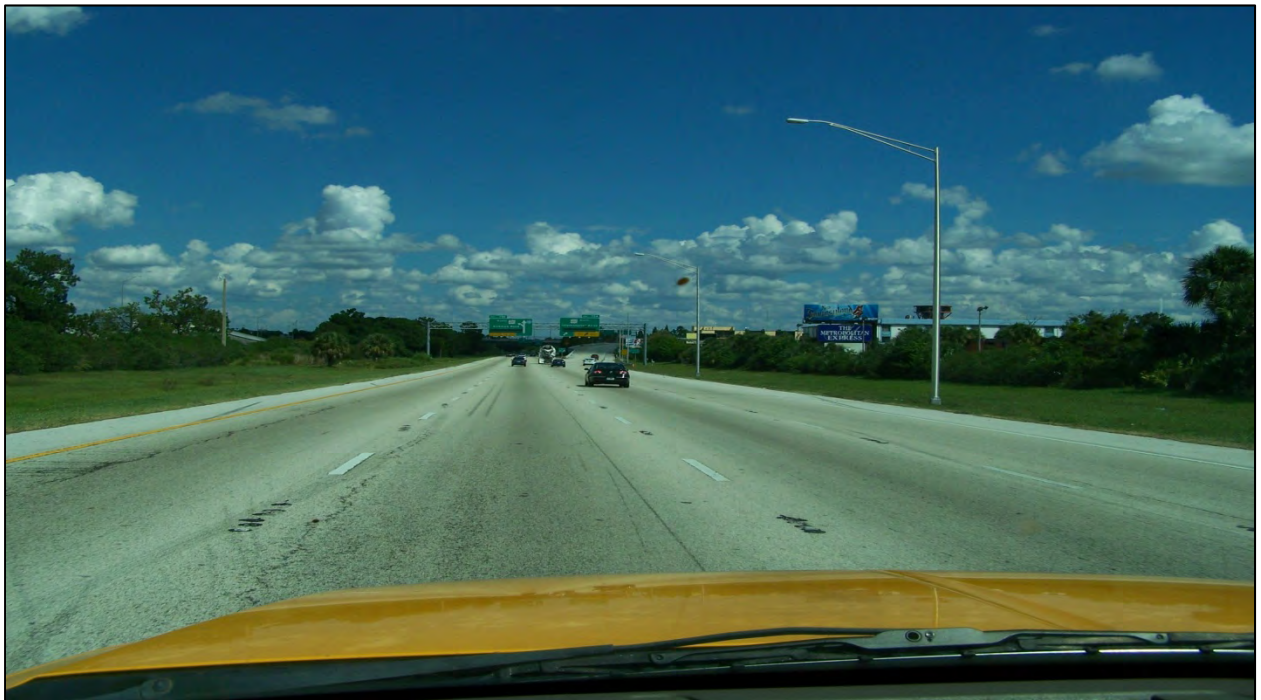
From MP 8.844 to MP 9.249, the roadway has not been resurfaced since 1992. This much older pavement has moderate to severe raveling, and branch cracking in all lanes.

Photo 10: I-4 eastbound near MP 9.155. The eastbound roadway from MP 8.844 to the end of the project at MP 9.249 was last resurfaced in 1993 and is in very worn condition.
