**Technical Memorandum: Cultural Resource
Assessment Survey of Proposed Improvements to**

**Segment 2: State Road 400 (SR 400)/Interstate 4 (I-4)
from West of SR 528 (Beachline Expressway)
to West of SR 435 (Kirkman Road)**

Orange County (75280), Florida

December, 2015

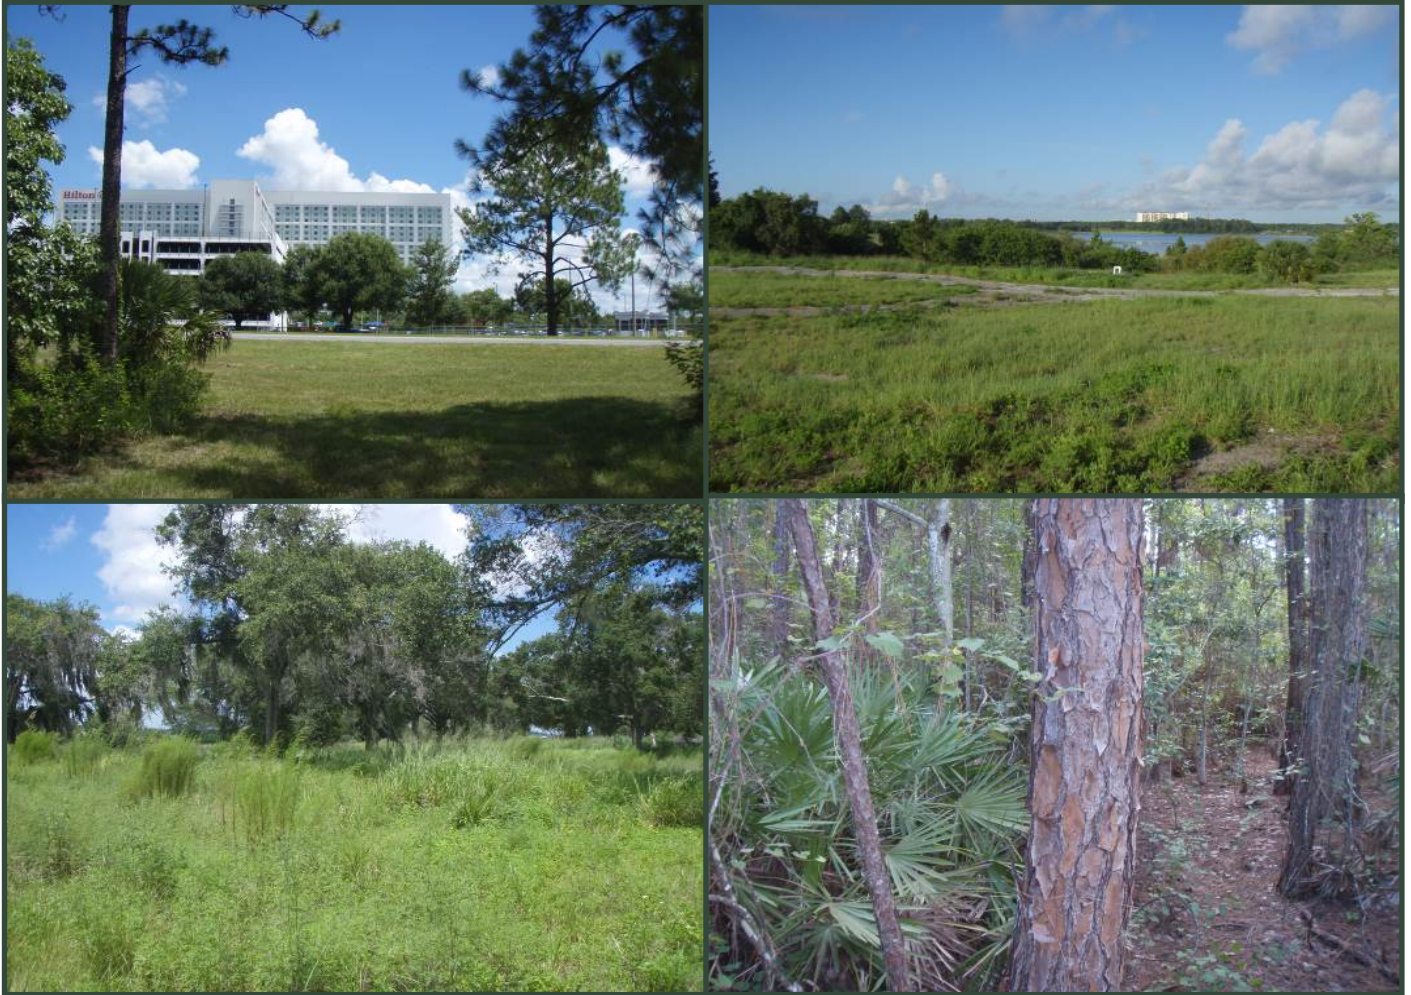
Modern land use within the APE consists of residential and commercial development as well as small parcels of undeveloped land. **Figure 4** provides representative views of modern conditions within the APE.

Figure 4 - Representative views of modern land use within the I-4 Segment 2 APE.

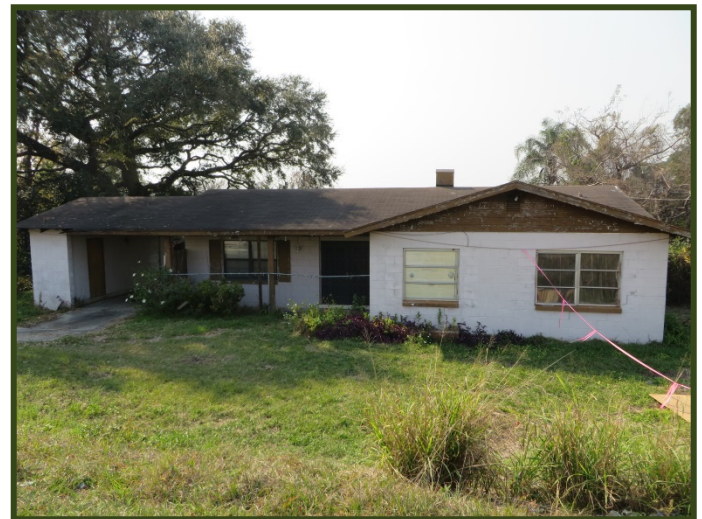
8OR10249 is a newly recorded building located at 9036 Turkey Lake Road within Segment 2 of the I-4 APE in Section 35 of Township 23 South, Range 28 East, as shown on the 1980 *Lake Jessamine, Fla.* USGS quadrangle map (see **Figure 13**). The ca. 1962 building is situated near the eastern edge of a triangular-shaped parcel that fronts Turkey Lake Road. Resource 8OR10249 is a one-story, L-shaped plan, Masonry Vernacular dwelling set on a continuous concrete block foundation (**Figure 15**). The gabled roof is clad with composition shingles with louvered vents and wood siding in the gable ends. A brick interior chimney pierces the center ridge of the roof. The exterior fabric is concrete block. The windows are not arranged in a particular pattern but consist of independent and paired three-light metal awning windows and one-over-one single-hung metal-sash windows, some with non-operational louvered shutters. The main entrance is on the south façade, but the entry has been boarded over. The entry is sheltered beneath a two-bay open porch with wood supports. A single-bay carport with a concrete block storage room is attached to the west façade and an irregular-shaped addition is attached to the north façade.

Figure 15. Resource 8OR10249, facing north.

Resource 8OR10249 is a Masonry Vernacular building that represents a highly prevalent approach to residential design in Florida and the United States in general. Based on the historic context, it is the opinion of SEARCH that the building is not significant under NRHP Criterion A because it is not indicative of a particular era and is not associated with any significant period, event, or theme. Furthermore, the resource is not eligible under Criterion B because it lacks association with any person(s) significant in history. Also, the resource is not eligible under Criterion C due to its lack of architectural distinction. Finally, the building is not significant under Criterion D because it lacks the potential to yield further

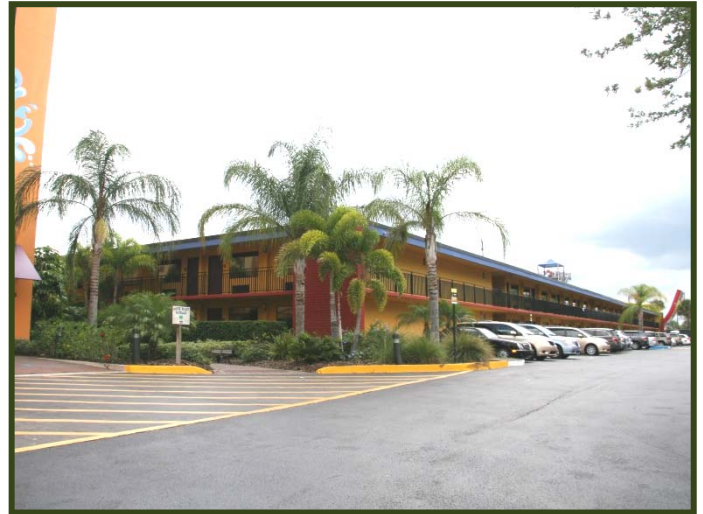
8OR10250 is a newly recorded building located at 7400 International Drive within Segment 2 of the I-4 APE in Section 25 of Township 23 South, Range 28 East, as shown on the 1980 *Lake Jessamine, Fla.* USGS quadrangle map (see **Figure 13**). The ca. 1970 building currently operates as the Coco Key Resort Hotel and is situated near the western boundary of a rectangular-shaped parcel that fronts International Drive. Resource 8OR10250 is a two-story, irregular-shaped plan Masonry Vernacular motel building set on a poured concrete slab foundation (**Figure 16**). The roof is a built-up flat roof design, and the exterior fabric is stucco over concrete with sections of brick laid in a running bond pattern along the east and west facades. The building consists of a U-shaped section that contains hotel rooms along the northern and eastern wings, while the southern wing is primarily ancillary hotel use. The U-shaped structure is separated by a courtyard with a swimming pool and water slides. The entire courtyard is covered by a steel-framed canopy that connects both the north and southern wings of the building. An additional section attached to the southwest of the building and outside of the canopy area gives the building an overall irregular shape and appears to also be used for ancillary hotel use and not used as lodging. The windows on the building are symmetrically balanced and consist of paired commercial fixed-sash windows for each individual motel room. There are multiple entrances for the separate motel rooms on the north and east (both parking lot facing) facades and the south (courtyard facing) facade that feature solid metal doors. An open, two-story piazza supported by stucco-clad concrete buttresses shelters the entries to the motel rooms. The second story of the piazza includes a painted metal railing. An additional below-grade swimming pool and water slide area is located to the west of the building and outside of the canopy area. Four similarly designed hotel buildings, including a five-story building, share the parcel with Resource 8OR10250. The additional buildings are located to the east, outside of the APE, and are not physically connected to Resource 8OR10250.

Figure 16. Resource 8OR10250, facing southwest.

Resource 8OR10250 is a Masonry Vernacular building that represents a highly prevalent approach to commercial architectural design in Florida and the United States in general. Based on the historic context, it is the opinion of SEARCH that the building is not significant under NRHP Criterion A because it is not indicative of a particular era and is not associated with any significant period, event, or theme. A review of historical sources including newspapers and Orange County Property Appraiser records did not identify additional information regarding this particular hotel or the property in general. Furthermore, the resource is not eligible under Criterion B because it lacks association with any person(s) significant in history. Also, the resource is not eligible under Criterion C due to its lack of architectural distinction. Finally, the building is not significant under Criterion D because it lacks the potential to yield further information of historical importance. It is the opinion of SEARCH that 8OR10250 lacks the minimum criteria for listing in the NRHP, either individually or as a contributing resource to a historic district.

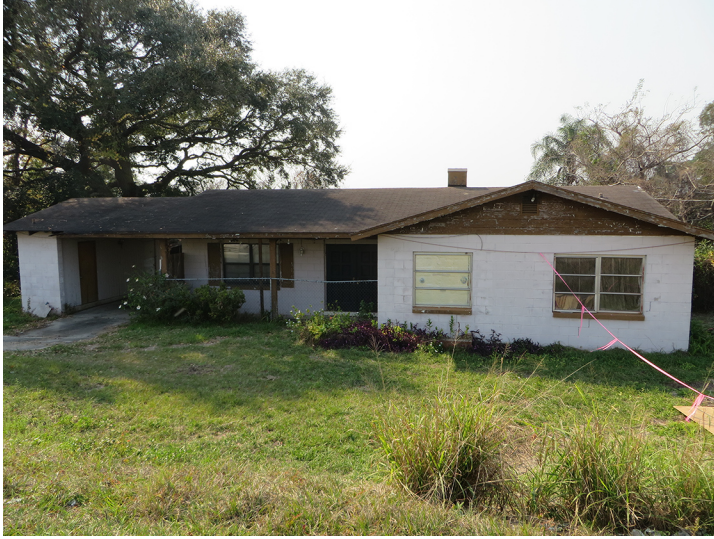
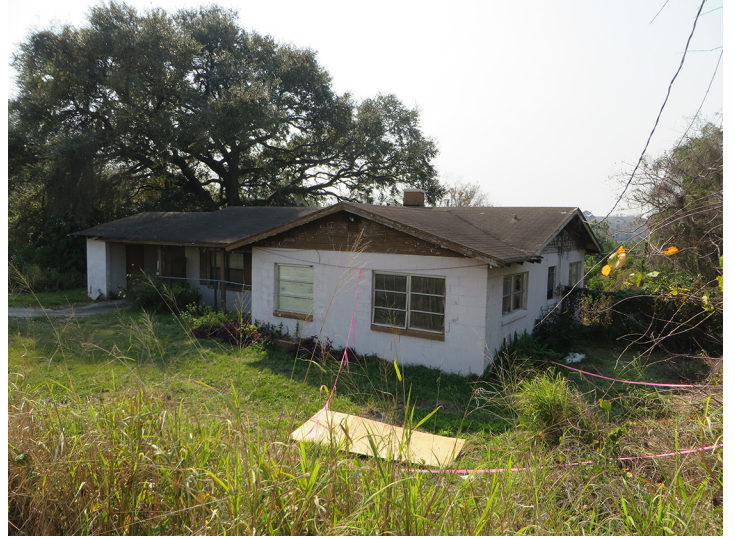
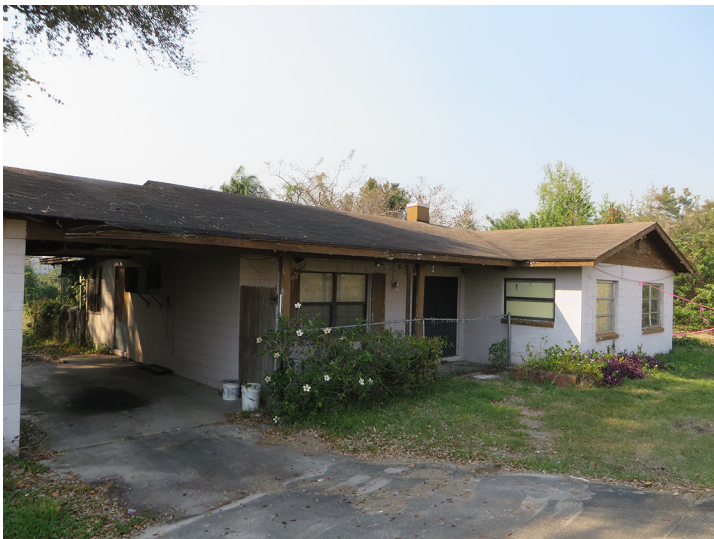
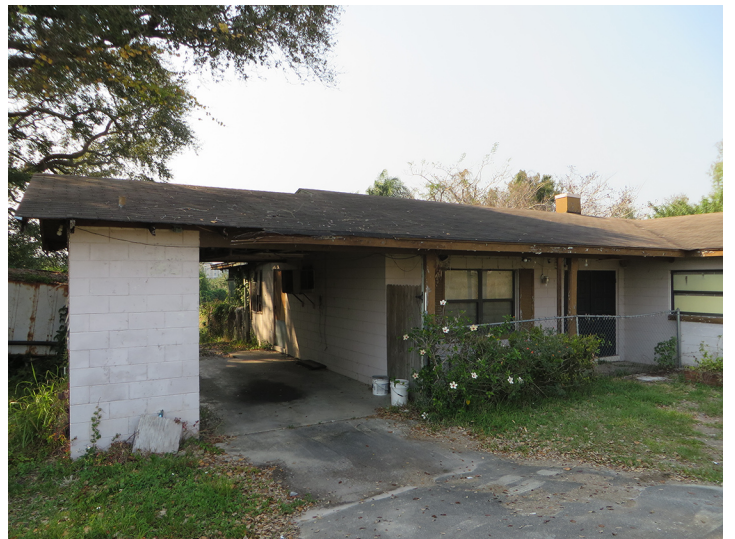
Narrative Description of Resource One-story, L-shaped plan, Masonry Vernacular dwelling set on a continuous concrete block foundation. A single-bay carport with a concrete block storage room is attached to the west facade and an irregular-shaped addition is attached to the north facade.

8OR10249_a Facing North

8OR10249_b Facing Northwest

8OR10249_c Facing Northeast

8OR10249_d Facing Northeast

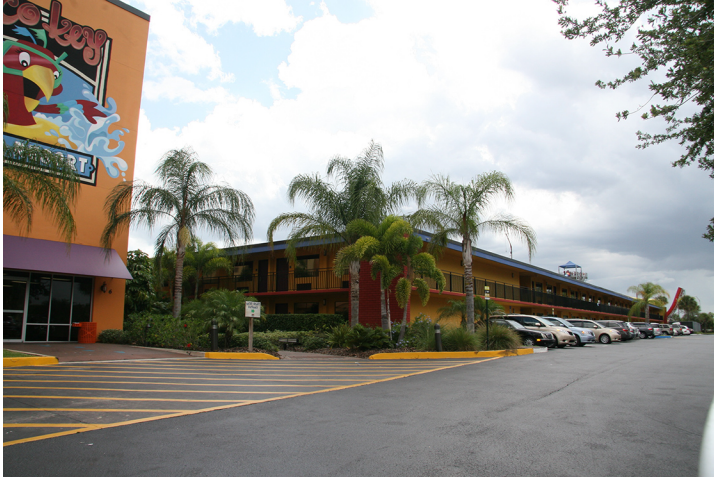
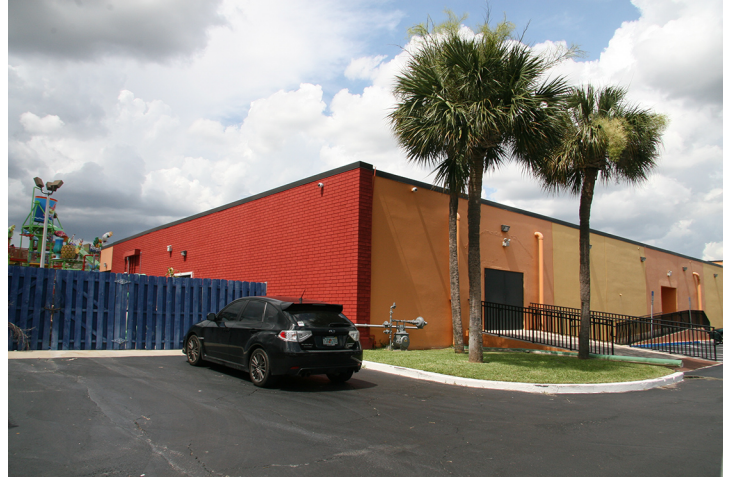
Condition (overall resource condition): []excellent [x]good []fair []deteriorated []ruinous
Narrative Description of Resource Two-story, irregular shaped plan Masonry Vernacular hotel building set on a poured concrete slab foundation. Wings of U-shaped section are connected via a canopy giving the building and overall irregular shape.
Archaeological Remains []Check if Archaeological Form Completed

8OR10250_a Facing Southwest

8OR10250_b Facing Northeast
