**SR 400 (I-4) Project Development and Environment (PD&E) Study**  
FM No.: 432100-1-22-01

**Technical Memorandum: Cultural Resource  
Assessment Survey of Proposed Improvements to**

**Segment 4: State Road 400 (SR 400)/Interstate 4 (I-4)  
from East of SR 15-600/US 17-92 (Seminole/Volusia County Line)  
to ½ Mile East of SR 472**

**December, 2015**

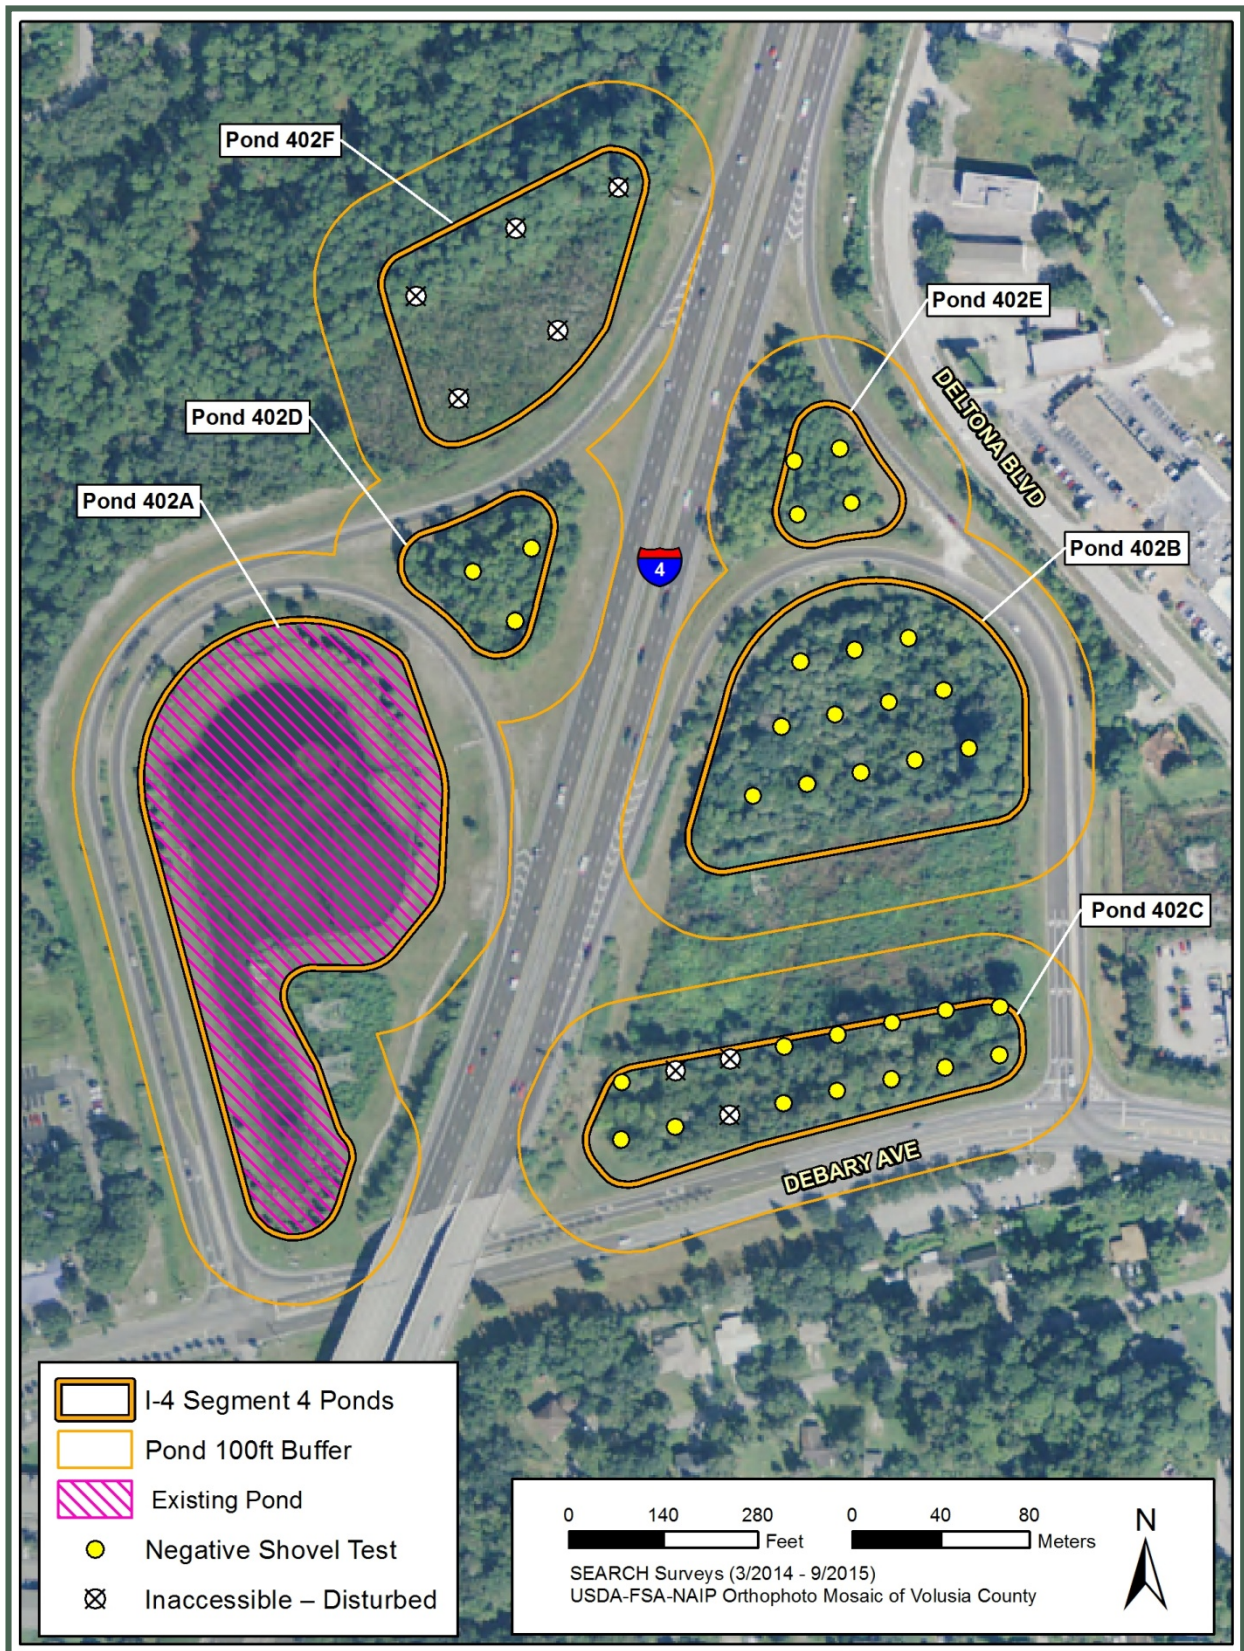
Figure 12 - Shovel test locations within the I-4 Segment 4 APE, Ponds part 1.

During the cultural resource survey of the I-4 Segment 4 ponds, pedestrian survey was combined with 120 subsurface shovel tests placed at 50- and 25-meter (164- and 82-foot) intervals, and judgmentally, throughout the 34 proposed pond footprints, the SSV, and two Treatment Swales. Six existing ponds (Ponds 400, 401, 402A, 413, 414, and D) did not warrant shovel testing because no additional modifications are proposed. **Figures 12–18** show the locations of shovel tests as recorded with handheld GPS units.

Of the ponds investigated, proposed Pond 402C exhibited the highest potential for the occurrence of archaeological materials due to its proximity to Lake Monroe and its moderately well-drained soils. Thirteen shovel tests were dug in the Pond 402C footprint, revealing a typical soil profile consisting of three strata. The upper stratum consisted of mottled dark grayish yellow-brown sand from the ground surface to a depth of 30 centimeters (12 inches). From 30 to 40 centimeters (12 to 16 inches) was light yellow-brown sand, and the lower stratum to 100 centimeters (39 inches) was noted as orange sandy clay. All shovel tests were negative.

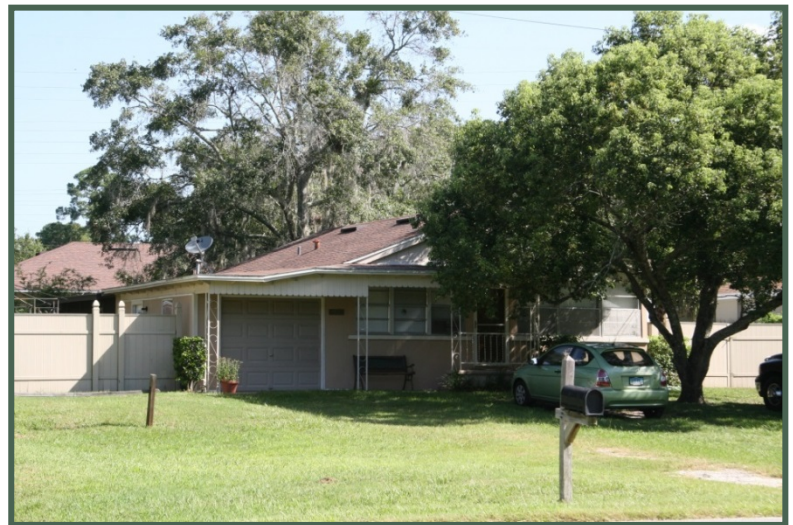
Figure 24 - Representative example of Masonry Vernacular style, Resource 8VO09414, facing northeast.

Eight resources in the I-4 Segment 4 APE can be categorized as Masonry Vernacular (**Figure 24**). Masonry Vernacular style generally refers to a type of building most often constructed by lay, or self-taught, builders (McAlester and McAlester 1996). Masonry Vernacular buildings typically have no predominant stylistic details and are not associated with any particular period of construction. Masonry Vernacular buildings are generally constructed of brick or concrete block and have a continuous or slab foundation. These buildings often incorporate elements from various architectural styles, including, but not limited to, Classical Revival, Georgian Revival, and Mediterranean Revival.

8VO09414	Original	276 Dirksen Drive	Sanford (1988)	T19S/R30E/S2	Private Residence	Private Residence	Masonry Vernacular	ca. 1963	One-story rectangular plan Masonry Vernacular residence set on a poured concrete slab foundation. The front-gable roof is clad in asphalt shingles and features vertical cement board in the gable end. The exterior fabric is stucco and the fenestration is four-light metal awning windows. The main entry on the south façade features a paneled wood door set behind a metal screen door sheltered beneath an open shed roof porch with metal railings. A flat roof garage addition is attached to the west façade and features a single-bay roll-up garage door. A wood fence surrounds the south façade.	Garage addition attached to the west façade. Unattached shed on the northwest of the property.	Not eligible	Lacks significant historical associations and architectural distinction.
