SR 400 (I-4) Project Development and Environment (PD&E) Study
FM No.: 201210-2-22-01

**Technical Memorandum: Cultural Resource
Assessment Survey of Proposed Improvements to**

**Segment 5: State Road 400 (SR 400)/Interstate 4 (I-4)
from West of SR 25/US 27
to West of CR 532 (Polk/Osceola County Line)**

March 2016

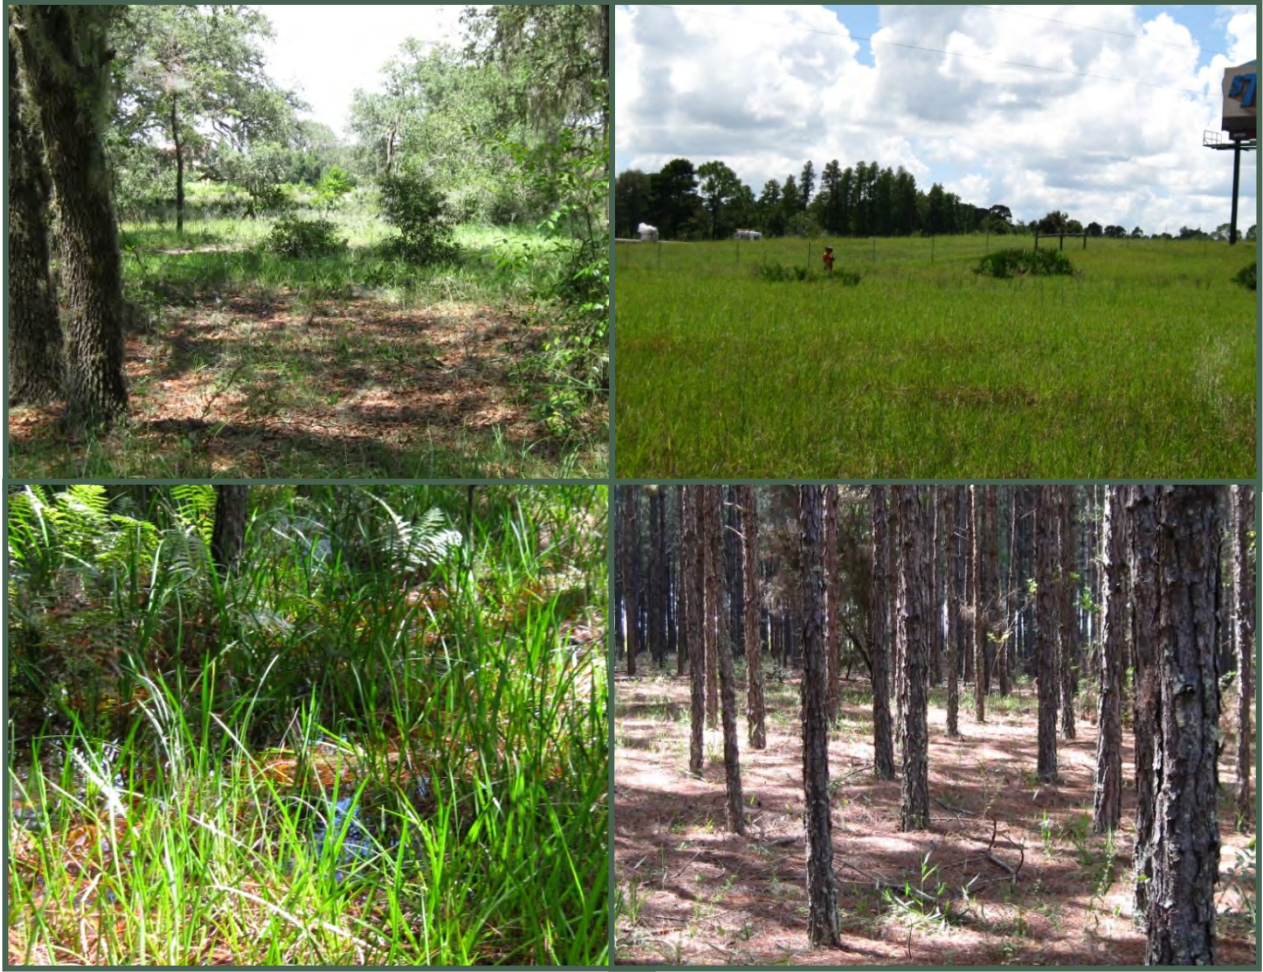
Figure 4 - Representative views of modern land use within the I-4 Segment 5 APE.

Modern land use within the APE consists of residential and commercial development as well as small parcels of undeveloped land. **Figure 4** provides representative views of modern conditions within the APE.

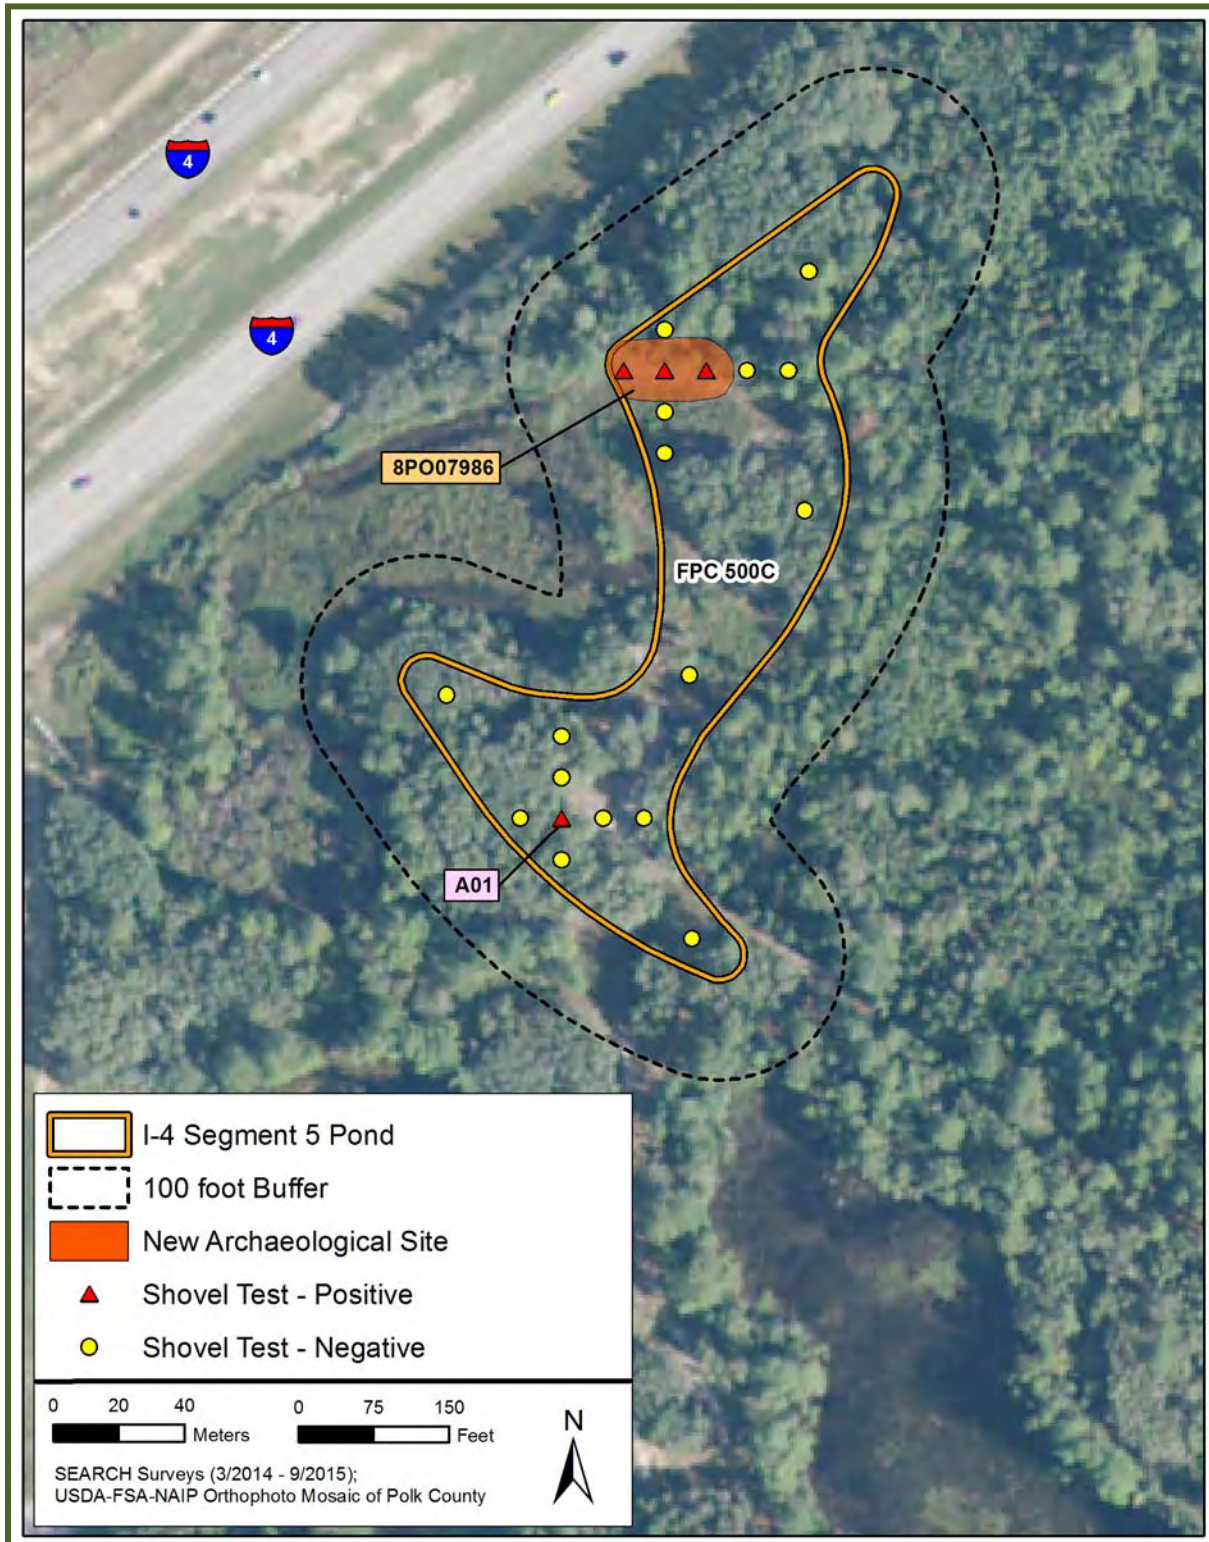
Figure 15 – Cultural resources recorded within the I-4 Segment 5 APE.

Comments: 8PO07986 was recorded to be a low-density prehistoric ceramic scatter located 65 meters southeast of I-4 (**Figure 15**). The temporal period associated with the prehistoric ceramics is unknown. SEARCH archaeologists excavated three shovel tests which were positive (STs 13, 28, and 30) for ceramic artifacts. Additional bounding shovel tests to the north, east, and south were negative for cultural material.

A01 is located approximately 140 meters south of site 8PO07986 (see **Figure 15**) and consists of a total of one prehistoric plain sand tempered sherd from Shovel Test 016. The pottery was located within Stratum III at a depth of 70 to 80 cmbs. The shovel test consisted of three strata, which included Stratum I (0-3 cmbs), dark brown humic sand; Stratum II (3-10 cmbs), yellow brown sand; Stratum III (10-100 cmbs), medium gray-brown sand. AO1 is not eligible for NRHP listing, and no further work is recommended.

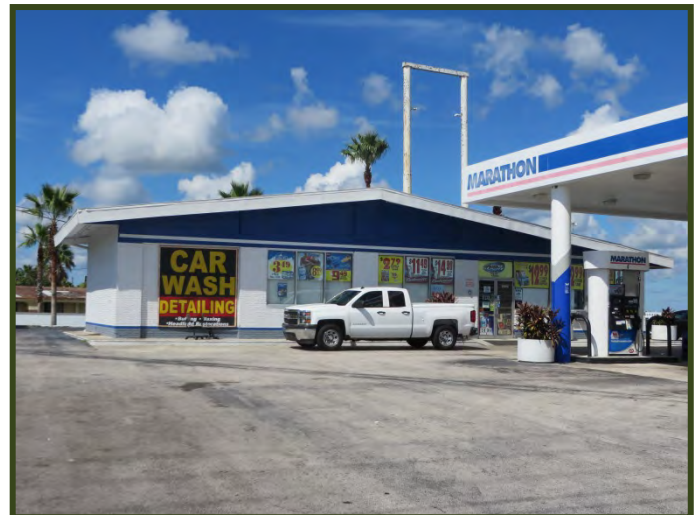
Figure 17 – Resource 8PO07962, facing west.

8PO07962 is a newly recorded structure located at 43804 US Highway 27 within the I-4 Segment 5 APE in Section 7 of Township 26 South, Range 27 East, as shown on the 1985 *Gum Lake, Fla.* USGS quadrangle map (see **Figure 16**). The ca. 1967 building currently functions as a gas station and is situated near the center of an irregular-shaped parcel that fronts US Highway 27. Resource 8PO07962 is a one-story, rectangular plan Masonry Vernacular building set on a poured concrete slab foundation (**Figure 17**). The roof is a built-up, front-gable design that features T1-11 plywood siding, brick, and stucco in the gable ends. The exterior fabric is a combination of concrete block and brick. The windows on the building are not arranged in a particular pattern but consist of clerestory windows on the west façade and commercial fixed-sash metal window set in groupings of two and three on the east and north facades. The main entry is on the east façade and features paired fixed-sash glass and metal doors with a one-light transom. A one-story, rectangular-shaped addition is attached to the west façade; and a wooden shed with paired, outward-swinging doors is attached to the west façade of the addition. A pump canopy consisting of four pumps and supported by four concrete columns is located to the east.

The main entry is on the east façade and features paired fixed-sash glass and metal doors with a one-light transom. A one-story, rectangular-shaped addition is attached to the west façade; and a wooden shed with paired, outward-swinging doors is attached to the west façade of the addition. A pump canopy consisting of four pumps and supported by four concrete columns is located to the east.

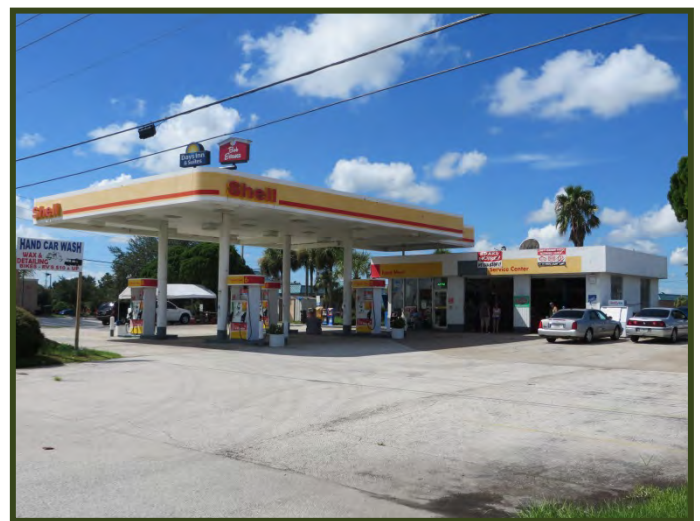
Figure 18 - Resource 8PO07963, facing west.

8PO07963 is a newly recorded structure located at 43750 US Highway 27 within Segment 5 of the I-4 APE in Section 7 of Township 26 South, Range 27 East, as shown on the 1985 *Gum Lake, Fla.* USGS quadrangle map (see **Figure 16**). The ca. 1964 building currently functions as a gas station and auto service center. The building is situated near the center of a rectangular-shaped parcel that fronts US Highway 27. Resource 8PO07963 is a one-story, rectangular plan Masonry Vernacular building set on a poured concrete slab foundation (**Figure 18**). The roof is a built-up, flat roof design that features an aluminum clad overhang surrounding the building. The exterior fabric is T1-11 plywood over concrete block. The windows on the building are not arranged in a particular pattern but consist of metal industrial windows with four rows of nine, fixed-sash lights on the north façade and commercial fixed-sash metal windows in a grouping of three on the east façade. The main entry is on the east façade and features a fixed-sash glass and metal door with a one-light transom. Two single-bay roll-up garage doors pierce the east façade, offset north. A one-story, rectangular shaped concrete block addition is attached to the west façade. A pump canopy consisting of four pumps and supported by four concrete columns is located to the east.

Resource 8PO07963 is a Masonry Vernacular building that represents a highly prevalent approach to commercial architectural design in Florida, as well as the United States in general. Based on the historic context, it is the opinion of the Principal Investigator that the building is not significant under NRHP Criterion A because it is not indicative of a particular era and is not associated with any significant period, event, or theme. Resource 8PO07963 is part of commercial infill along I-4 and US 27. The building was constructed for commercial use and has no known role or significant association with the development of interstate tourism in central Florida.

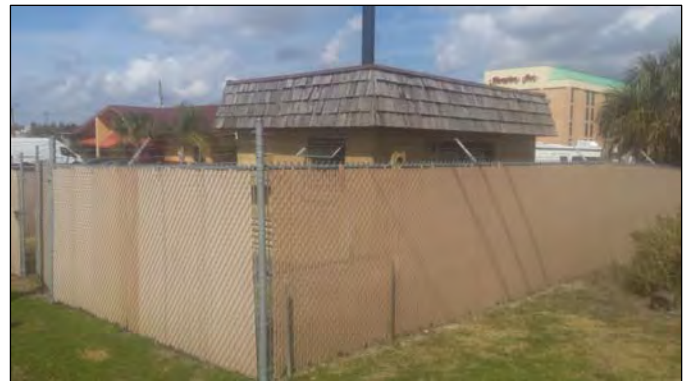
Figure 19 - Resource 8PO07989, facing north.

8PO07989 is a newly recorded structure located at 44079 US Highway 27 within Segment 5 of the I-4 APE in Section 7 of Township 26 South, Range 27 East, as shown on the 1985 *Gum Lake, Fla.* USGS quadrangle map (see **Figure 16**). The ca. 1970 building currently functions as a storage facility. The building is situated near the center of a rectangular-shaped parcel that fronts US Highway 27. Resource 8PO07989 is a one-story, rectangular plan Masonry Vernacular building set on a poured concrete slab foundation (**Figure 19**). The flat roof design features a wood shingle clad overhang in a mansard style surrounding the building. The construction and structural system is concrete block. The windows on the building are not arranged in a particular pattern but consist of metal awning windows. A flat metal roof supported by two posts extends from the southwest façade and covers mechanical equipment. The resource is surrounded by a chain-link fence with plastic infill and barbed-wire at the top. A double-leaf gate opens on the west side of the fence.

Resource 8PO07989 is a Masonry Vernacular building that represents a highly prevalent approach to industrial architectural design in Florida, as well as the United States in general. Based on the historic context, it is the opinion of the Principal Investigator that the building is not significant under NRHP Criterion A because it is not indicative of a particular era and is not associated with any significant period, event, or theme. Resource 8PO07989 is part of commercial and industrial infill along I-4 and US 27. The building was constructed for industrial use and has no known role or significant association with the development of central Florida. Furthermore, the resource is not eligible under Criterion B because it lacks association with any person(s) significant in history. Also, the resource is not eligible under Criterion C due to its lack of architectural distinction. The overall design of Resource 8PO07989 does not represent or embody the distinctive characteristics of a type of construction, and it does not possess high artistic value. Finally, the building is not significant under Criterion D because it lacks the potential to yield further information of historical importance. It is the opinion of the Principal Investigator that 8PO07989 does not meet the minimum criteria for listing in the NRHP, either individually or as a contributing resource to a historic district.

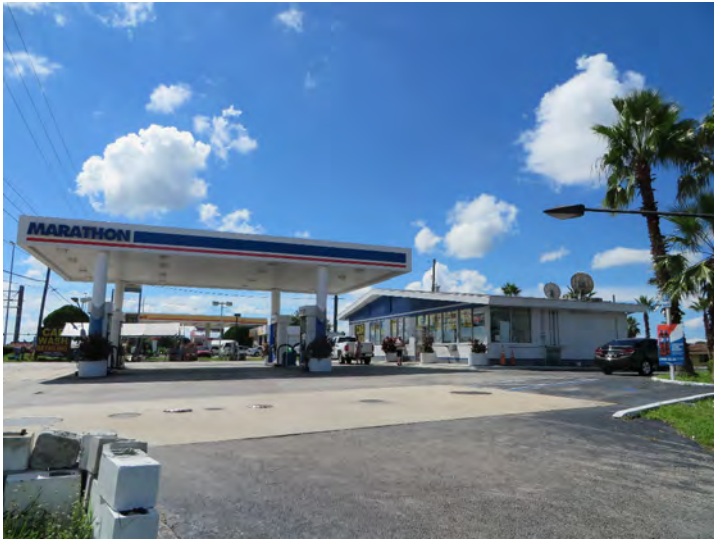
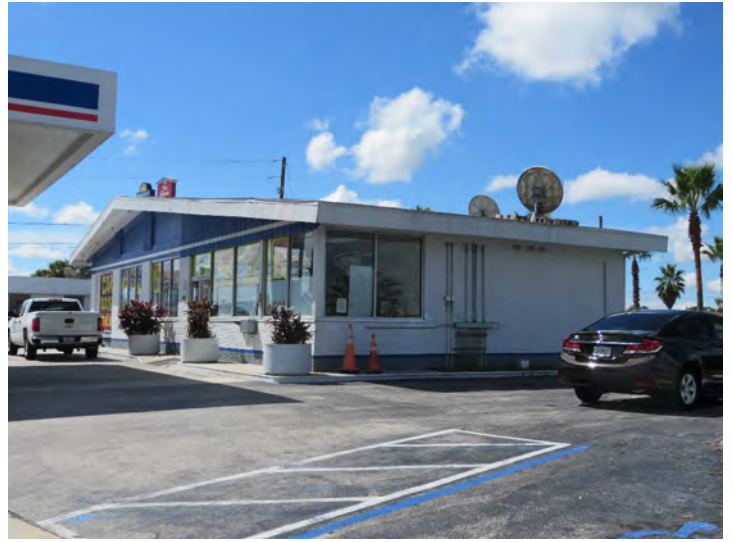
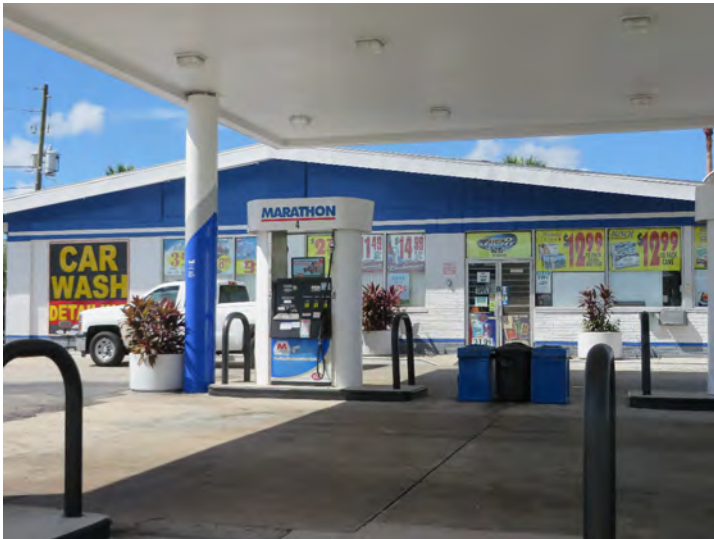
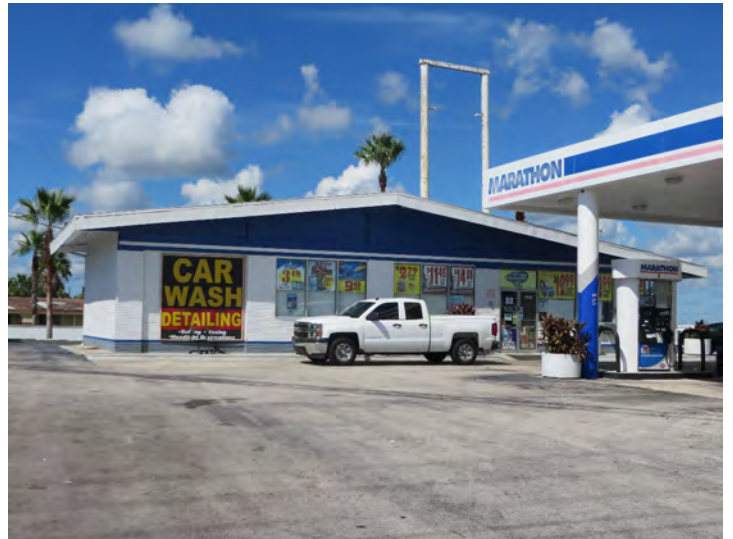
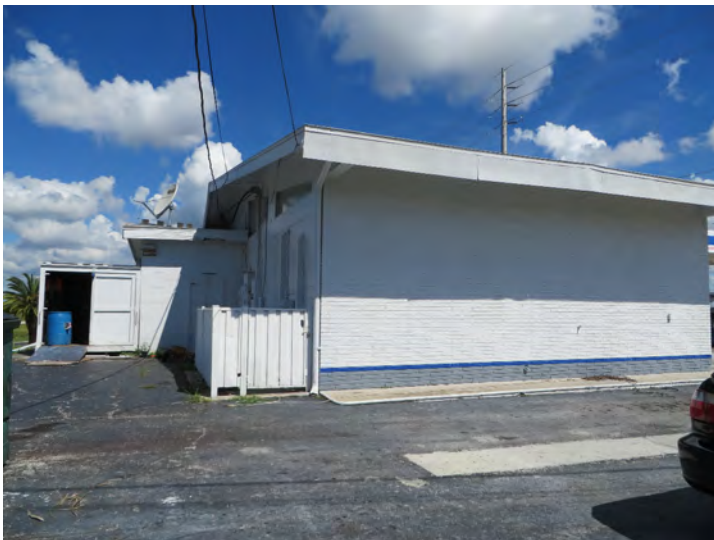
8PO07962_a Facing Southwest

8PO07962_b Facing Southwest

8PO07962_c Facing Southwest

8PO07962_d Facing West

8PO07962_e Facing North

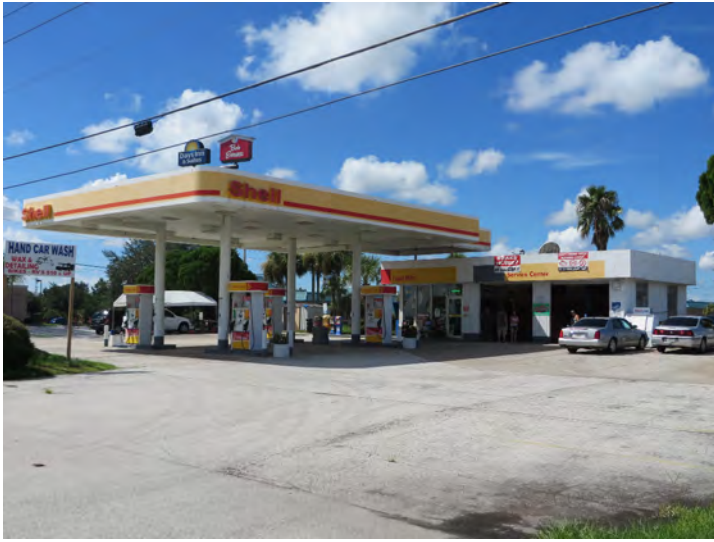
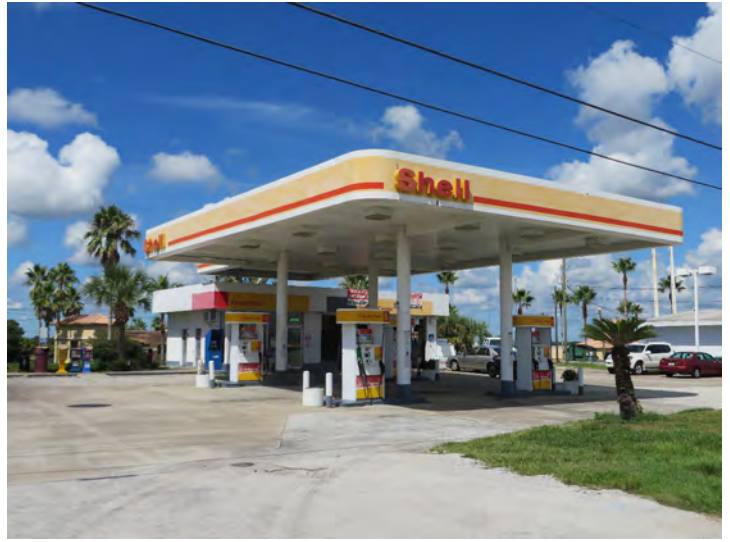
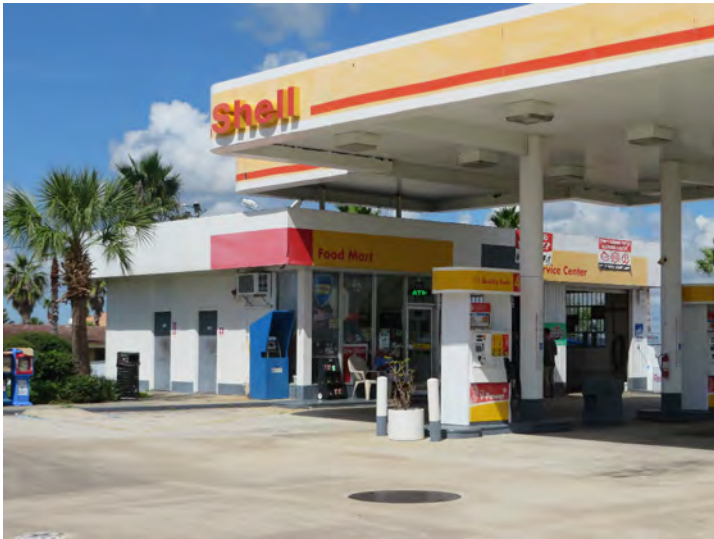
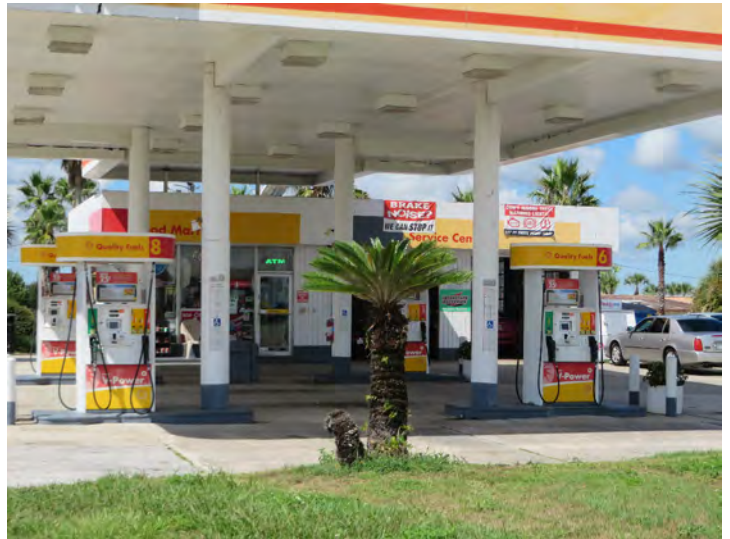
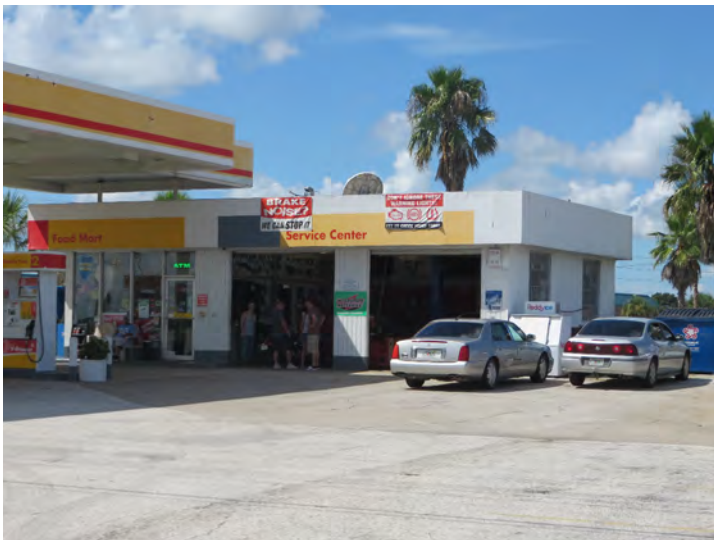
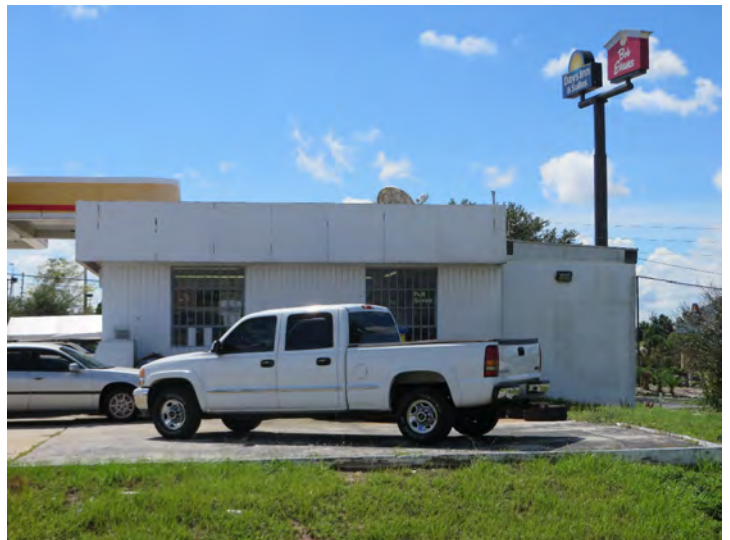
8PO07963_a Facing West

8PO07963_b Facing Northwest

8PO07963_c Facing Northwest

8PO07963_d Facing West

8PO07963_e Facing Southwest

8PO07963_f Facing South

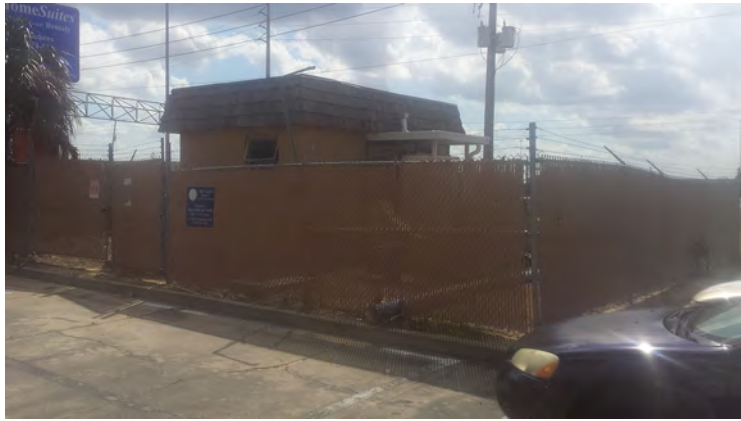
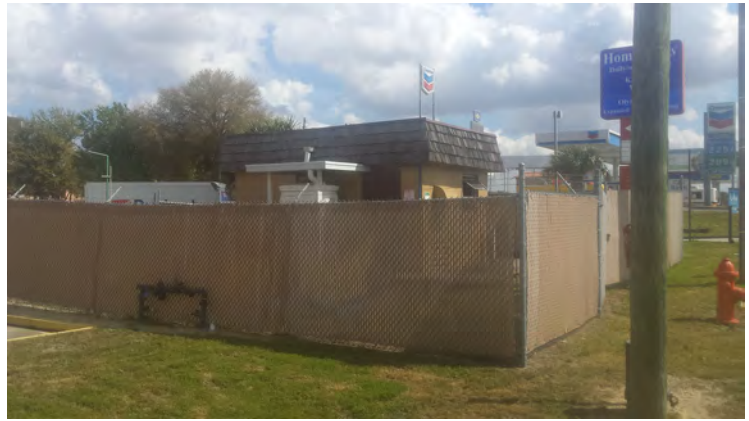
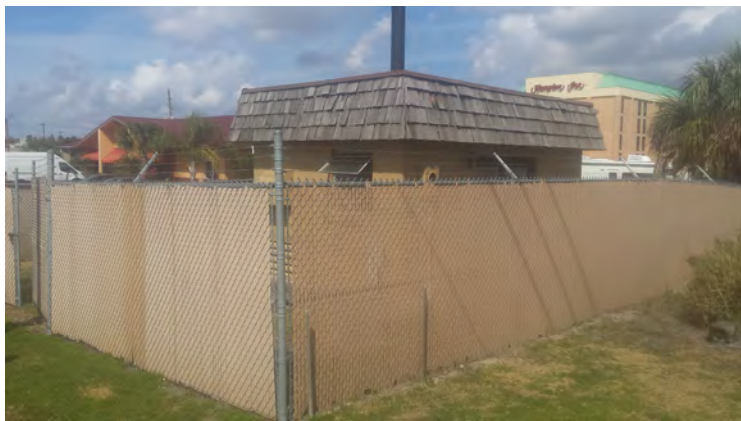
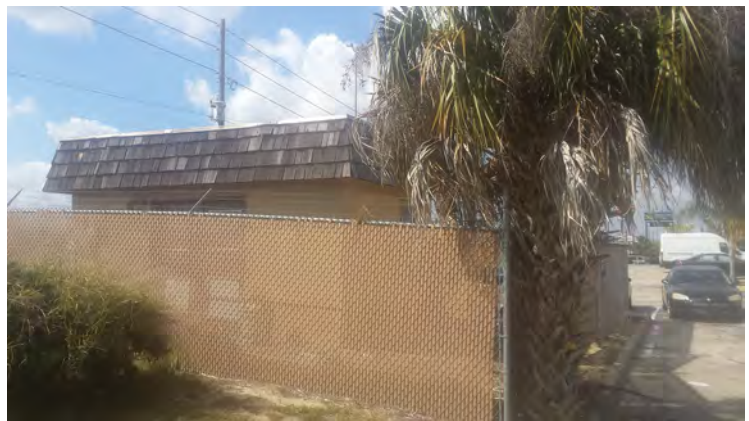
8PO07989_a Facing South.jpg

8PO07989_b Facing Southeast.jpg

8PO07989_c Facing North.jpg

8PO07989_d Facing Northwest.jpg
