SR 400 (I-4) Project Development and Environment (PD&E) Study
FM No.: 432100-1-22-01

Contamination Screening Evaluation Report
Segment 1: from west of CR 532 (Polk/Osceola County Line) to west of
SR 528 Beachline Expressway

Polk County (16320), Osceola County (92130), Orange County(75280)

July 2016

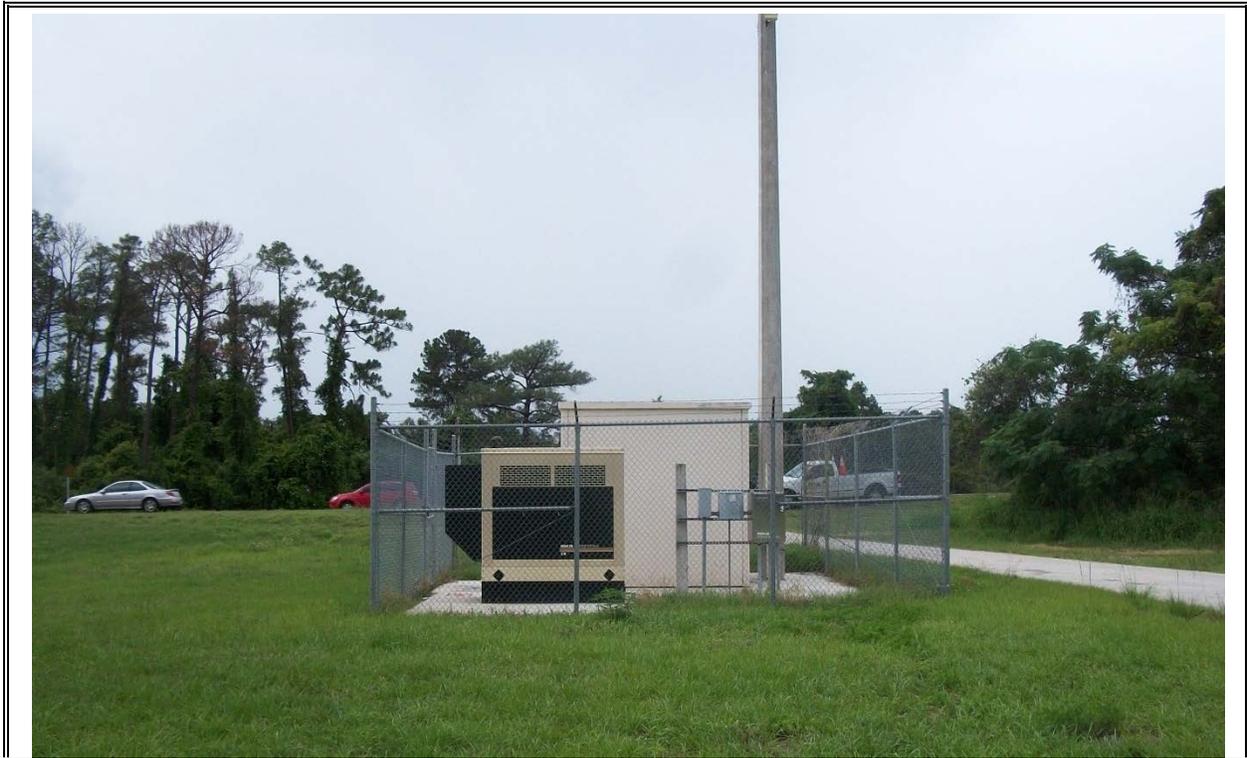
Site 84: SeaWorld of Florida Inc., Florida Festival

Site 84 – SeaWorld of Florida Inc., Florida Festival (FLR000149609) – This site, listed as a small quantity generator, is located at 6295 Sea Harbor Drive. Despite minor noncompliance incidents in the past regarding failure to correctly label containers, no contamination incidents have been reported. This facility is rated as **LOW RISK** due to it being currently in full compliance and the distance (0.42 miles southeast) from the right-of-way.

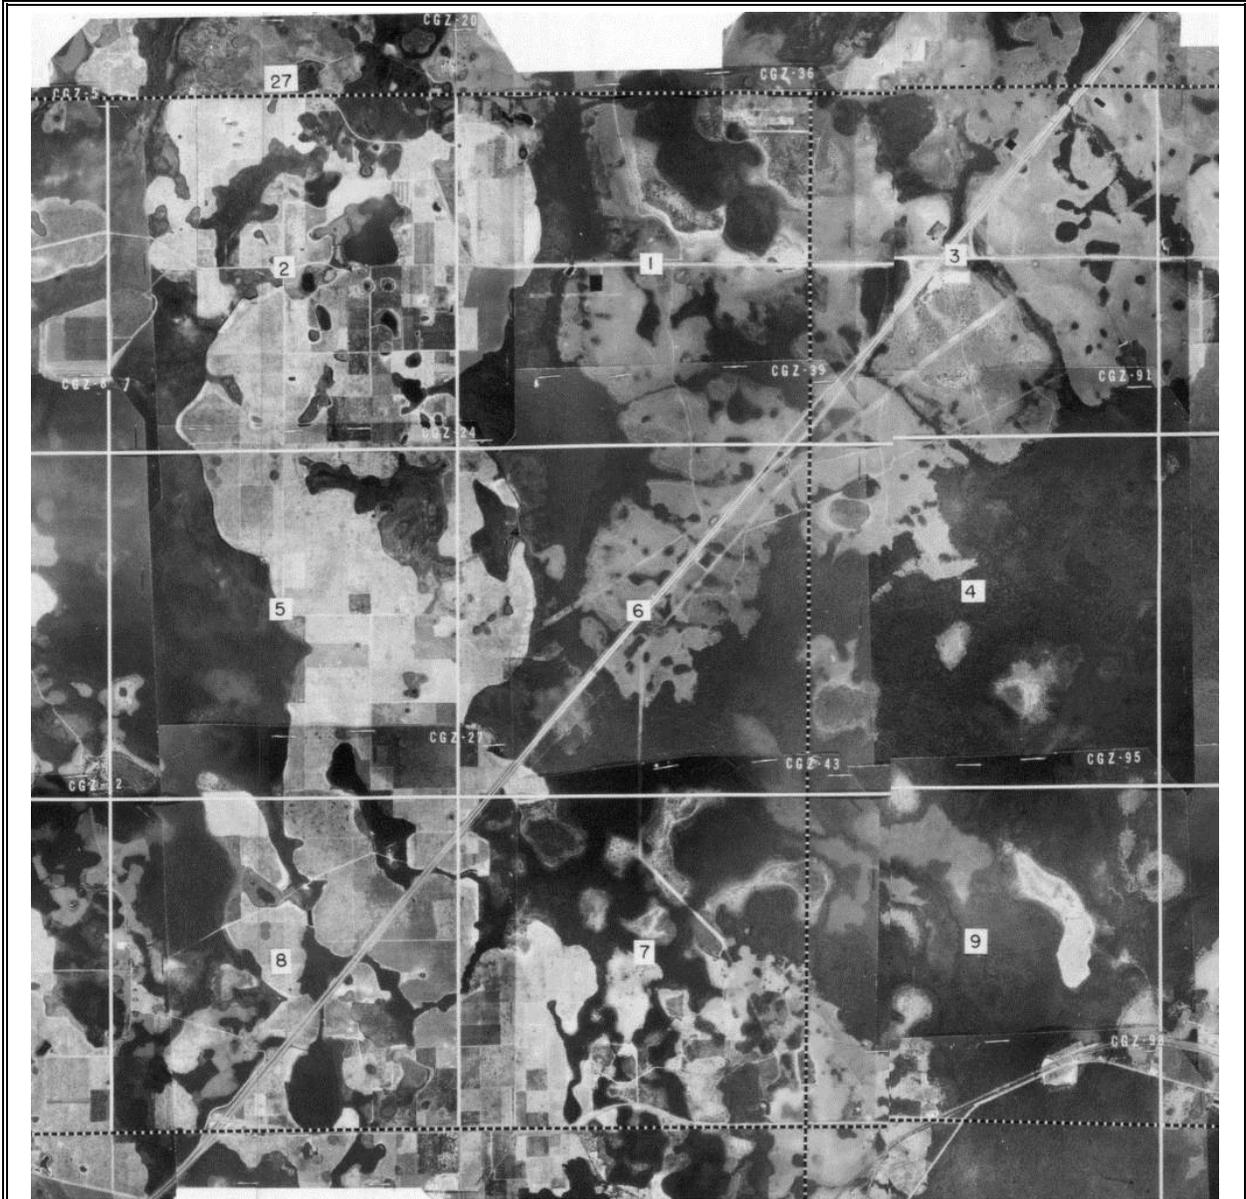
Aerial Photography: 1968

Conditions in Osceola County were generally the same as observed on the 1968 aerial photos. The groves were still present between Osceola Polk Line Road and Old Lake Wilson Road. An excavation, possibly an unregistered landfill, was located in an area between where Old Lake Wilson Road and World Drive exist today. The US 192/I-4 interchange had major changes with a hotel complex located in the northeast quadrant. Additional infrastructure was occurring in the Walt Disney World and SeaWorld areas of Orange County. It is likely that several gasoline service stations would have been located along several roadways in the study area, but positive identification of these facilities could not be made.

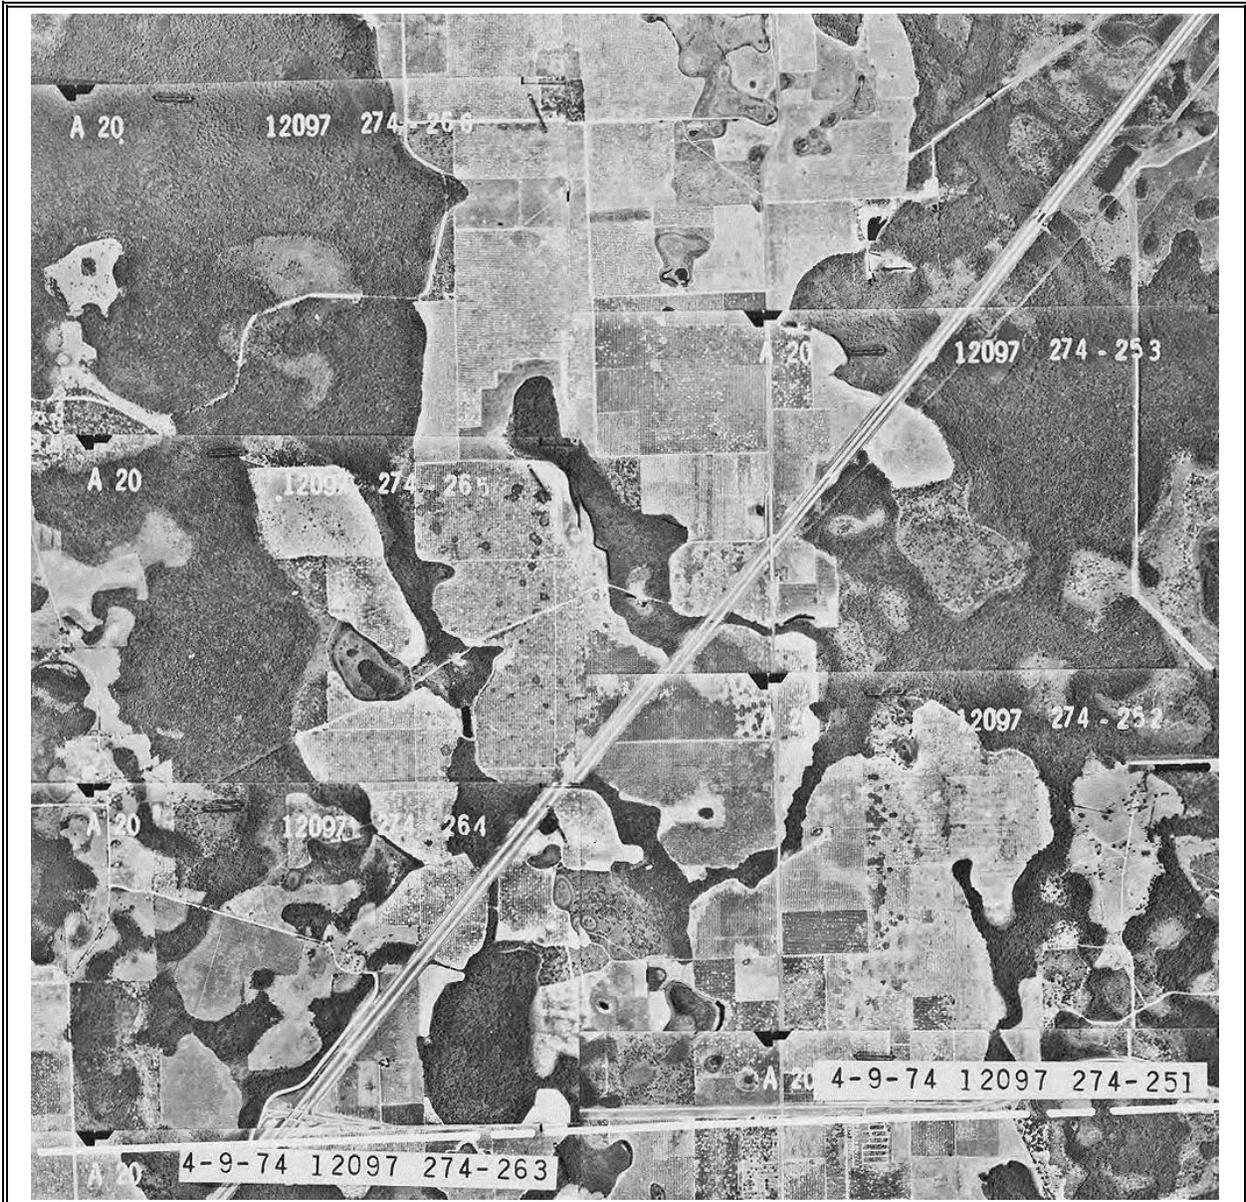
Aerial Photography: 1974A

Conditions in Osceola County were unchanged from what was viewed on the 1974 aerials. Additional development was occurring east of the Walt Disney World attraction area along SR 535. Hotels and a golf course were located at the northeast quadrant of the SR 536/I-4 interchange. This area of Orange County was experiencing large scale hospitality, entertainment, and residential developments.
