PAVEMENT SURVEY AND EVALUATION REPORT

FINANCIAL PROJECT NUMBER: 429079-1

STATE ROAD 400 (I-4)

SECTION NUMBER: 75280; MP 0.000 to MP 1.740
From Osceola County Line to East of SR 536

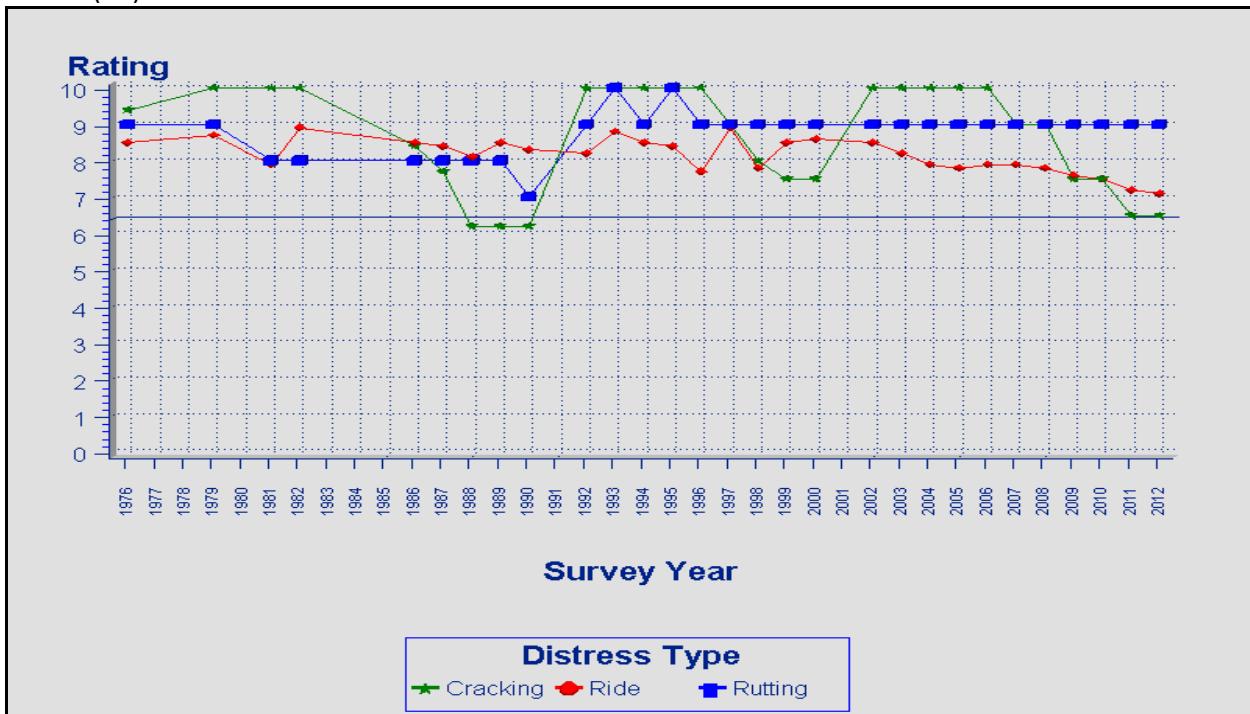
SR 400 (I-4) MP 0.000 to MP 1.740 Eastbound

Currently, there is a borderline crack rating of 6.5 for the eastbound lanes according to the 2012 Pavement Condition Survey. The Pavement Condition Survey ratings are in the Appendix for review.
