# PAVEMENT SURVEY AND EVALUATION REPORT

FINANCIAL PROJECT NUMBER: 430644-1

## STATE ROAD 400 (I-4)

SECTION NUMBER: 75280; MP 1.740 to MP 6.018  
**From East of SR 536 to West of SR 528**

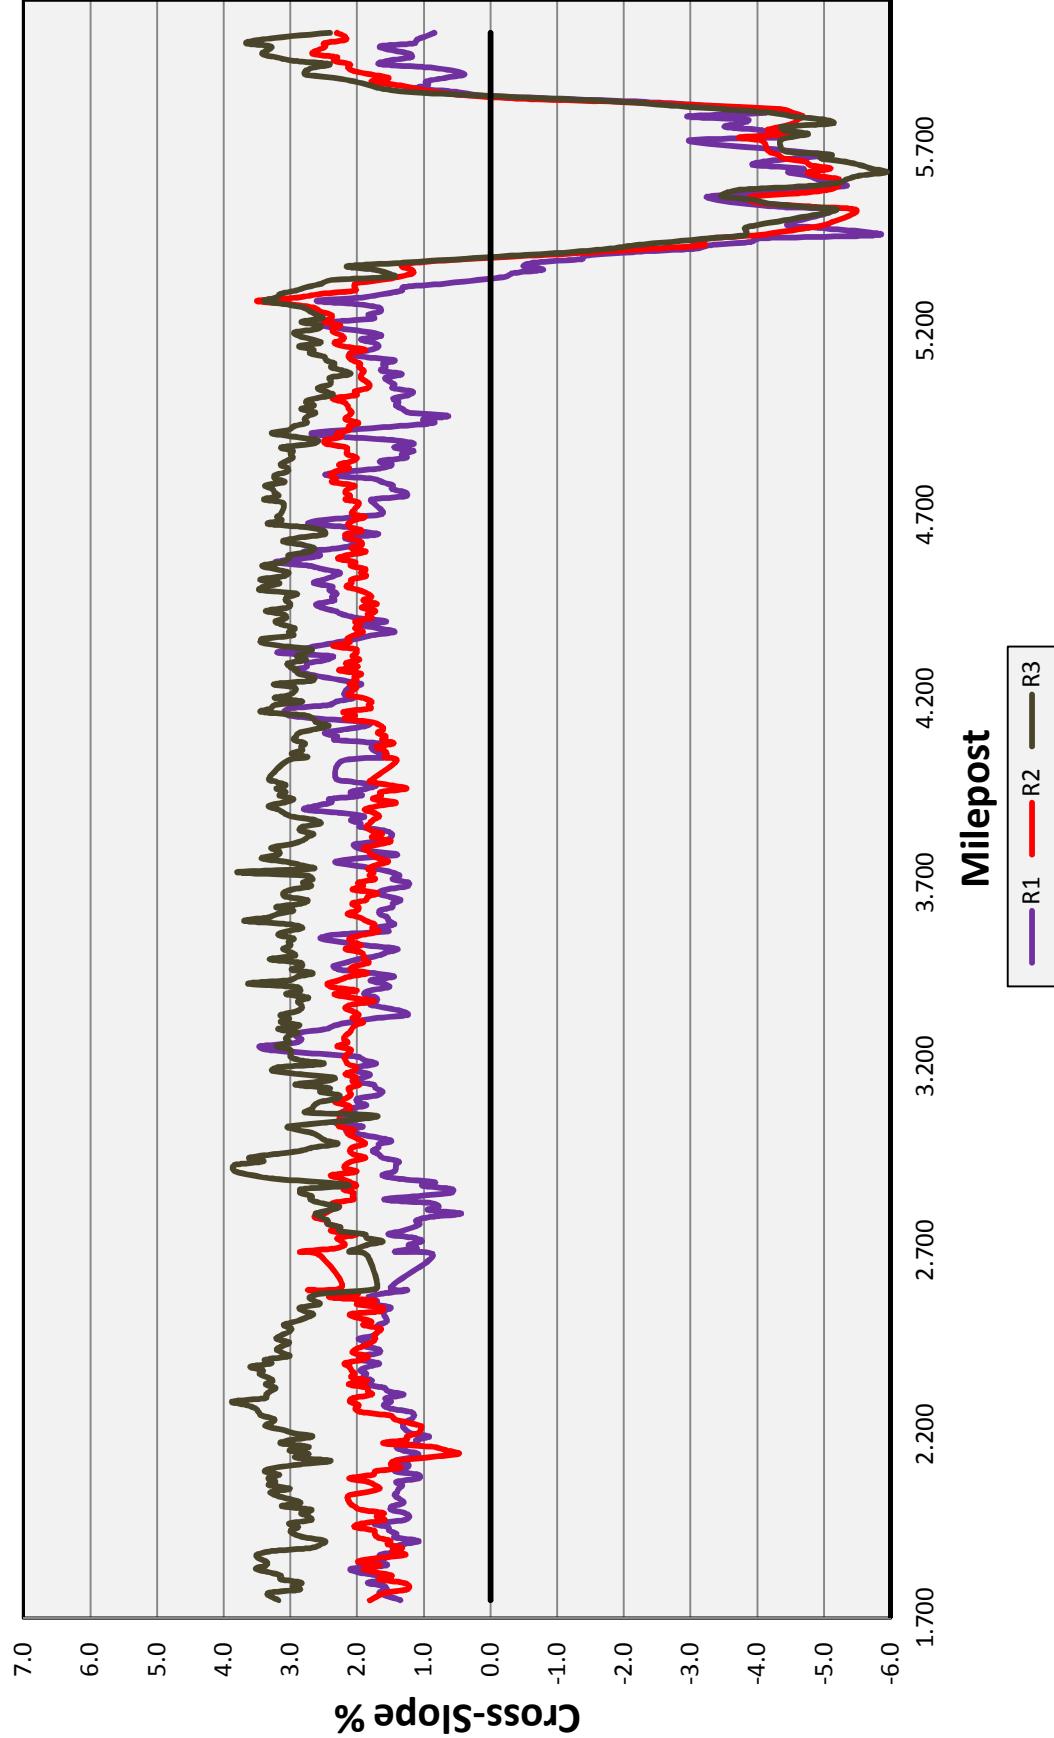
## SR 400 (I-4) Eastbound MP 1.740 to MP 6.018

The eastbound mainline lanes are in fair to poor condition. The inside R1 passing and R2 middle lanes are in fair condition with shallow open-graded friction course cracking, minor asphalt flushing and minor raveling. The R3 travel lane is in poor condition. There is moderate raveling of the coarse aggregates within the friction course and in the wheelpaths. The cracking observed is mostly shallow (under one inch) Class I branch cracking in the wheelpaths. There are also two moderate to severe longitudinal Class II/III cracks at the pavement joints between the R2 to R3 lane, and from the R3 lane to the R4 lane. The R4 auxiliary lane is in fair condition, with pavement distresses similar to the R1 and R2 lanes.

We recommend that 2.75 inches of milling be performed to provide long-term pavement preservation of the existing pavement. This will remove the majority of all cracks and friction course raveling.

We recommend that 3.25 inches of milling be performed to provide long-term pavement preservation of the existing pavement. This will remove all cracks and friction course raveling.

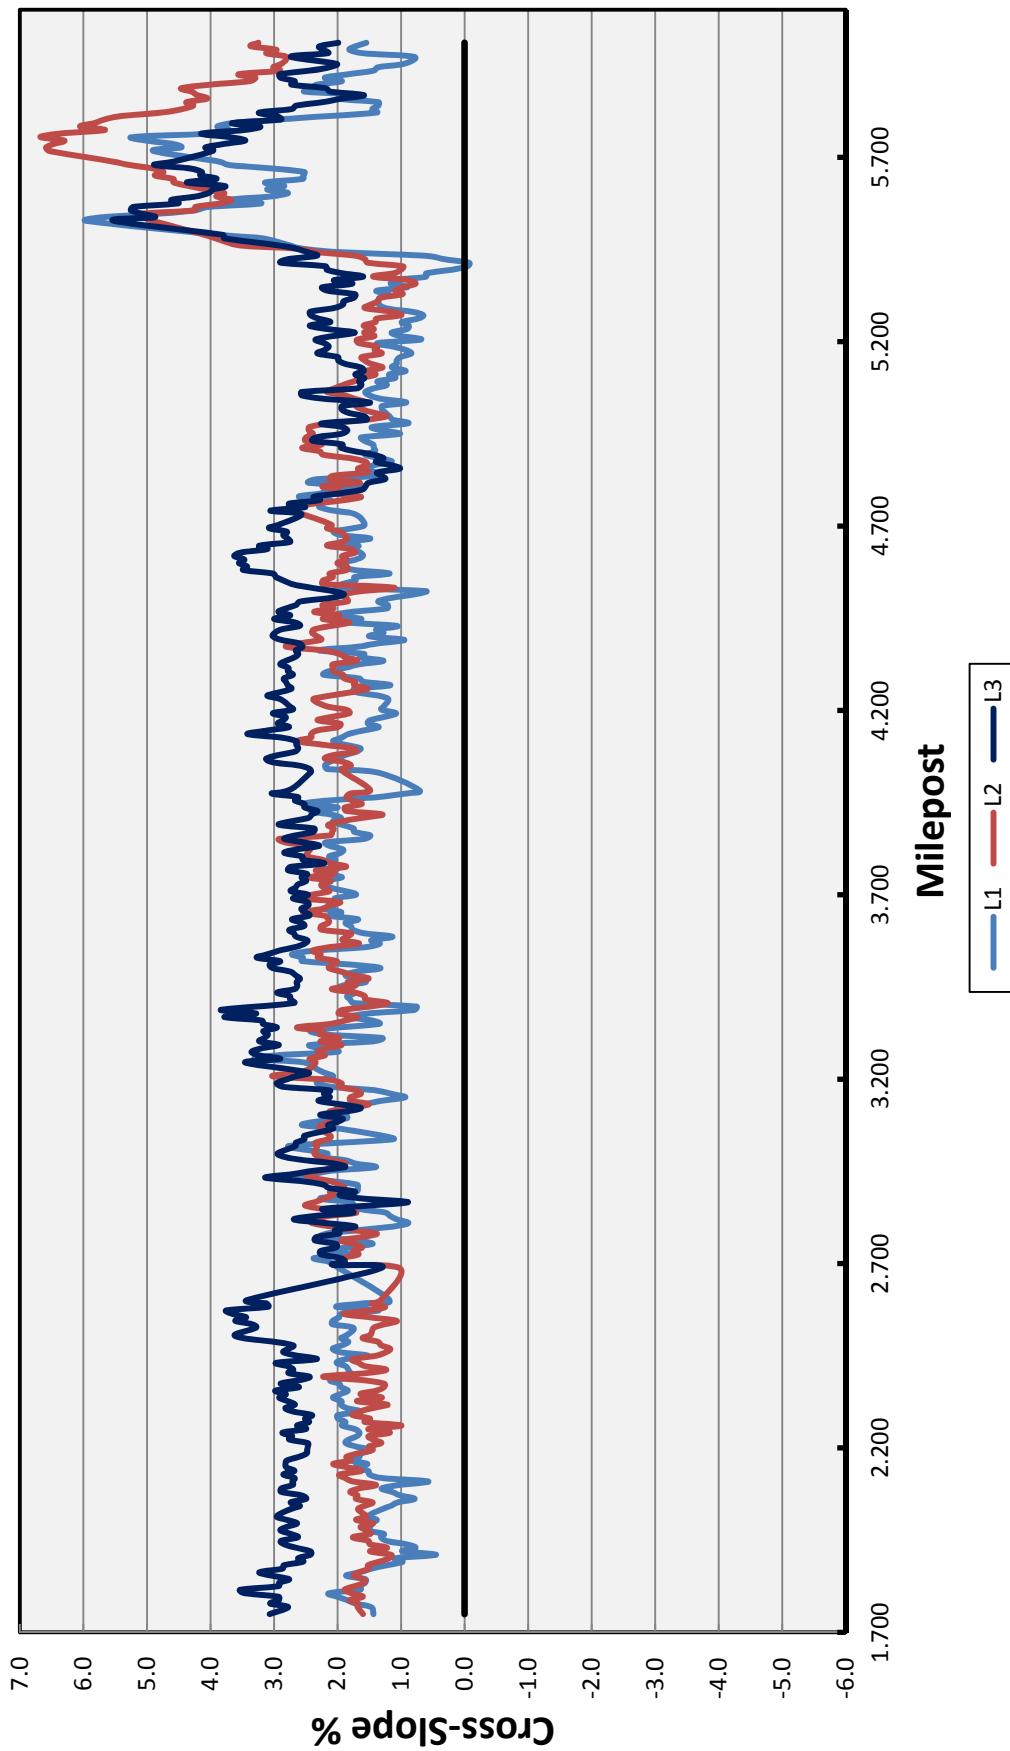
## SR 400 (I-4) Westbound MP 1.740 to MP 6.018

The westbound mainline lanes are in fair condition. All lanes (L1, L2, L3, and L4) have mostly shallow (less than one inch) Class I branch cracking of the open-graded friction course in the wheelpaths. There were no significant locations of rippling or raveling of the friction course. There is light to moderate longitudinal cracking in the pavement joints between all mainline lanes.

We recommend that 2.75 inches of milling be performed to provide long-term pavement preservation of the existing pavement. This will remove all cracks and friction course raveling.

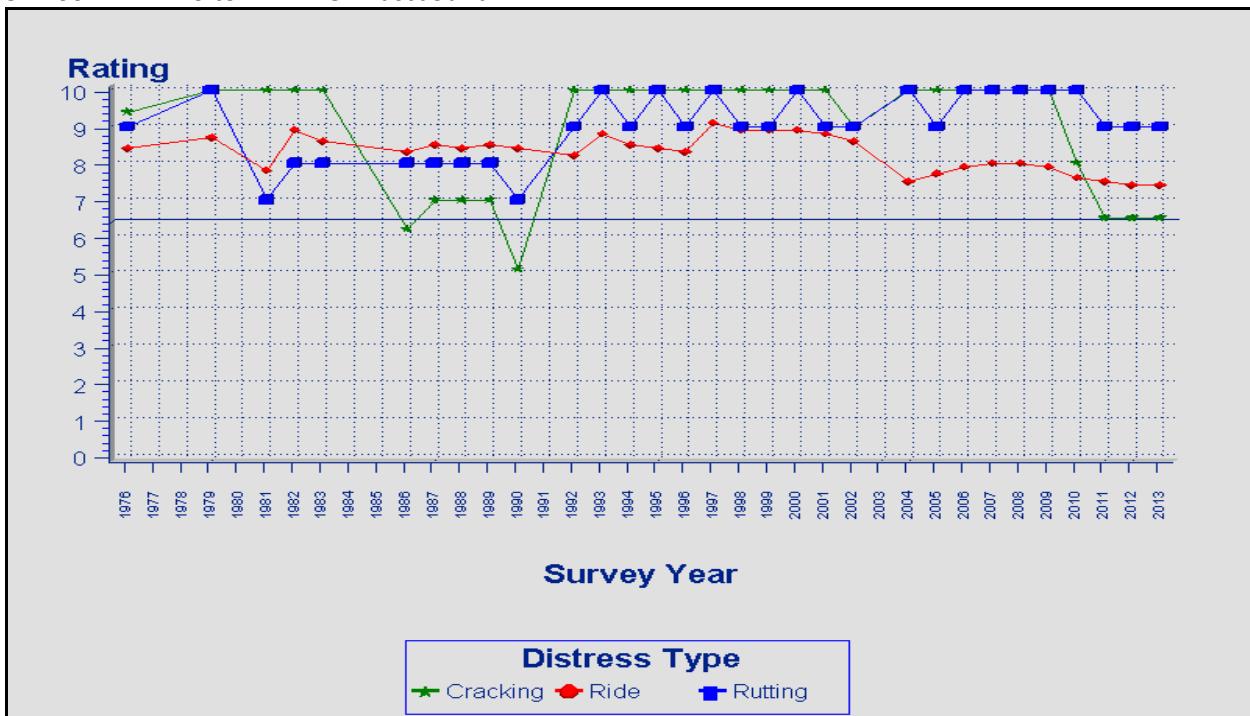
SR 400 MP 1.740 to MP 4.232 Eastbound

Currently, there is a borderline crack rating of 6.5 for the eastbound lanes according to the 2013 Pavement Condition Survey. The Pavement Condition Survey ratings are in the Appendix for review.
