SR 400 (I-4) Project Development and Environment (PD&E) Study
FM No.: 201210-2-22-01

Contamination Screening Evaluation Report

Segment 5: SR 400 (I-4) from West of SR 25/US 27 to West of CR 532
(Polk/Osceola County Line)

April, 2017

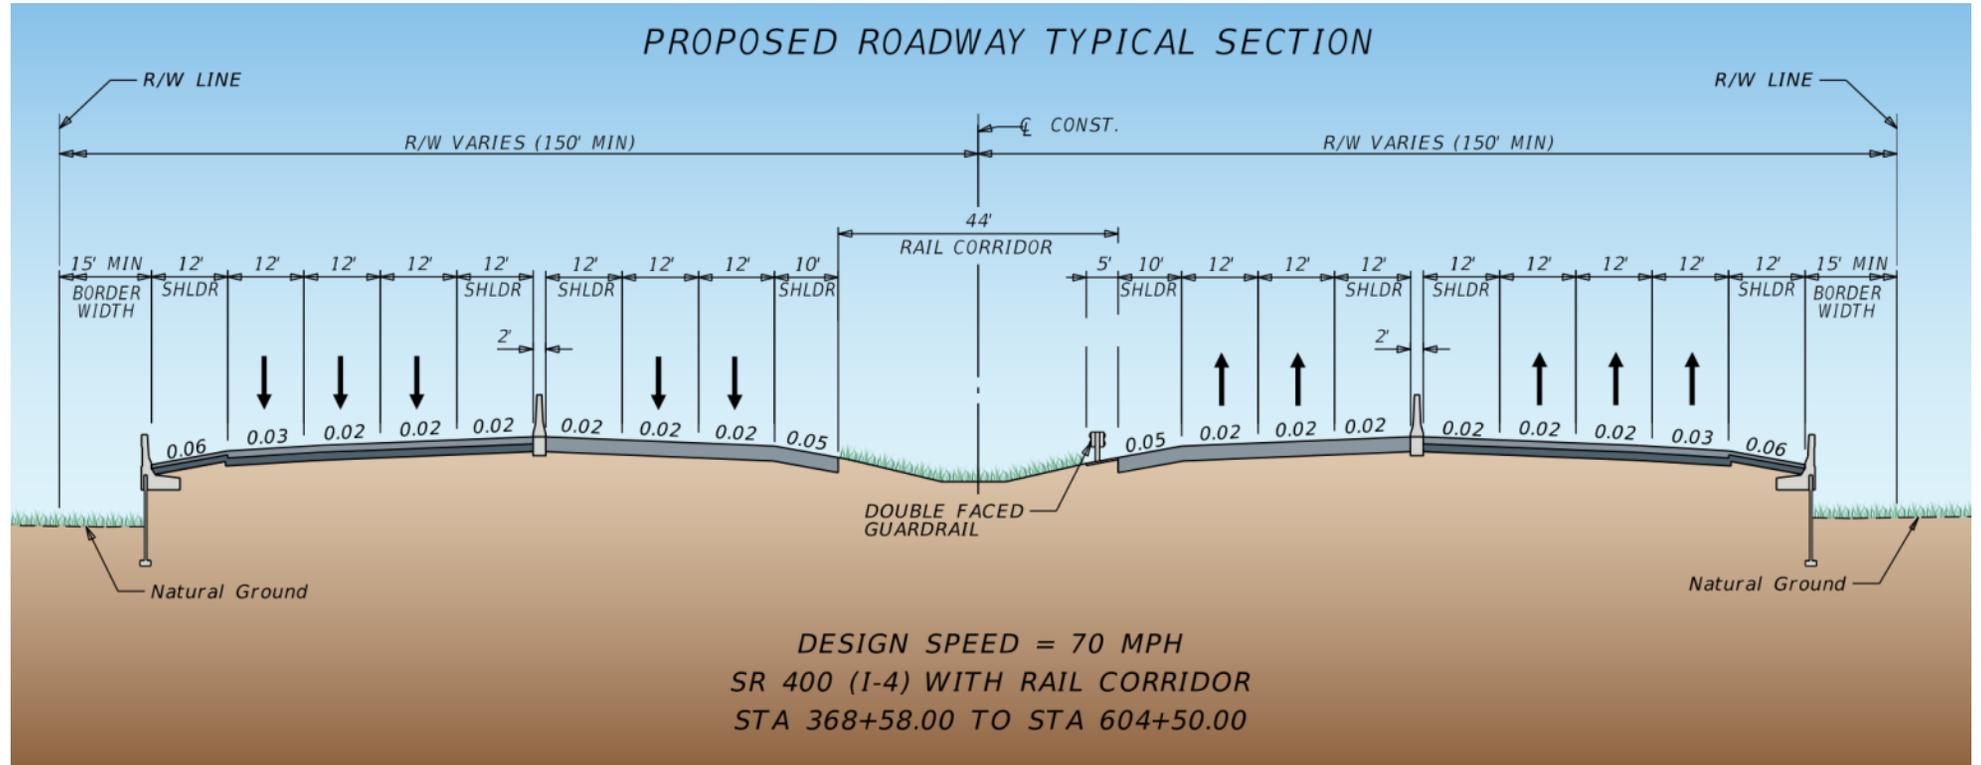
Figure 1.3 – SR 400 (I-4) Segment 5 Proposed Typical Section (6+4 with rail envelope)

The proposed improvements to I-4 include widening the existing six lane divided urban interstate to a ten lane divided highway. Generally, the typical section will be consistent throughout Segment 5 and will have three 12-foot general use travel lanes with 12-foot inside and outside shoulders (10-foot paved outside) and two 12-foot express lanes with 10-foot inside and 12-foot outside shoulders in each direction. A 2-foot barrier wall between the adjacent shoulders will separate the express lanes from the general use lanes. The typical section includes a 44-foot rail corridor in the median within a minimum 300 foot right of way (ROW). **Figure 1.2** illustrates the proposed mainline typical section for I-4 Segment 5.

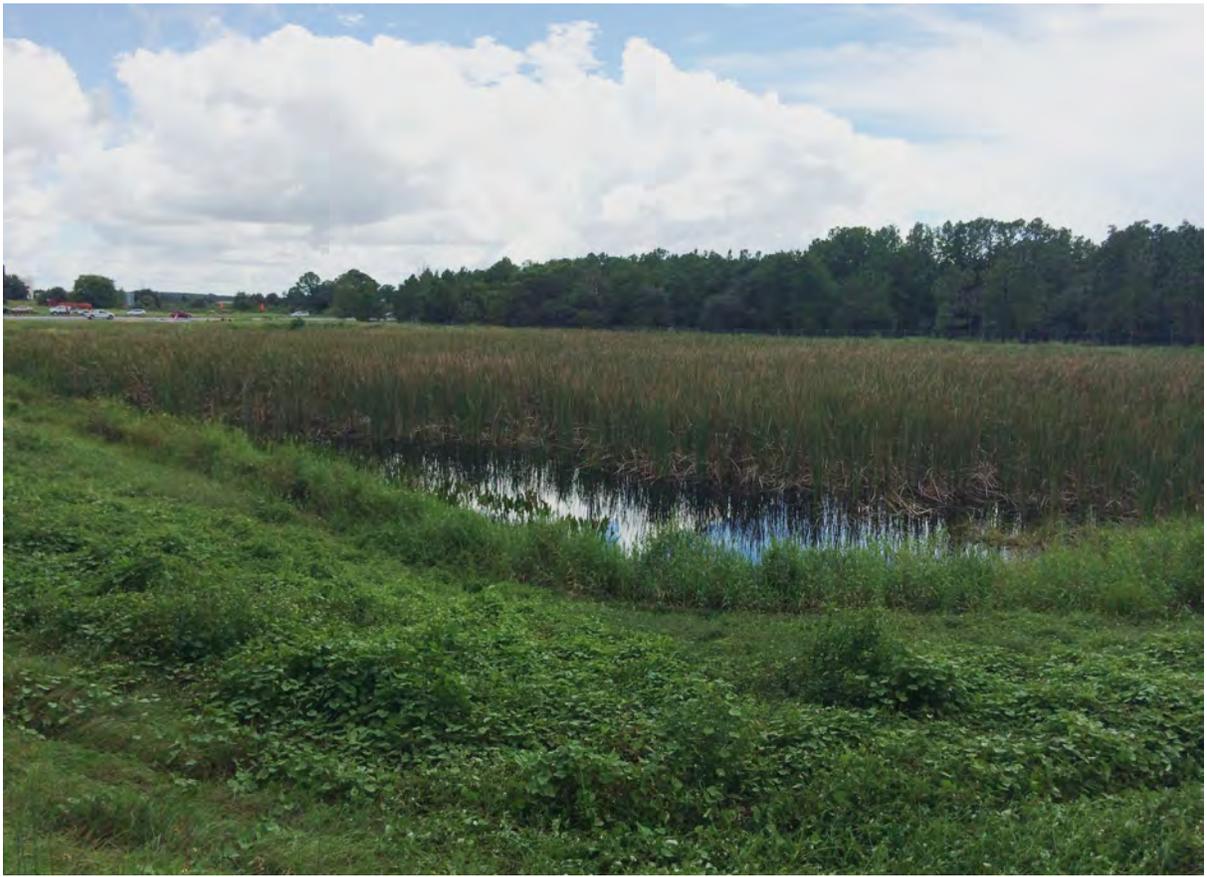
Pond Site 500 is located west of the US 27 interchange, along the westbound roadway. This is an existing pond site, proposed to be regraded. The pond site is primarily dominated by cattails at the north end and has a mix of duck potato, torpedo grass, primrose, and Carolina willow in the shallower south end. The banks are dominated by cogon grass and weedy herbaceous species. No obvious signs of contamination were observed in the field for this site. This pond site is within the delineated Groundwater Contamination Plume #53263279 (Site #8), which is a known contamination plume from the agricultural pesticide ethylene dibromide (EDB). This pond site was given a **MEDIUM RISK** rating based on the documented contamination present at the site.

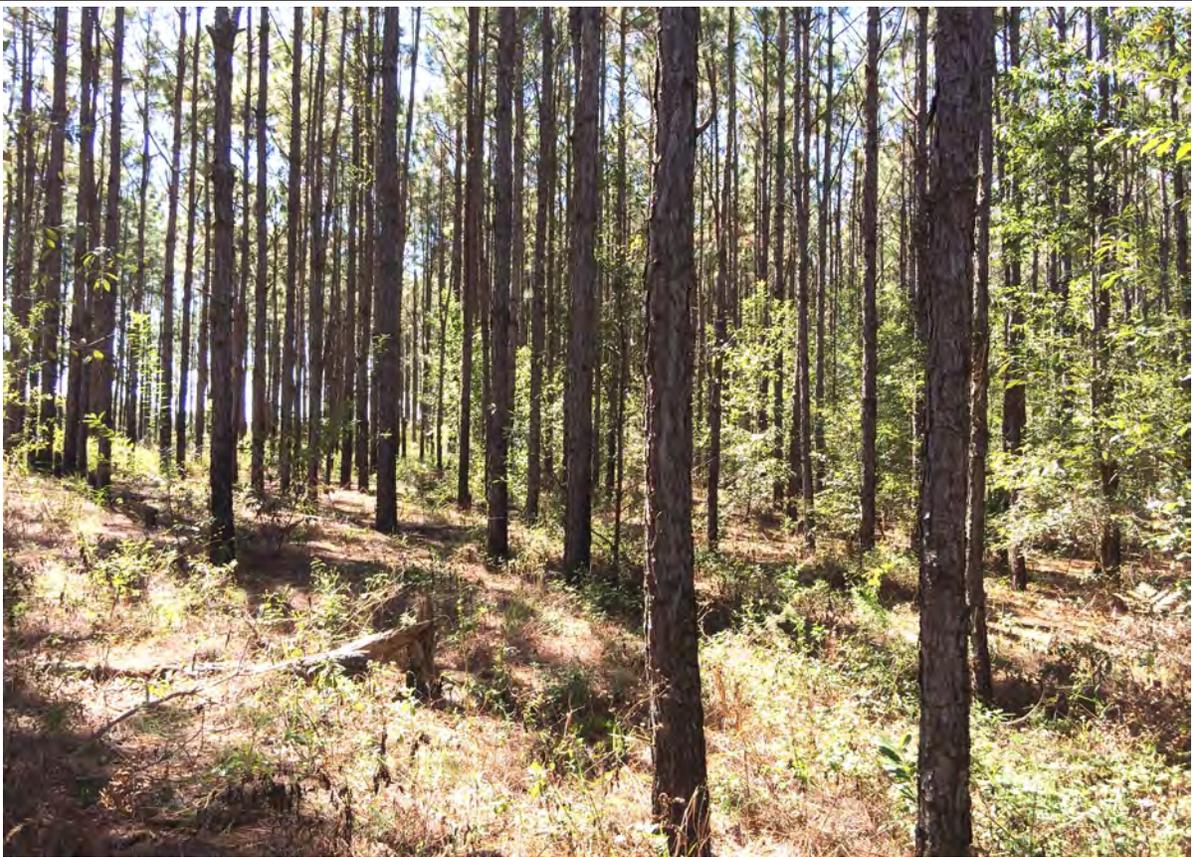
Pond Site FPC 500D is located east of the US 27 interchange, to the west of the right-of-way. This is a proposed new floodplain compensation pond. The existing site is entirely planted pines with some small fallow citrus, persimmon, cherry, scrub live oak, and weedy herbaceous species in the understory. The presence of fallow citrus indicate that this pond site could have been used for citrus production in the past and could potentially contain contamination from EDB, but no obvious signs of contamination were observed in the field for this site and it is not located in a known EDB contamination plume. This pond site was given a **MEDIUM RISK** rating based on the presence of fallow citrus trees.

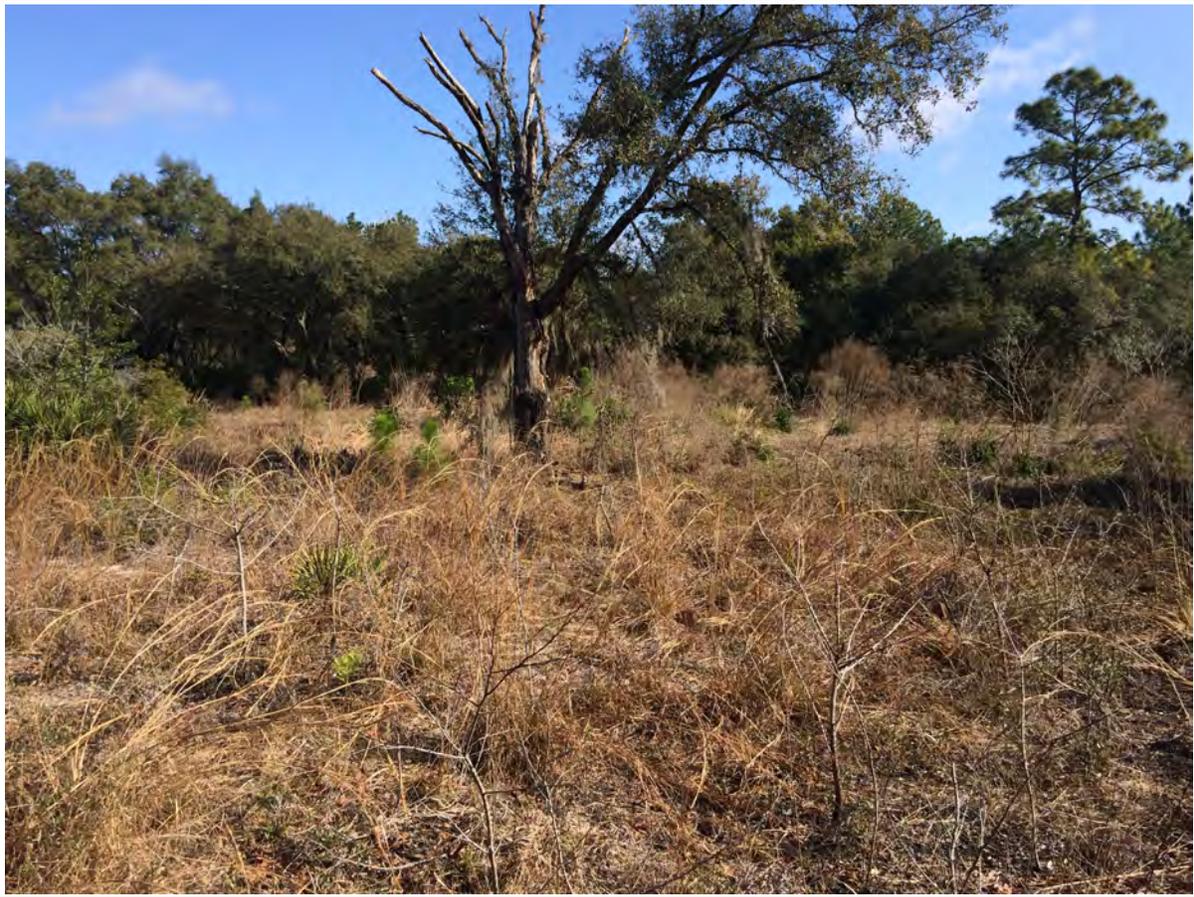
Pond Site FPC 500C is located east of the US 27 interchange, to the east of the right-of-way. This is a proposed new floodplain compensation pond. The existing site is primarily scrub live with saw palmetto in the understory with some open patches of sand with mixed herbaceous vegetation. No obvious signs of contamination were observed in the field for this site. Therefore, this pond site was given a **LOW RISK** rating.

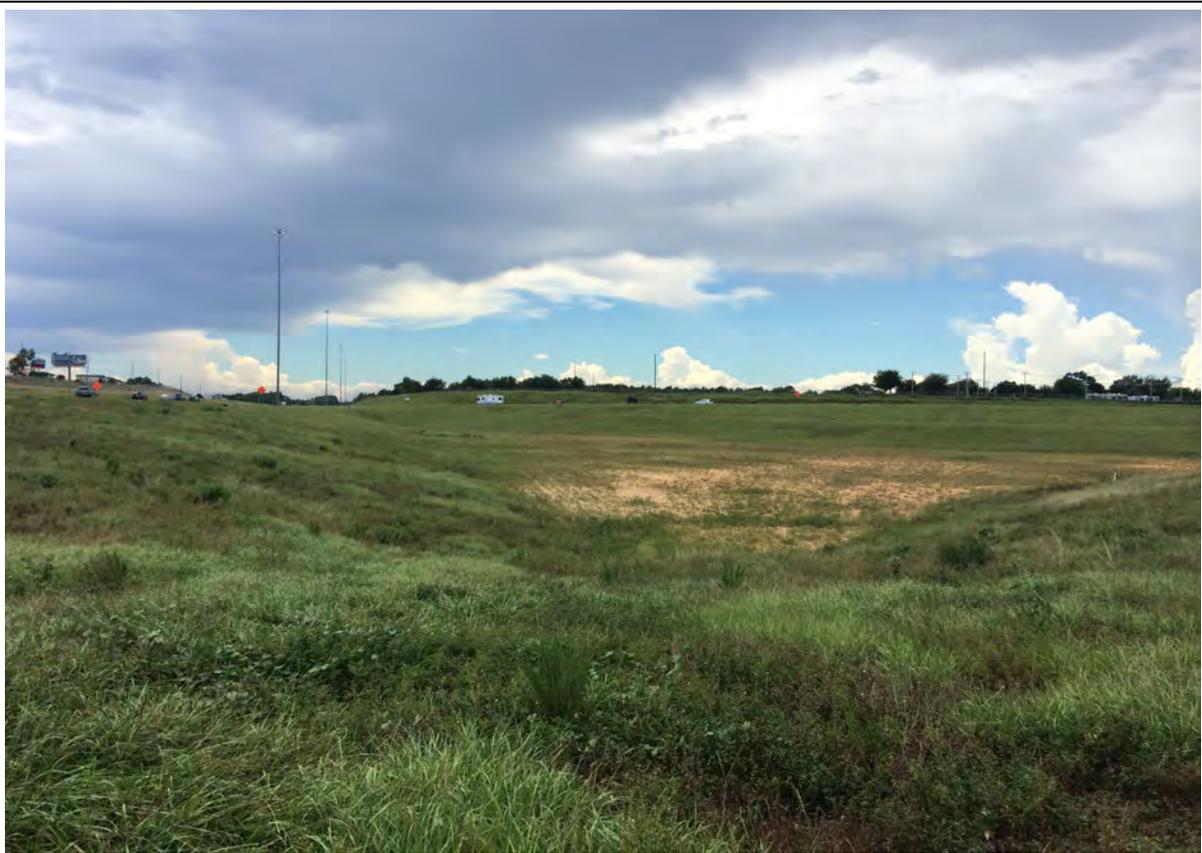
Pond Site 501A is located within the US 27 and I-4 interchange in the northwest quadrant. This is an existing pond site being reduced in size and regraded. The pond site is primarily maintained Bahia grass with some patches of cogon grass and planted trees for landscaping. No obvious signs of contamination were observed in the field for this site. This pond site is partially within the delineated Groundwater Contamination Plume #53263278 (Site #24), which is a known contamination plume from the agricultural pesticide EDB. This pond site was given a **MEDIUM RISK** rating based on the documented contamination present at the site.

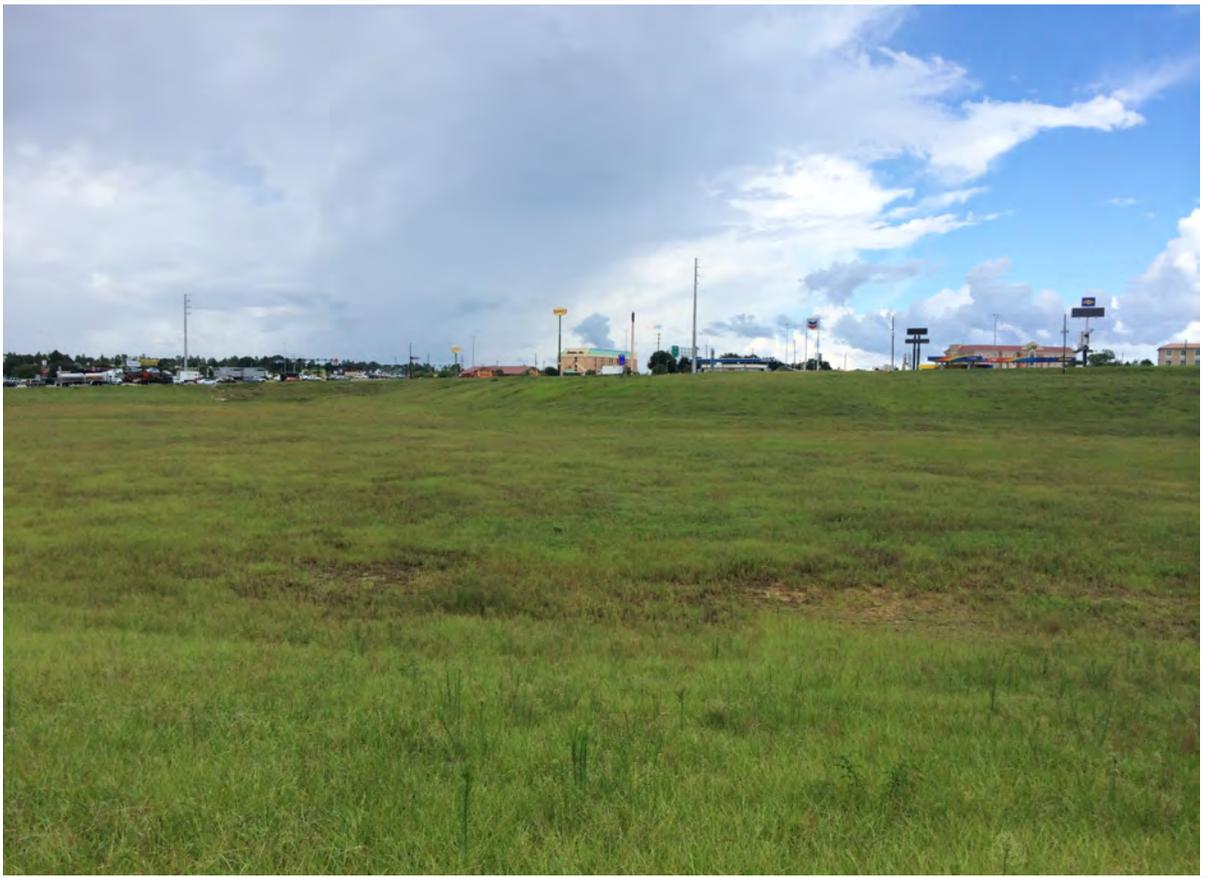
Pond Site 501B is located within the US 27 and I-4 interchange in the northwest quadrant. This is an existing pond site proposed to be expanded and regraded. The pond site is primarily maintained Bahia grass with some patches of cogon grass and planted trees for landscaping. No obvious signs of contamination were observed in the field for this site. This pond site is located along the northwest edge of the delineated Groundwater Contamination Plume #53263278 (Site #24), which is a known contamination plume from the agricultural pesticide EDB. This pond site was given a **MEDIUM RISK** rating based on the documented contamination present at the site.

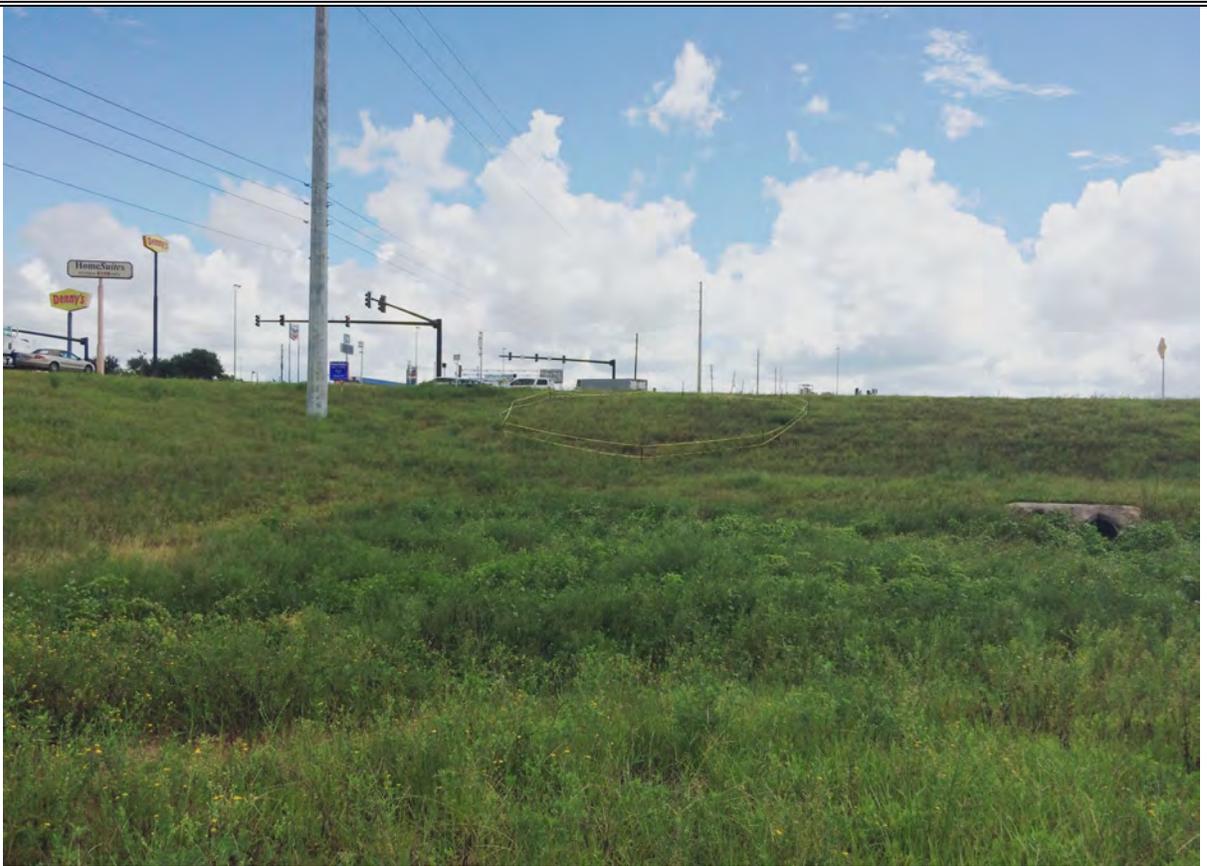
Pond Site 501C is located within the US 27 and I-4 interchange in the northwest quadrant. This is an existing pond site proposed to be regraded. The pond site is primarily maintained Bahia grass with some patches of cogon grass and planted trees for landscaping. No obvious signs of contamination were observed in the field for this site, but this pond site may have been historically used for citrus production based on historic aerials and nearby land use. This pond site was given a **LOW RISK** rating based on no documented contamination.

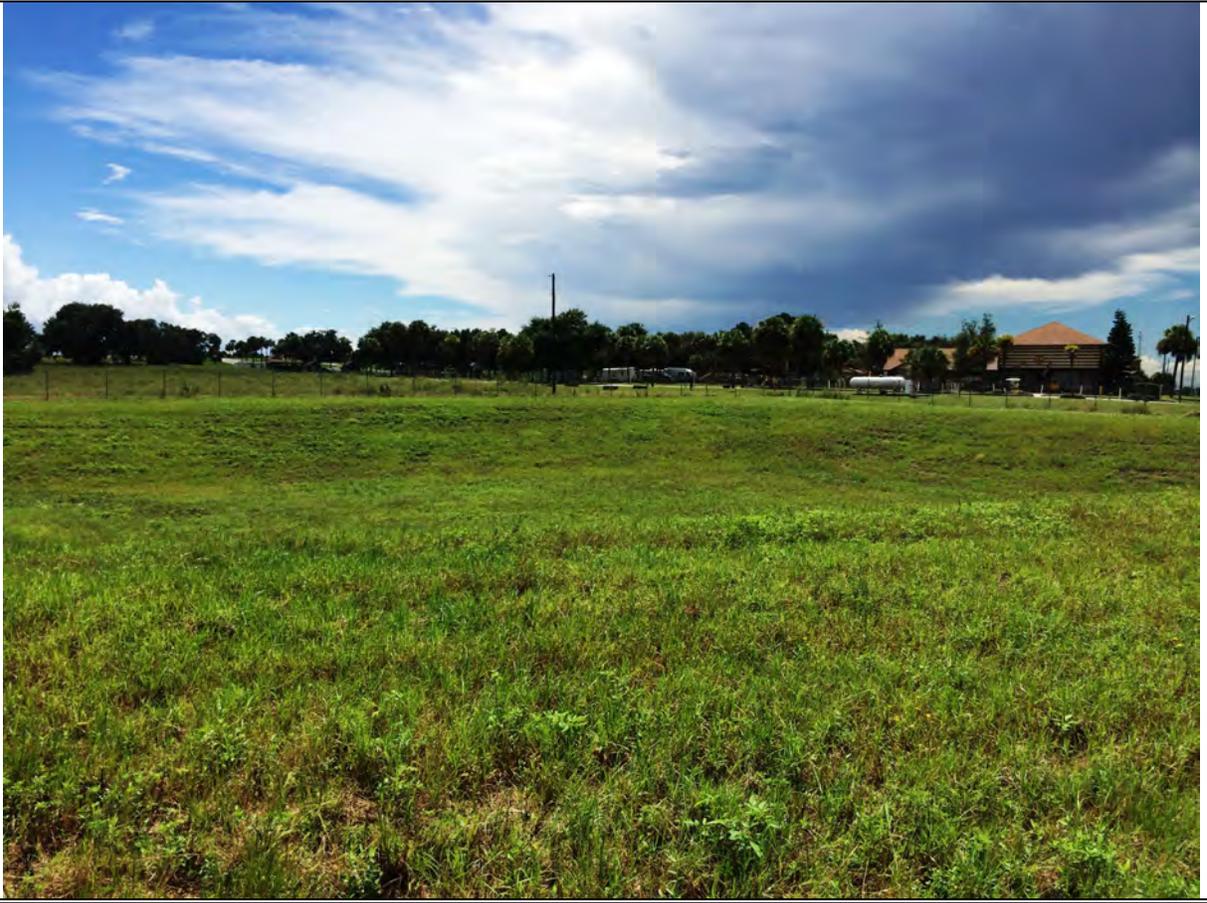
Pond Site 502 is located southwest of the intersection of Frontage Road and Southwest Access Road. This is an existing pond site, no modifications are proposed. The pond site is primarily maintained Bahia grass. No obvious signs of contamination were observed in the field for this site, but a drum labeled "bleach" (Site #18) was observed approximately 50 feet south of the pond site. No signs of contamination or a release from the drum were observed. This pond site is within the delineated Groundwater Contamination Plume #53263278 (Site #24), which is a known contamination plume from the agricultural pesticide EDB. This pond site was given a **MEDIUM RISK** rating based on the documented contamination located near the site, but further investigation may not be warranted due to there being no modifications proposed for this pond site.

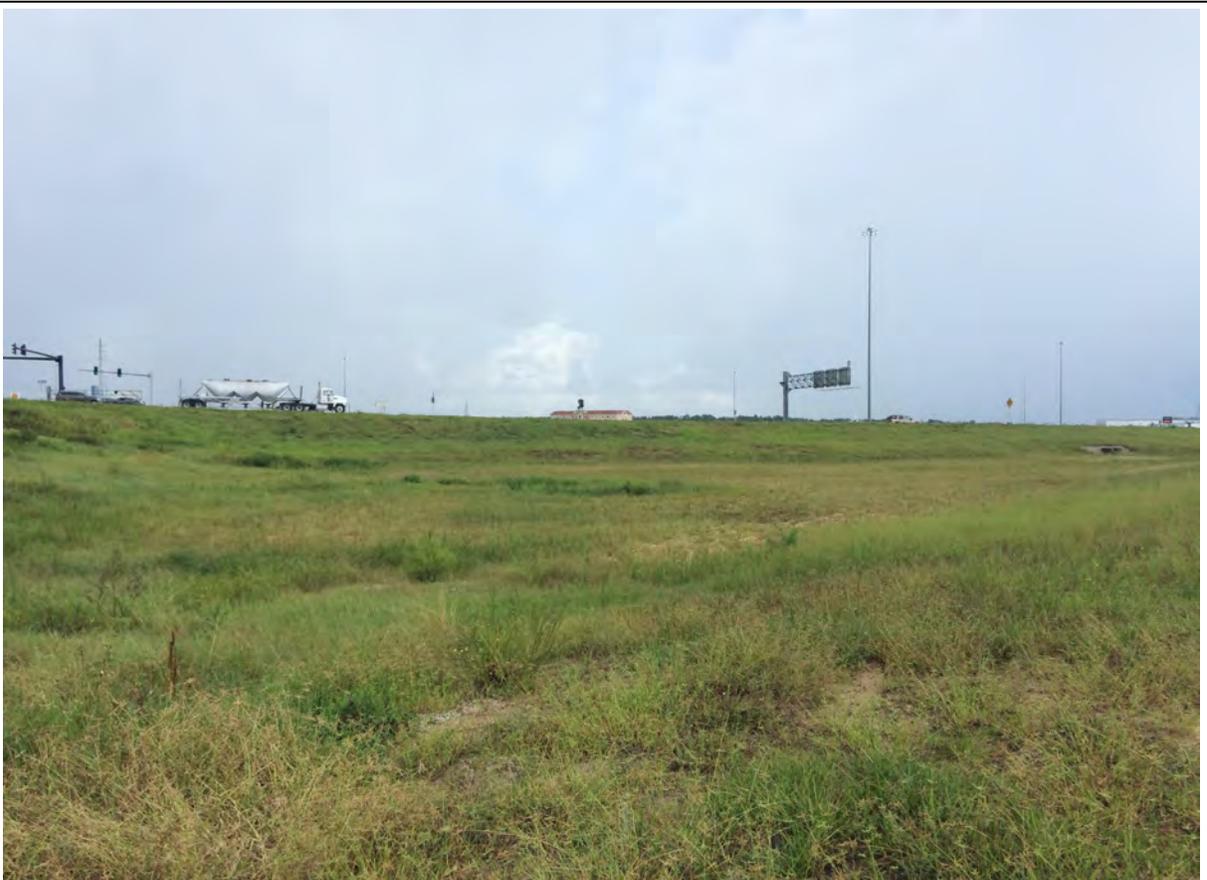
Pond Site 503A is located within the US 27 and I-4 interchange in the southeast quadrant. This is an existing pond site proposed to be reduced in size and regraded. The pond site is primarily maintained Bahia grass and planted trees for landscaping. No obvious signs of contamination were observed in the field for this site. This pond site is within the delineated Groundwater Contamination Plume #53263278 (Site #24), which is a known contamination plume from the agricultural pesticide EDB. This pond site was given a **MEDIUM RISK** rating based on the documented contamination present at the site.

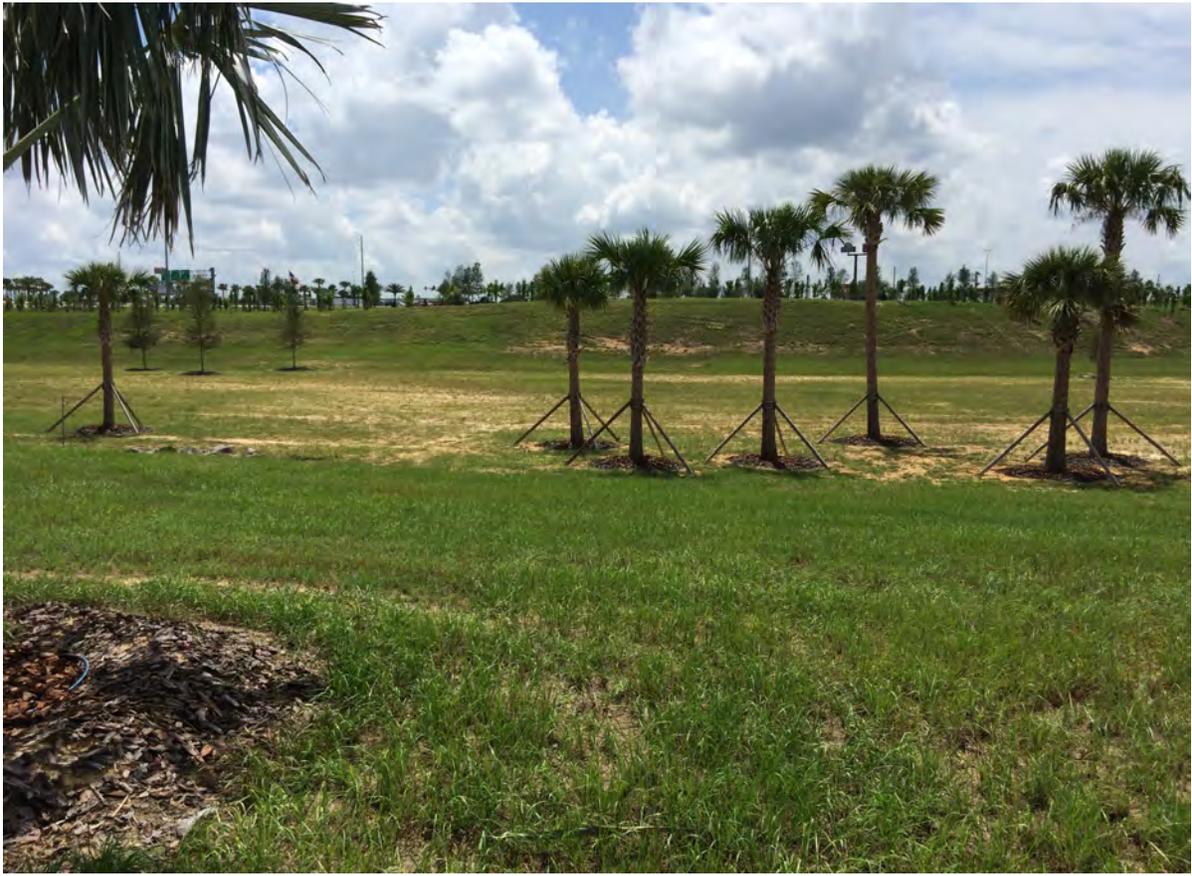
Pond Site 503B is located within the US 27 and I-4 interchange in the southeast quadrant. This is an existing pond site which is proposed to be enlarged and regraded. The pond site is primarily maintained Bahia grass with some patches of cogon grass and planted trees for landscaping. No obvious signs of contamination were observed in the field for this site. This pond site is within the delineated Groundwater Contamination Plume #53263278 (Site #24), which is a known contamination plume

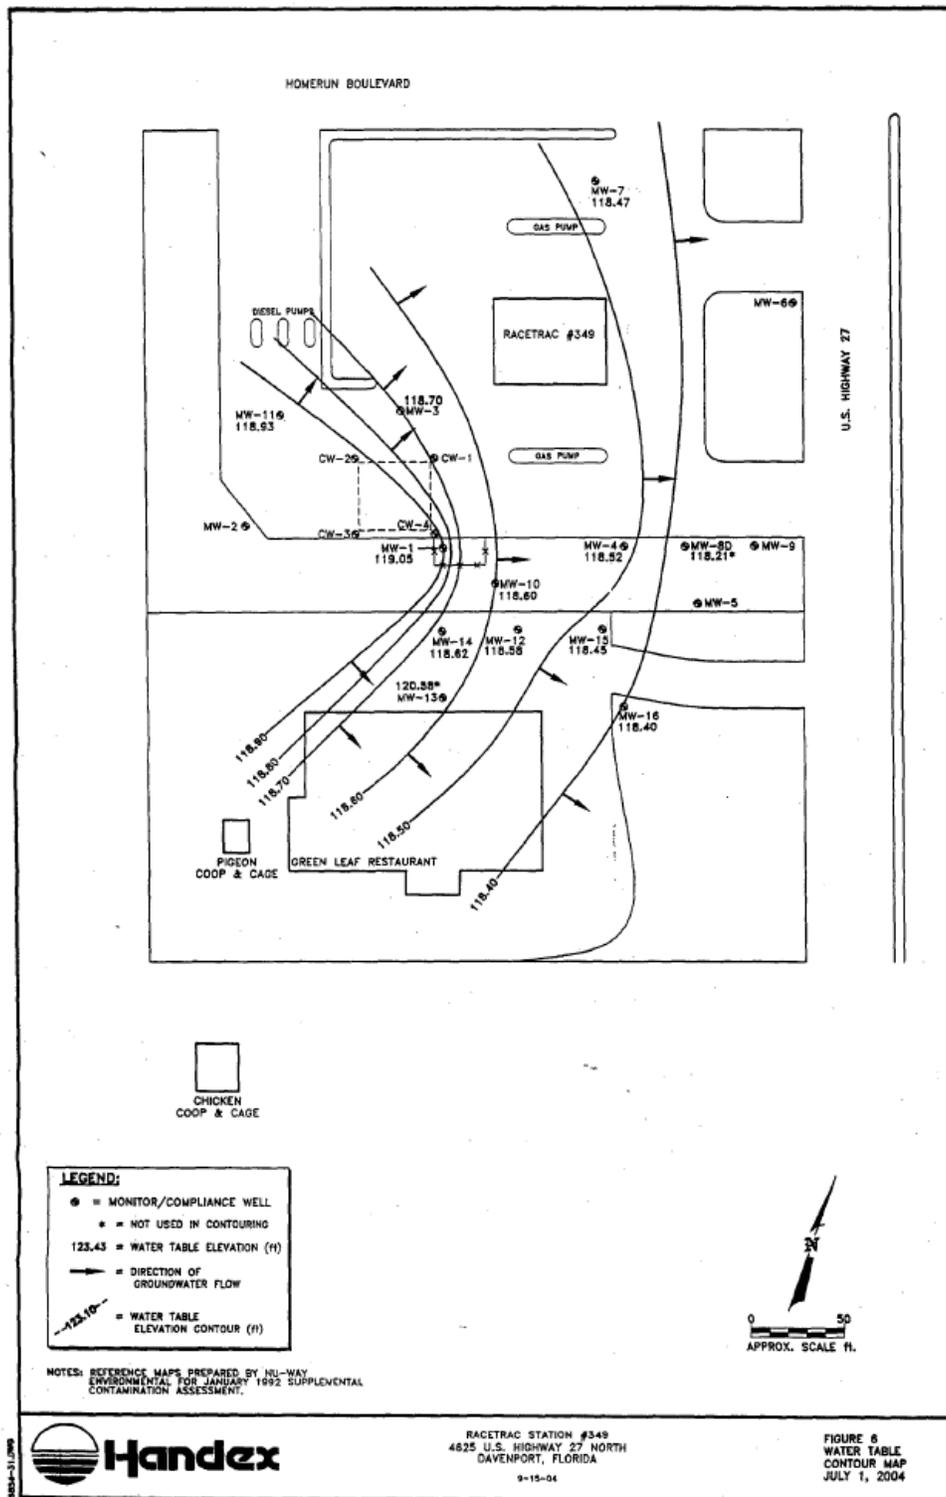
Site 6: Racetrac #2338 – Water Table Contour Map of old Racetrac station – by Handex Inc.

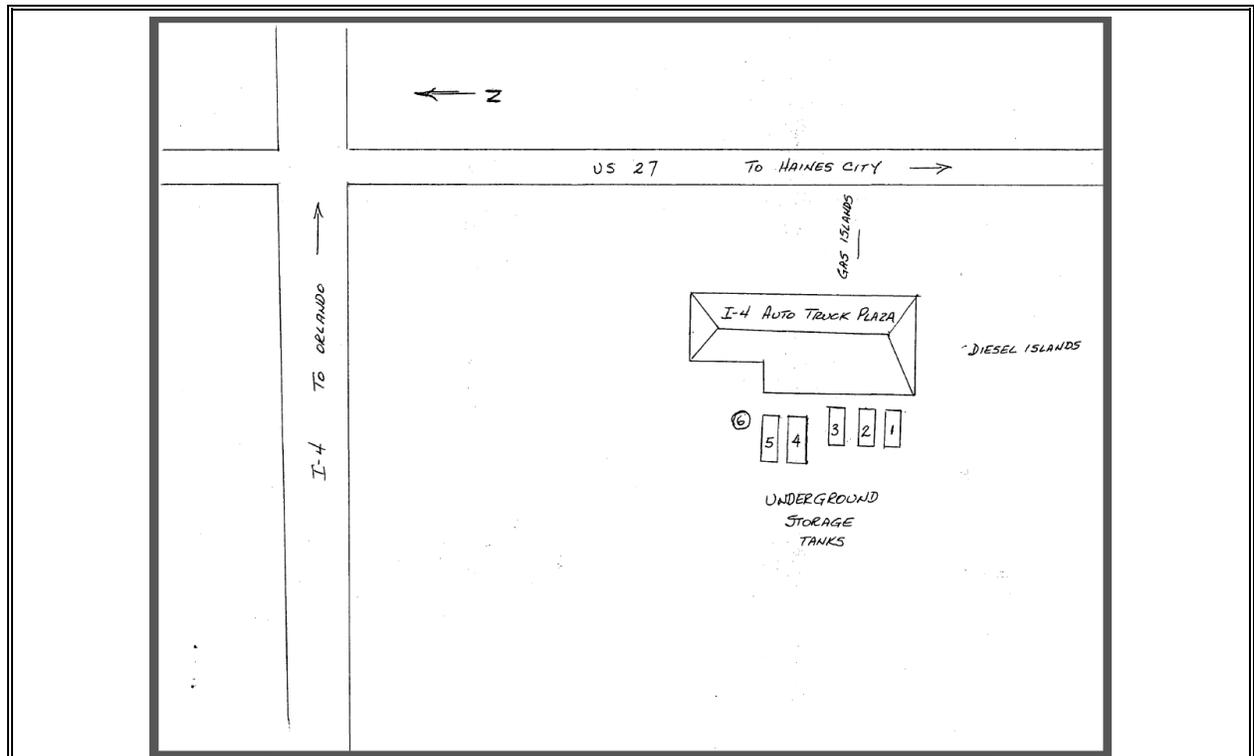
Site 11: I-4 Auto Truck Plaza – Historic location sketch

APPROX
LOCATION
OF OLD
SCALE

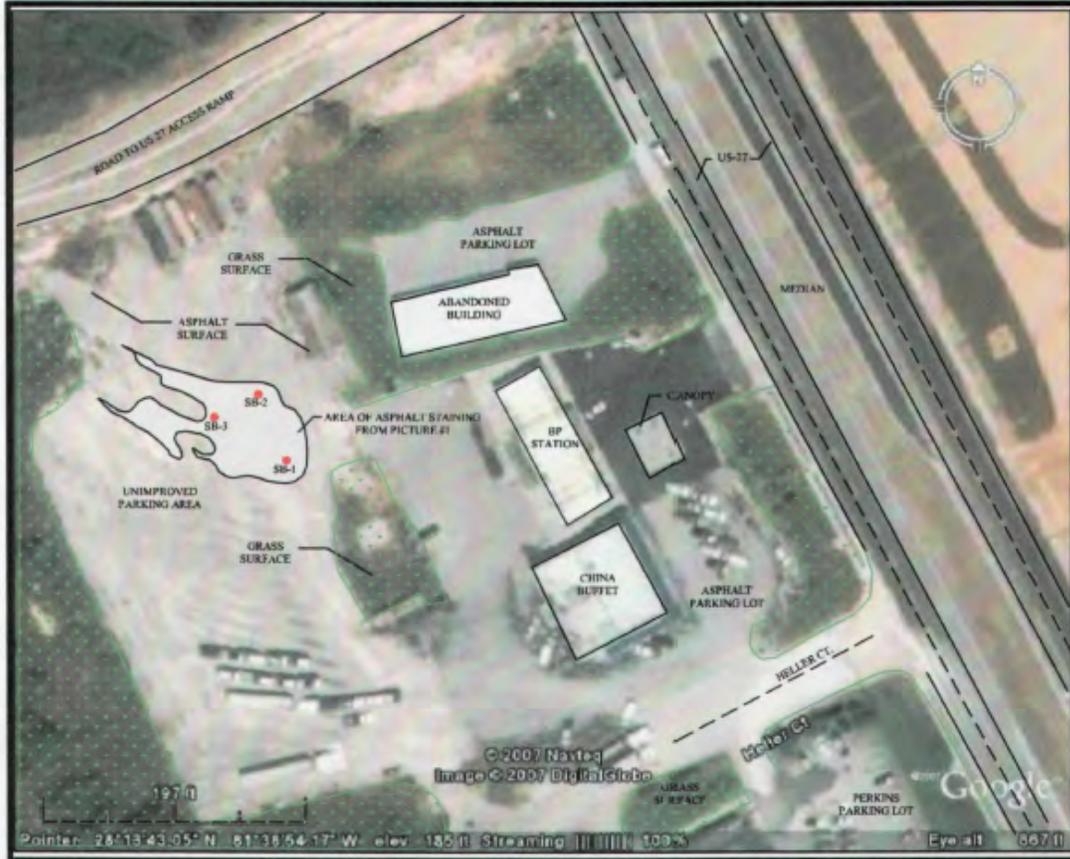
Site 14: Florida Novelty Works Property – Site Location Map and Soil Boring Locations by Environmental & Analytical Management Inc.

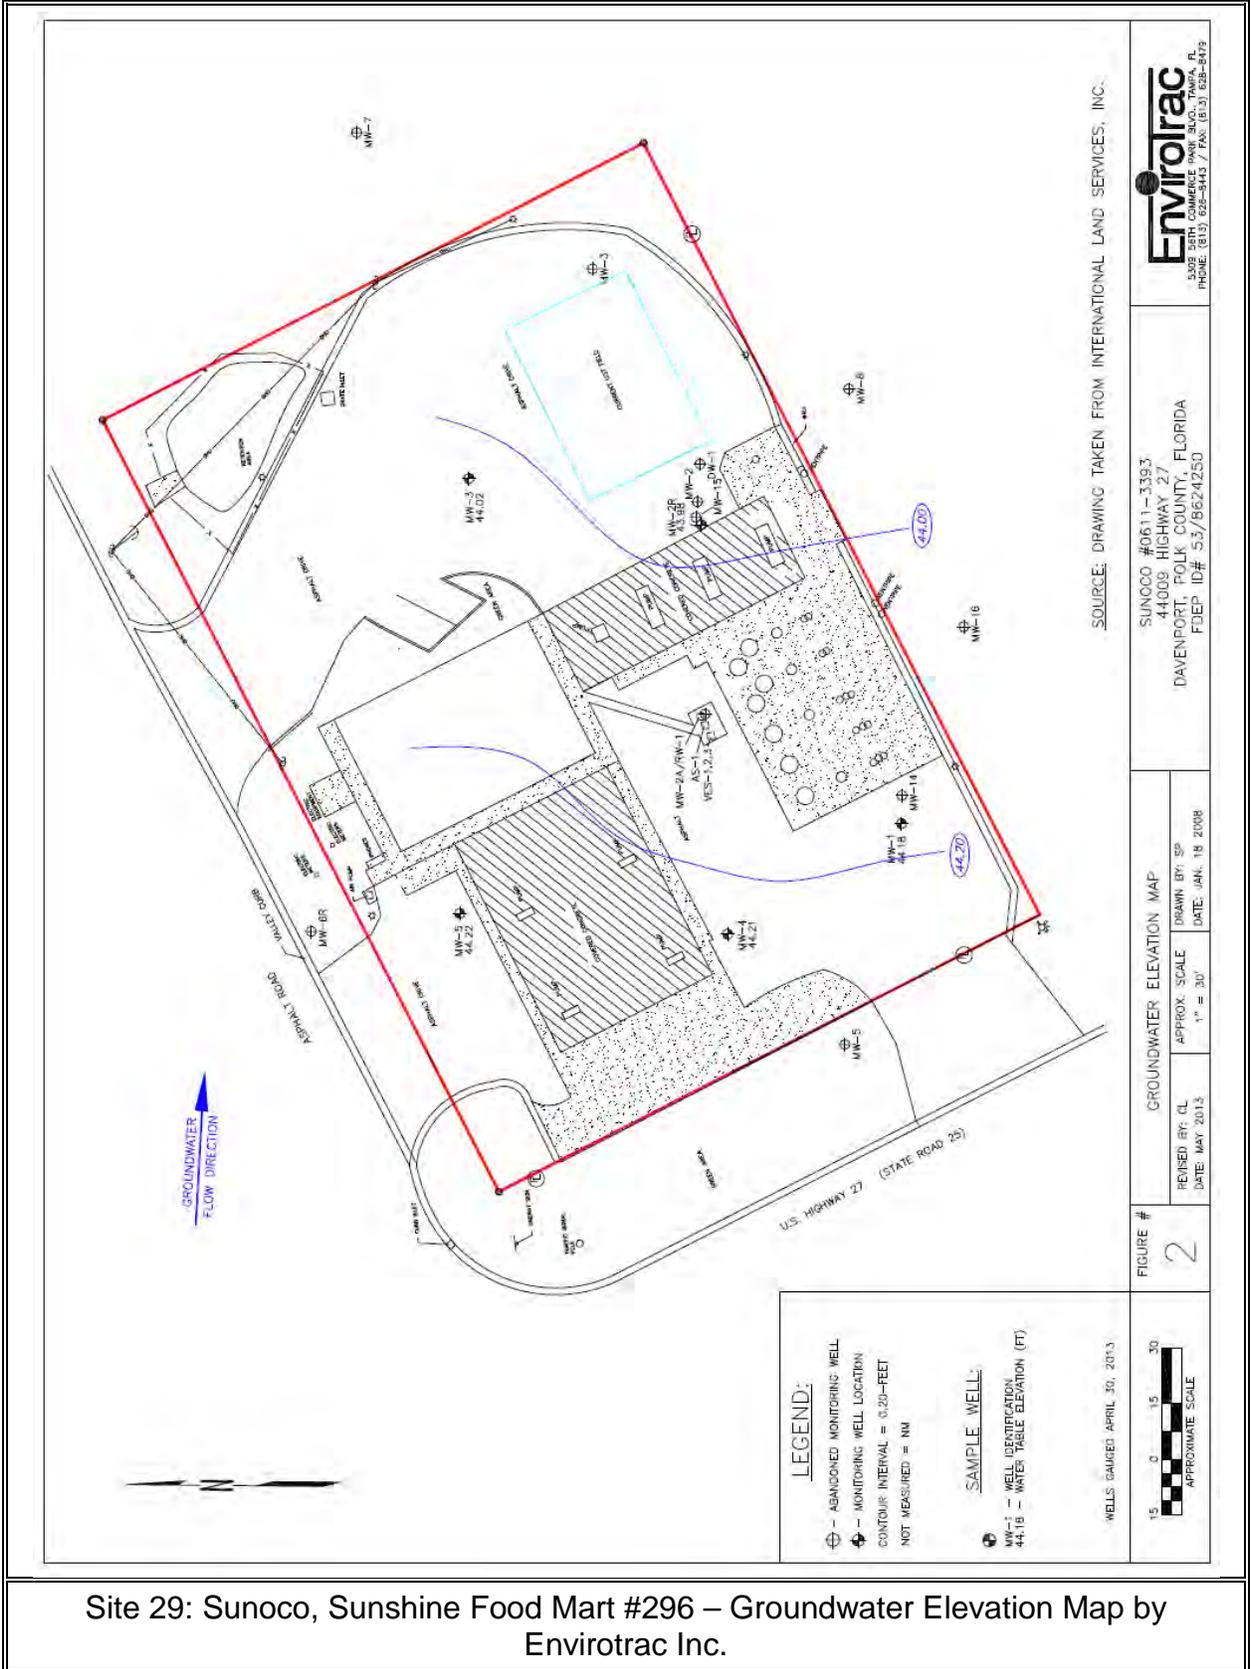
Site 29: Sunoco, Sunshine Food Mart #296 – Groundwater Elevation Map by Envirotrac Inc.
